Salt River Ecosystem Restoration Project

Adaptive Management Plan Monitoring Report 2020

Finalized February 2021

Prepared by the Humboldt County Resource Conservation District
5630 South Broadway
Eureka, CA 95503
707.442-6058 ext. 5
hcrd@gmail.com

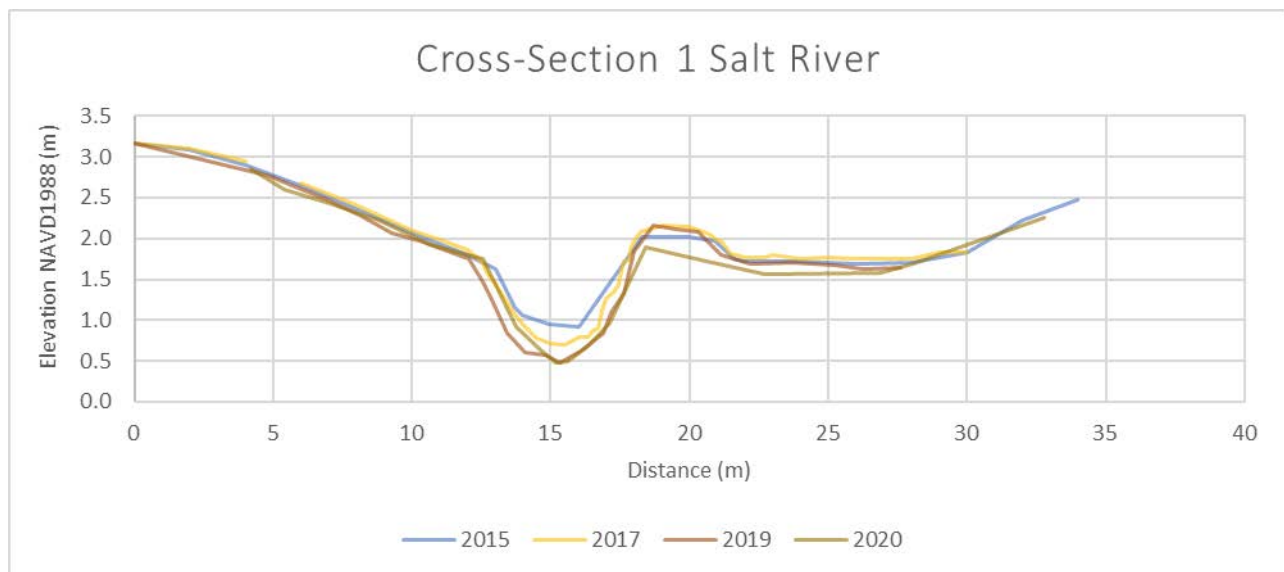
Figure 3: Cross-section one, profile for years 2015-2020.

The profile for cross-section one (figure 3) indicates some possible deposition on the left side of the channel since 2019, however is consistent with surveyed channel morphology in

previous years. Channel bottom elevation is consistent with the 2019 survey. Since the original survey in 2015, the channel elevation has dropped by 0.42 meters. The coarse resolution on the active channel berm, above the right side of the channel, does not capture the relief of the feature. Possible minor scour and elevational lowering of 0.14 meters occurred on the floodplain compared to previous years.

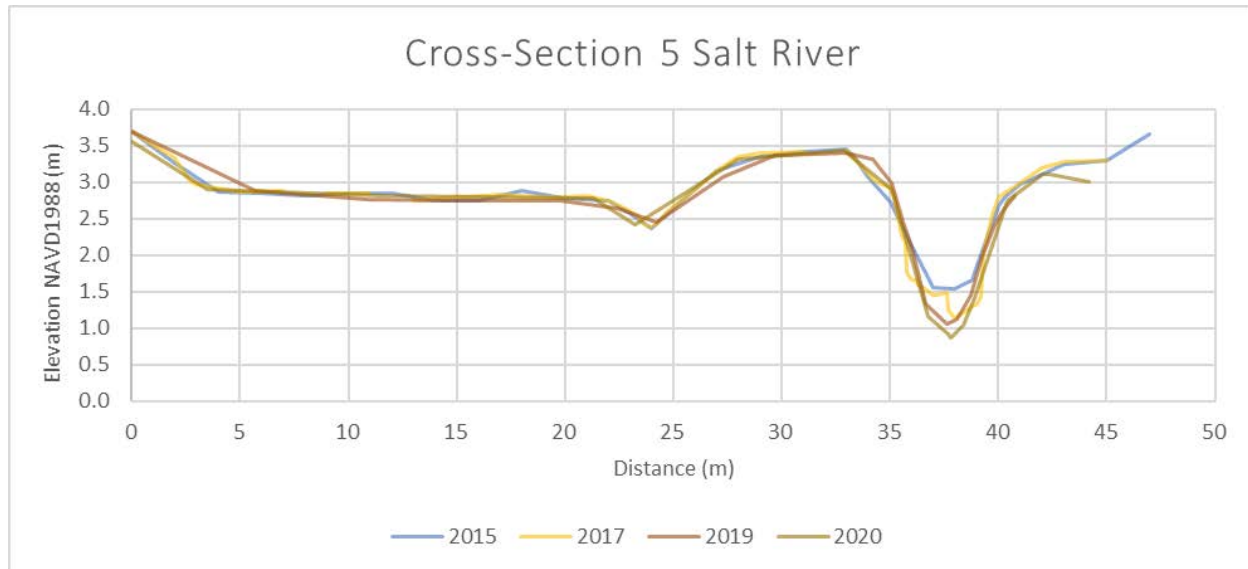
Figure 4: Cross-section five, profile for year 2015-2020.

Cross-section five closely maintained a similar configuration with 2019's survey, with a decrease in thalweg elevation of 0.19 m from the previous year (figure 4). Overall, the channel bottom has decreased by 0.57 meters since 2015. The cross-sectional profile shows floodplain elevations consistent with previous survey years.

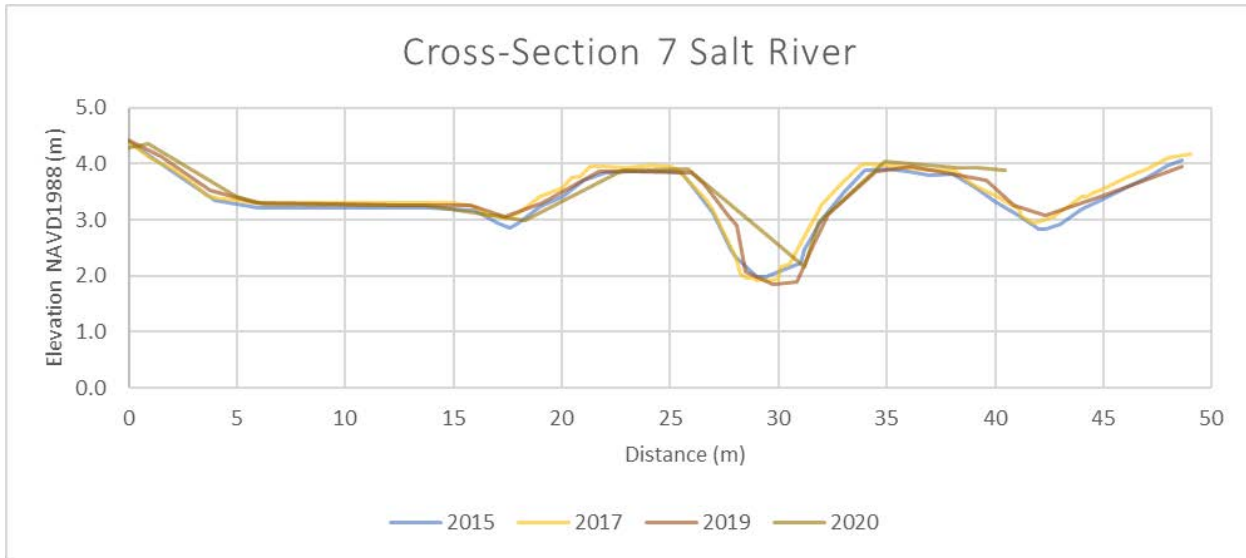
Figure 5: Cross-section seven, profile for years 2015-2020.

Current and previous surveys show consistent floodplain and active berm elevations for cross-section seven (figure 5). However, the collection of the 2020 active channel data points are far too coarse to compare them to previous surveys. This may have been due to high water levels in the channel. Some deposition appears to have occurred in 2019 on the left side of the channel and scour on the right channel bottom and side, resulting in slight widening and decrease in thalweg elevation of 0.26 m compared to 2018. Channel geometry remains relatively stable with potential for more lateral migration based on visual observation in the field of slumping on the right bank.

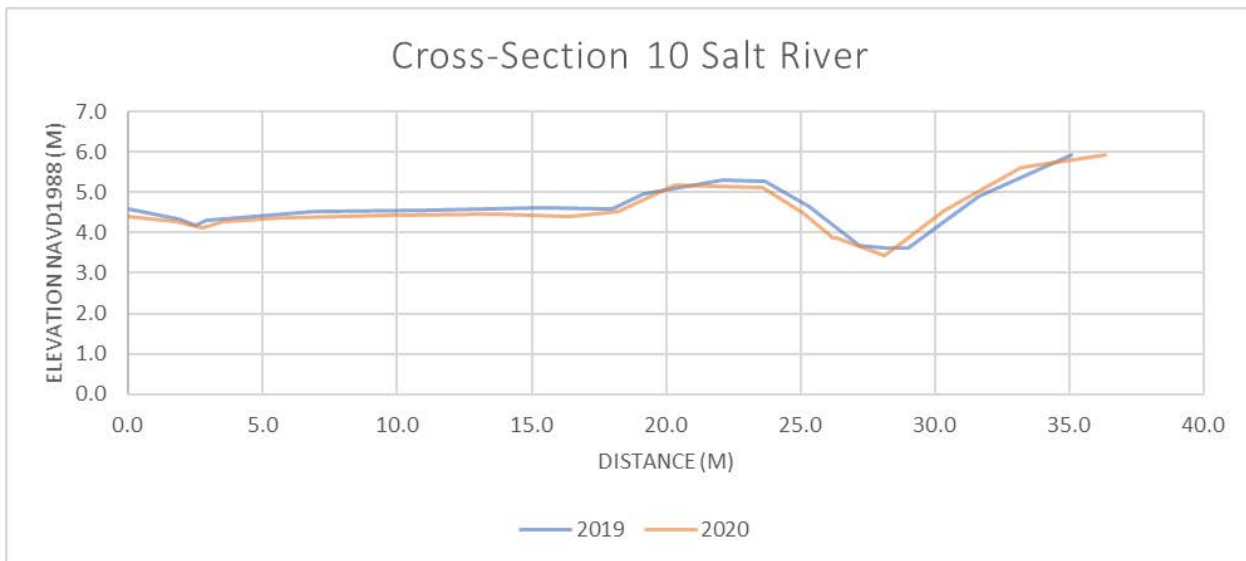
Figure 6: Cross-section ten, profile for year 2019.

Cross-section ten was established in 2019 on a reach of the restored Salt River that was constructed in 2018 (figure 6). The Salt River constructed upstream of cross-section ten is not connected to a perennial water source as of 2021. Therefore, water entering the system upstream of cross-section ten is surface runoff during winter rain events. The deviations of surveyed points between years maybe due to typical surveying error, though some scour may have occurred in the channel bottom (0.19 meters). Deposition is unlikely on channel sides.

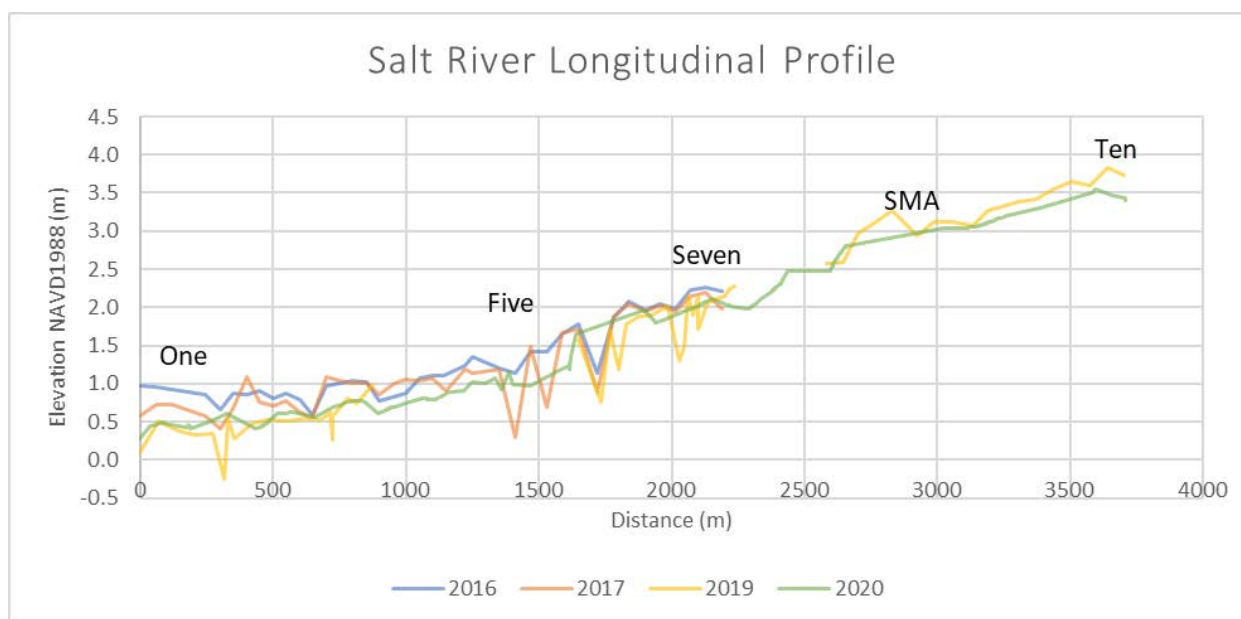
Figure 7: Phase 2 longitudinal profile

The longitudinal profile spans a distance of 3,700 meters and is presented between years 2016 and 2020. Cross-section sites are labeled to show approximate locations. The sediment management area (SMA) on Francis Creek, at the confluence of the Salt River, is also shown. Data resolution is coarser in portions of the reach due to dense vegetation and excessive water depth. In agreement with cross-sectional surveys, the longitudinal profile shows a dominant trend of scouring as illustrated by reductions in elevation throughout majority of the channel. However, the 2020 survey did not capture the scour holes between 400 meters to 2,200 meters. This may be due to the increased water level heights during the time of the survey. Notably, the 2019 deposition immediately downstream of the SMA was not captured in the 2020 profile due to lack of data points taken in that reach. In-channel vegetation in that reach was thick and in late 2020 vegetation was removed in a 200-foot reach in that area. Overall, the 2020 profile was consistent with the recent 2019 survey (figure 7).

In total, the data shows trends of decreased channel bottom elevations and potential net sediment transport out of the project area, which is consistent with past survey years. Channel degradation is most prominent in the downstream portions of the river as indicated by mean bed lowering in the longitudinal profile and lower thalweg elevations in cross-sectional profiles compared to previous years. In previous years' surveys, the downstream section had relatively uniform bed lowering, whereas the upstream portion had more variable scour patterns leading to incipient pool formation and greater morphological complexity.

Future geomorphic surveys are required. It is recommended that surveys occur in the late fall when water levels are at their lowest in order to collect sufficient points for high resolution depiction of the active channel and when tree leaf vegetation is sparse as to not interfere with equipment collecting data.

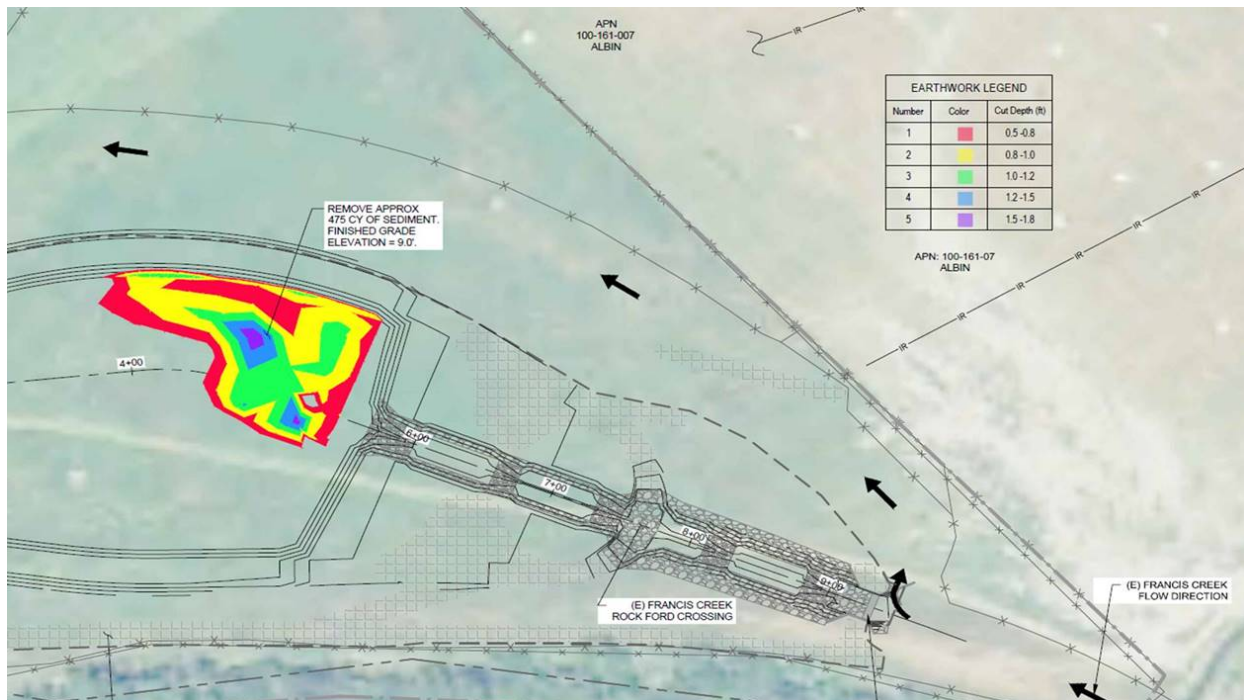
Results & Discussion: The active sediment management area at the confluence of Francis Creek and Salt River was constructed in the fall of the 2017 and experienced its third winter. By spring of 2020, the SMA captured an estimated amount of 475 cy of sediment (Figure 9). The SMA can accommodate up to 15,000cy, therefore no excavation occurred in the summer/fall of 2020. Sediment volumes will be assessed in the spring of 2021.

Figure 9. Geomorphic survey of the sediment management area and estimated captured sediment volume (475 cy).

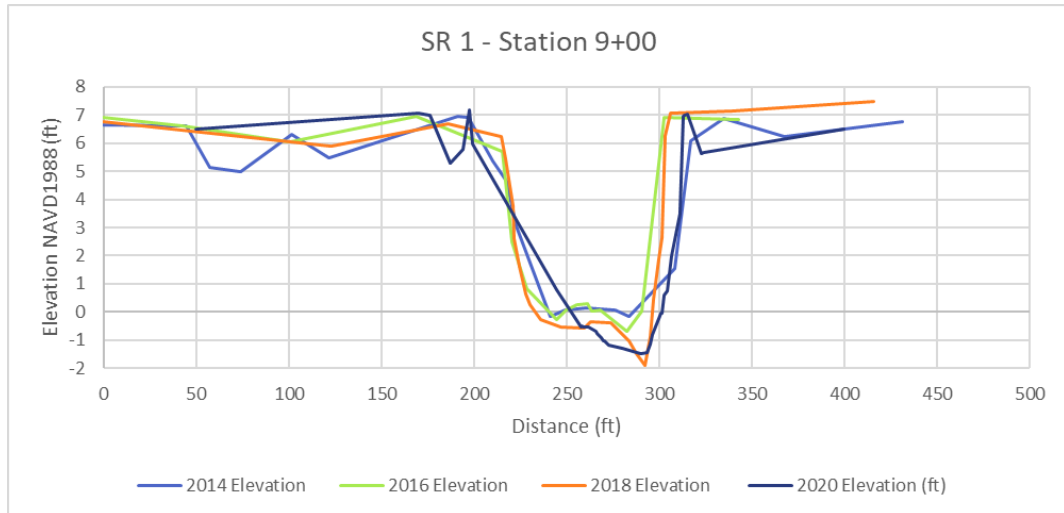
Results and Discussion: Cross section profiles of the main channel indicate that the SR1 and SR2 has predominately experienced scour and deposition (Figures 11 and 12). SR2 channel capacity is estimated to have decreased by approximately 13% from possible side bank deposition. SR3 channel shape remains relatively stable compared to recent years but experienced deposition between 0.25ft and 0.5ft throughout the channel width compared to the 2014 cross section (Figure 13).

Figure 11. SR1 – Salt River main channel cross section for selected years between 2014 and 2020

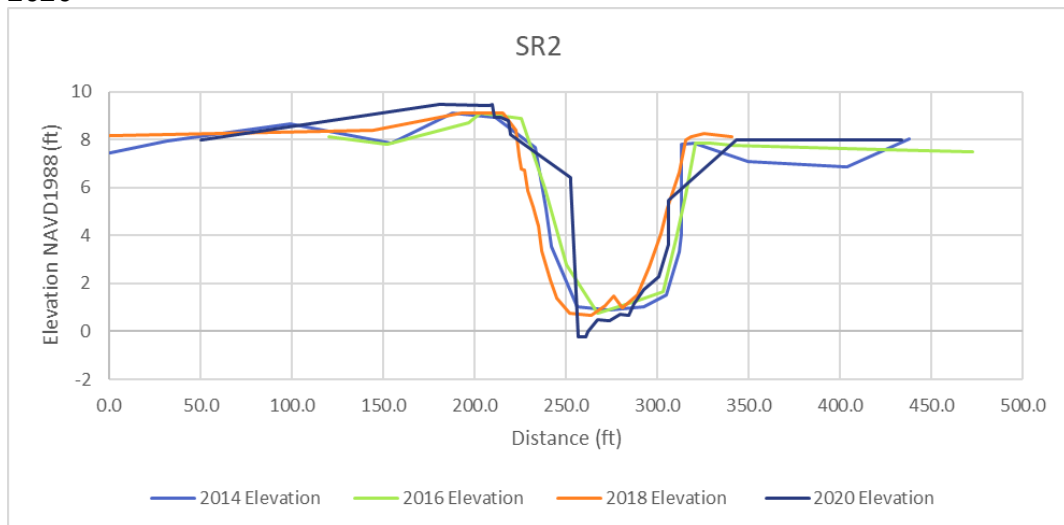
Figure 12: SR2 – Salt River main channel cross section for selected years between 2014 and 2020.

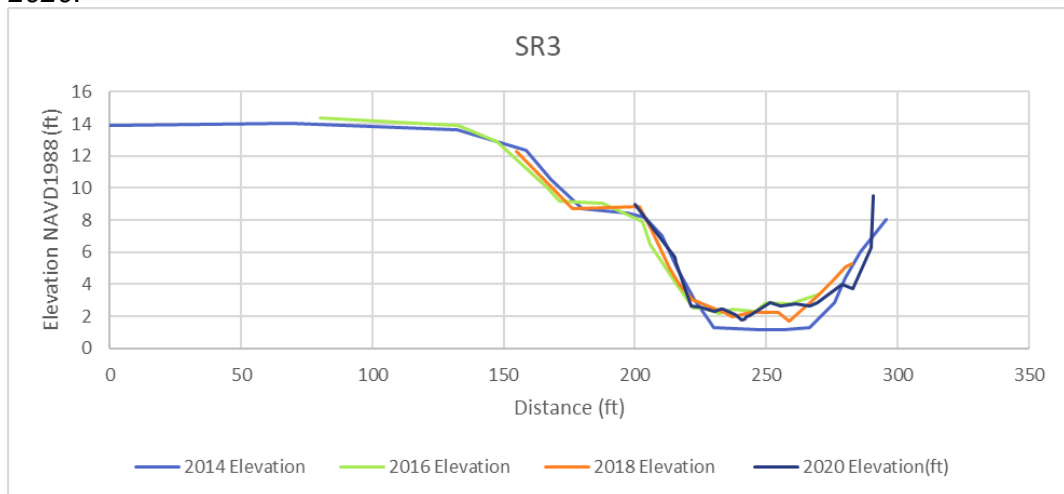
Figure 13. SR3 – Salt River main channel cross section for selected years between 2014 and 2020

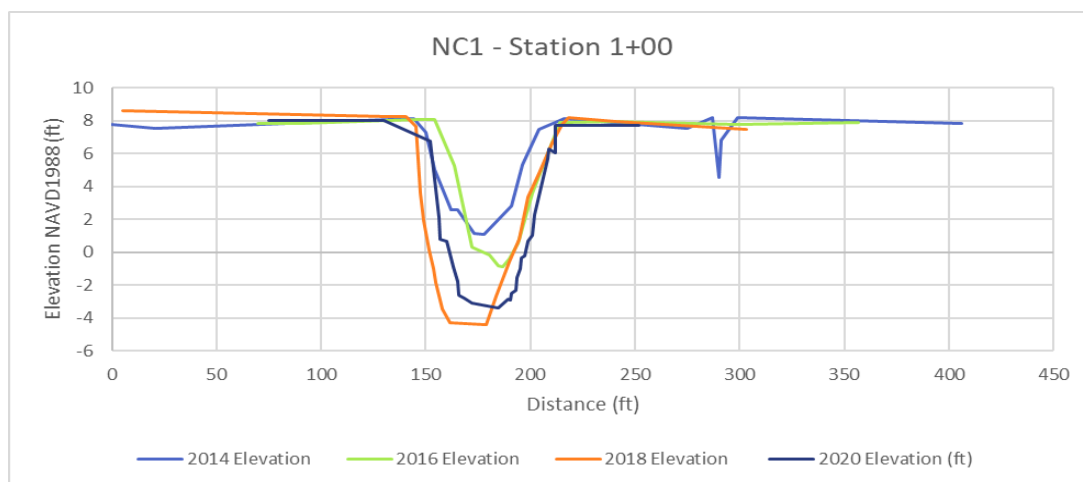
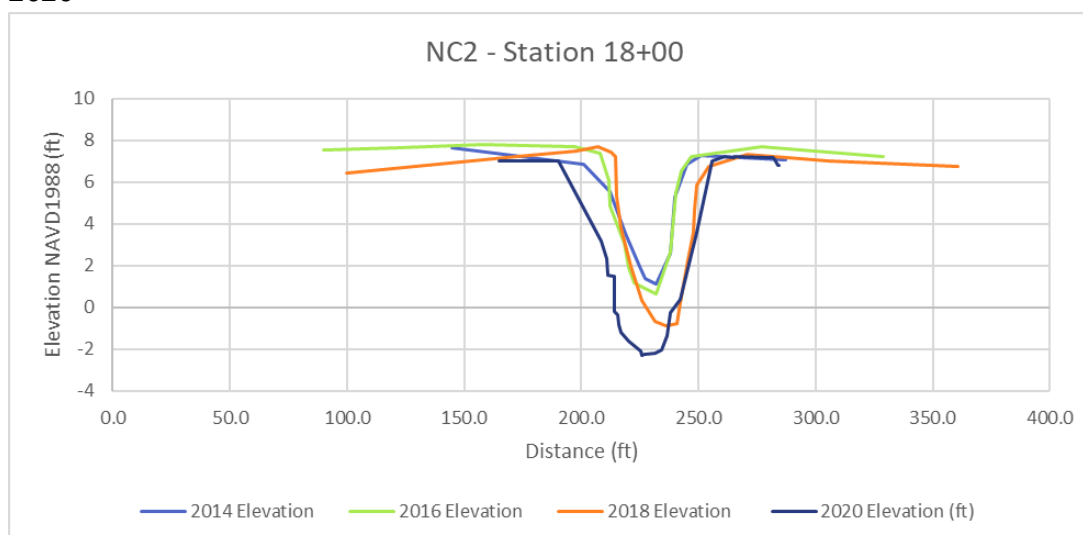
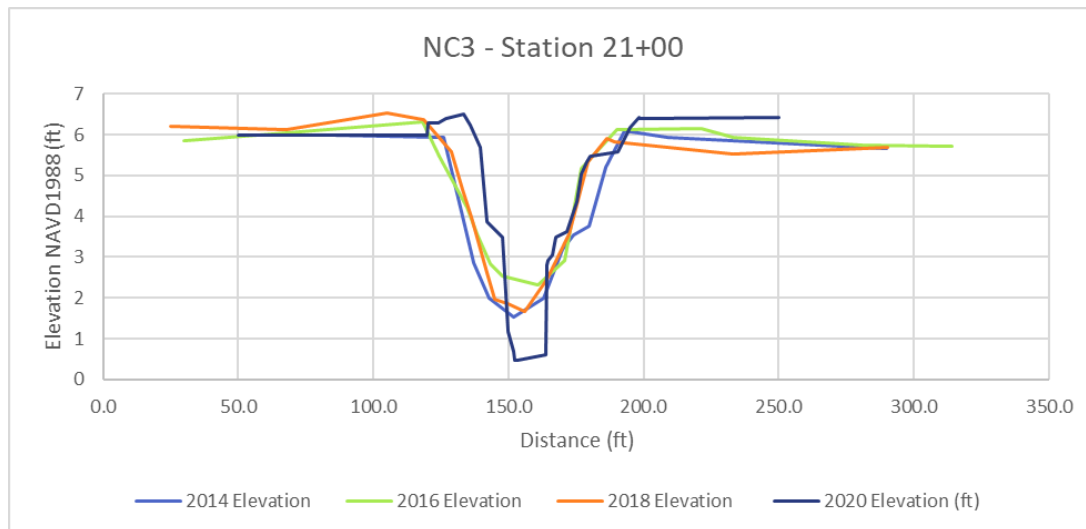
The Northern slough channel cross section profiles show a general trend of deepening in the upper reaches of the slough channels and minor deposition in the lower reach. NC1 has appeared to have deposition in the channel bottom since 2018, however overall scour has significantly occurred since 2014 (Figure 14). NC2's capacity has significantly increased and has continued to increase since 2014. NC2 capacity has increased by 150% since 2014 and by 64% since 2018. Scour at this site is dominantly reducing elevation (deepened by 0.78ft since 2017) while widening of the channel increases at a lower rate (Figure 15). The 2020 cross section at NC3 depicts the channel as deepening and incising with deposition occurring on the sides of the channel (Figure 16).

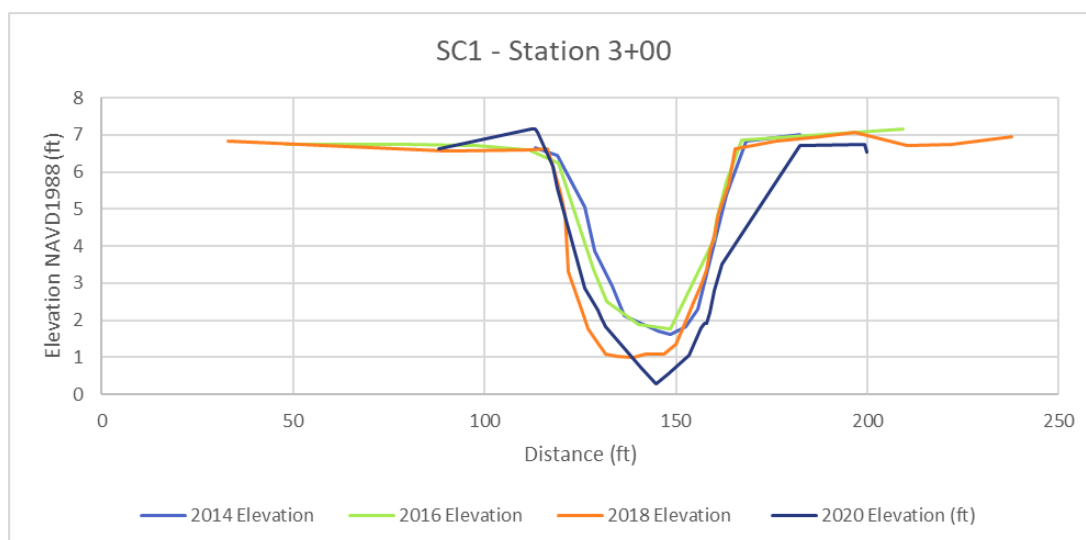
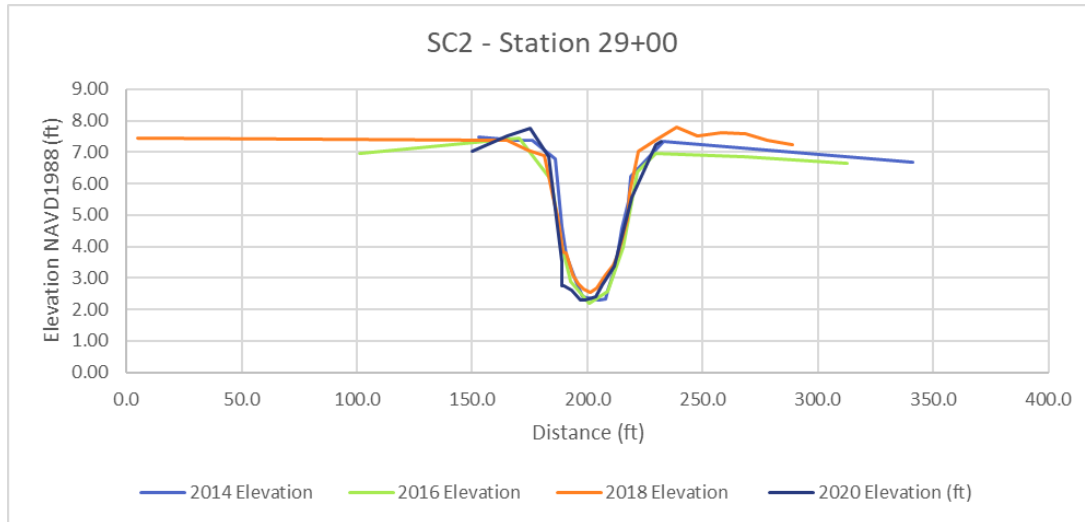
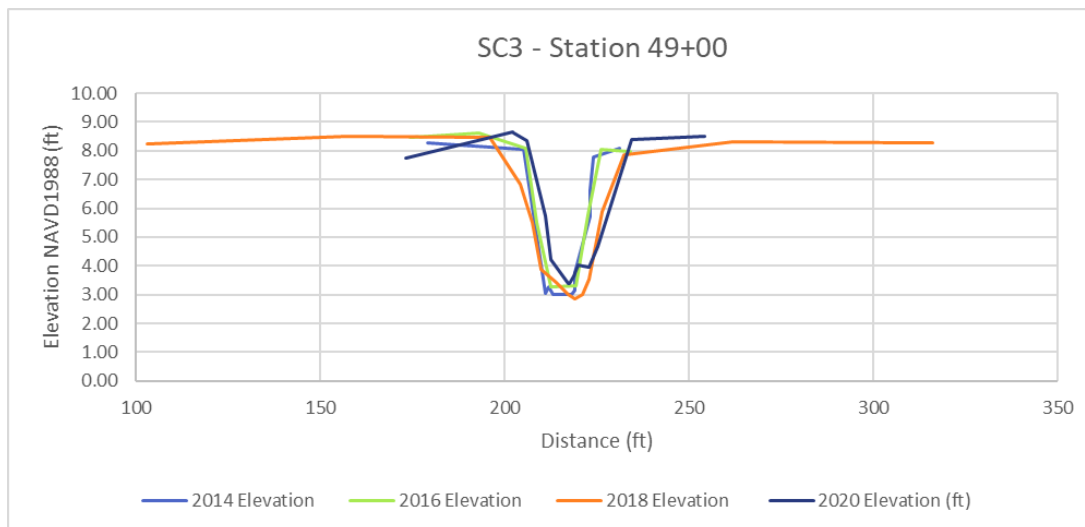
The Southern slough channel cross-sectional profiles indicate that the mid and upper portions of the project area have undergone the least morphological change while the lower reach of the slough channel experienced larger modifications by environmental factors. SC1 showed lateral migration of the right bank from 2014 and 2018 (10 to 15ft) and change in thalweg elevation of eight inches since 2014 and 1.4ft since 2018 (Figure 17). Therefore, capacity increased by approximately 15% since 2018. SC2 uniformly remained primarily unchanged from pervious years' surveys (Figure 18). SC3 experienced a decrease in capacity with approximately 0.3 ft. of aggradation along the channel bottom and 4ft of deposition along the left bank (Figure 19) equating to approximately a 25% change in capacity.

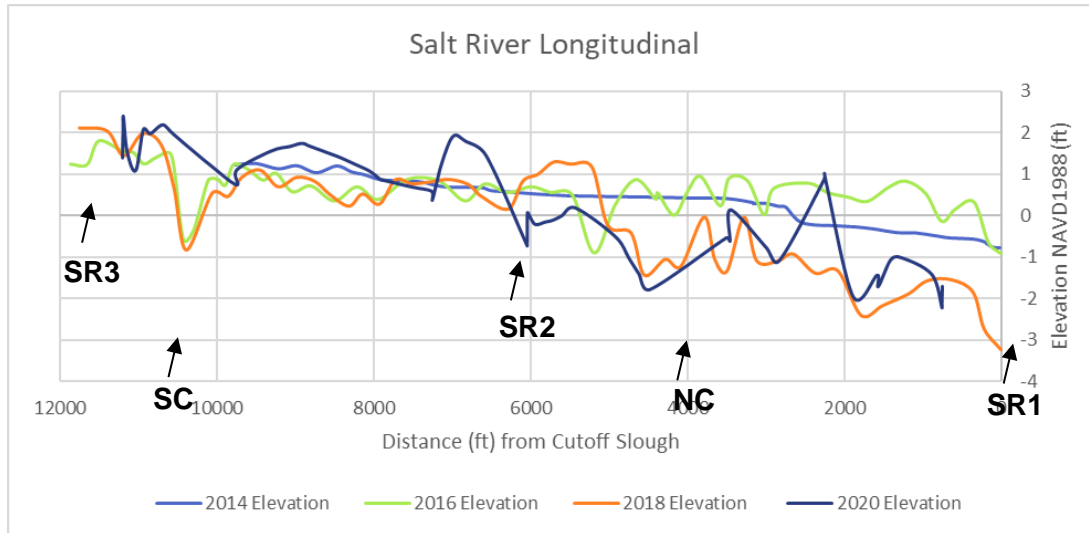
The total relief on the approximate 11,200-foot longitudinal profile section of the main Salt River channel surveyed in 2020 is 4.6 feet, yielding an average gradient of 0.41% per thousand feet, which is a 0.11% increase from 2018 (Figure 20). Compared to the 2018 survey, the dominant trend in the 2020 main channel longitudinal profile was deposition, most notably in the upper and lower reaches. However, comparing the 2020 to the 2014 and 2016 surveys, deposition occurred in the upper half of the reach and scoured in the lower half.

Figure 20. Salt River Longitudinal surveys for selected years between 2014 and 2020

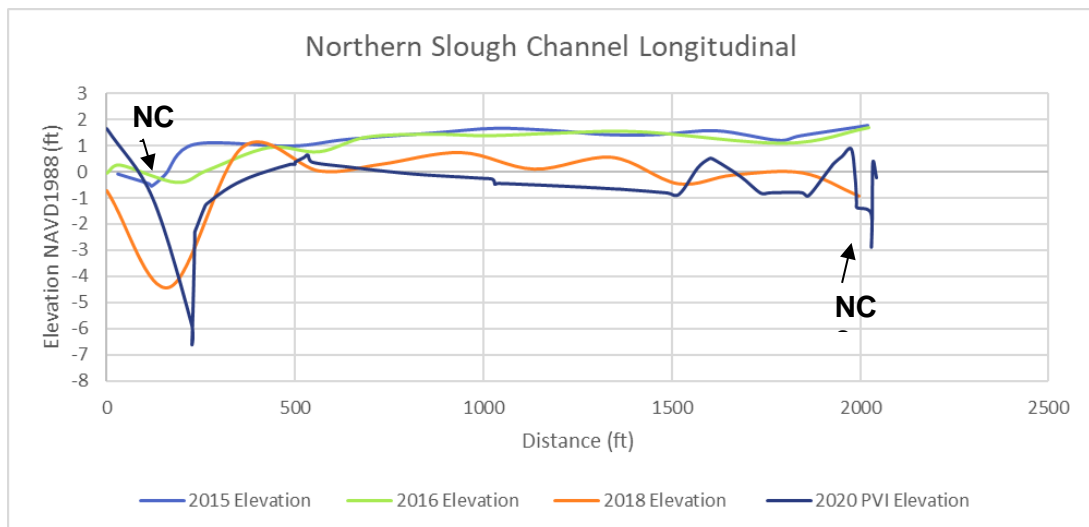
The longitudinal profile of the NC for 2020 indicates scouring throughout almost the entirety of the channel reach with the exception of approximately one foot of deposition on either side of the cross section NC2 (Figure 21). Degradation of the channel was relatively consistent, with considerable thalweg scour occurred at the beginning of the reach (at NC1) and undercutting of the bank was observed.

Figure 21. Northern Slough Channel Longitudinal surveys for selected years between 2014 and 2020

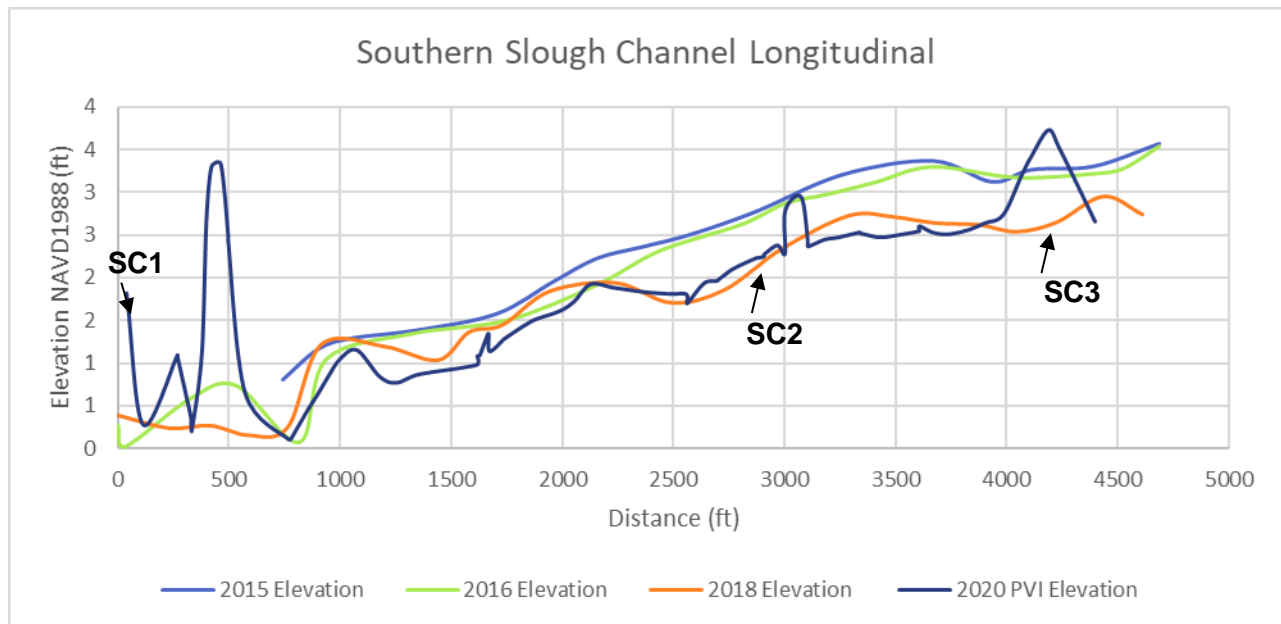
The 2020 longitudinal profile for the southern slough channel is relatively consistent with previous surveyed channel elevations, excluding significant deposition in the lowest (500 ft) and upper (4,500 ft) sections. These sites experienced six feet and 2.5 feet of deposition, respectively, compared to the 2018 profile (Figure 22).

Figure 22. Southern Slough Channel Longitudinal surveys for selected years between 2014 and 2020

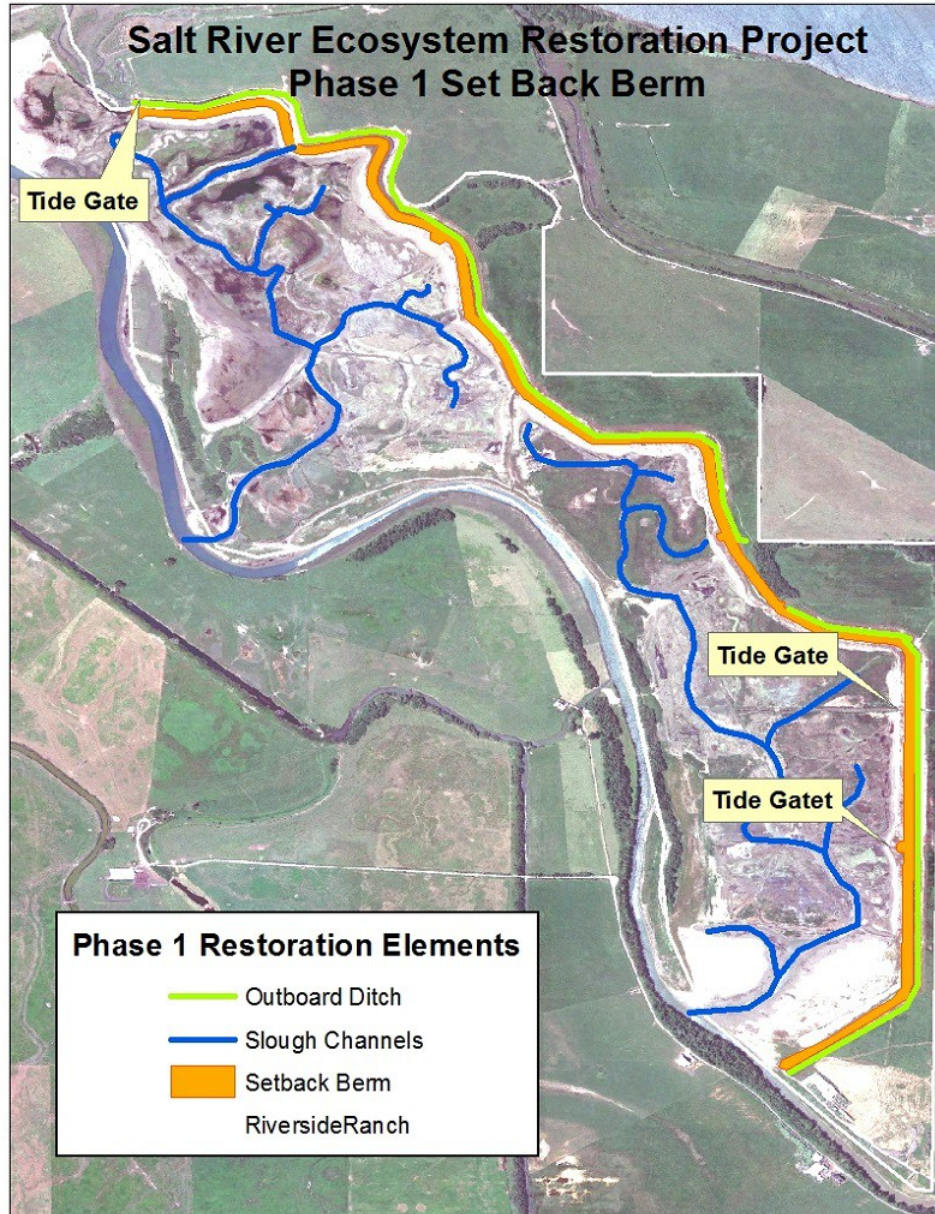
Figure 24: Setback Berm Location

Results and Discussion: Observations of the setback berm and the berm road (Figure 24) are were performed periodically in 2020. Minor rills are observed on the estuary side of the berm and have been stable since 2016. Some minor erosion caused by wind wave fetch during large winter events is also evident on the northern end of the berm on the estuary side. The road that leads up to the berm from the barn was impacted by a very large Eel River flood event in February 2019, where all gravel and road base material were washed away. California Department of Fish and Wildlife (Riverside Ranch landowner) intends to address the impacts to the road.

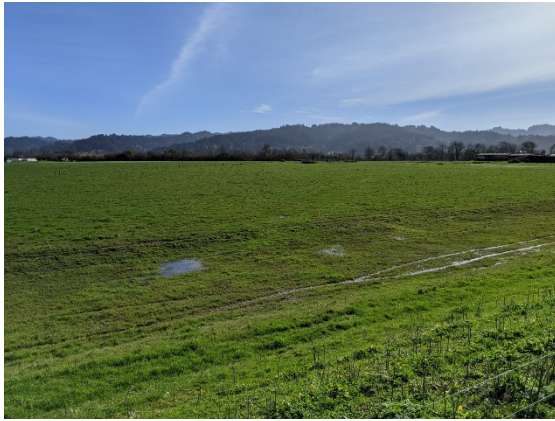
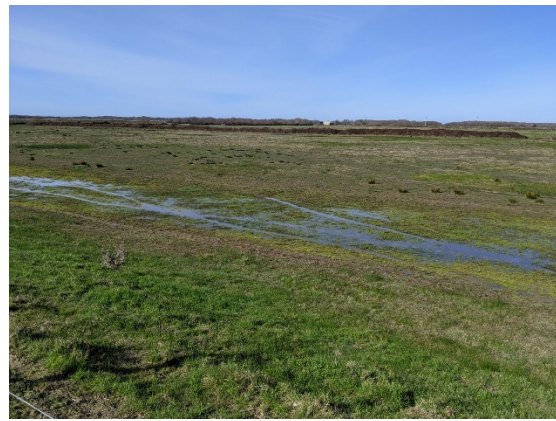
A field visit was performed on February 10, 2021, prior to spring turnout. The two Riverside Ranch fields were sampled in February 2021. The fields were agriculturally managed by using light weight cows (heifers) to graze the pastures. Cows were removed from the pastures in late winter. Grass sward heights were sampled across two fields where biologists determined geese would prefer to forage, as shrub and tree vegetation was minimal or absent. Sward heights were averaged and the values equaled 3.6 inches and 2.7 inches in the respective fields. CDFW recommends that sward height be in the range of 1.5 inches to 3 inches from December to March. The average sward height in field 1 (3.6 inches) slightly exceeds the criteria range. However, field 1 appeared to have productive grass habitat and small water features that are more desirable to geese. Average sward height in field 2 falls within the range of the December-March criteria, however, the vegetation composition is not as desirable (sparse rye grass with wetland species) and frequent bare ground was observed (Figures 26 and 27).

Figures 26 (left) and 27 (right). Field 1 (Figure 26) shows lush pastures with water features. Field 2 (Figure 27) shows sparse pasture with juncus clumps, bare ground, and water features.
