# 2021 Channel Profile Report: Salt River Ecosystem Restoration Project

Phase Two- Year 2021

January 2022

Humboldt County Resource Conservation

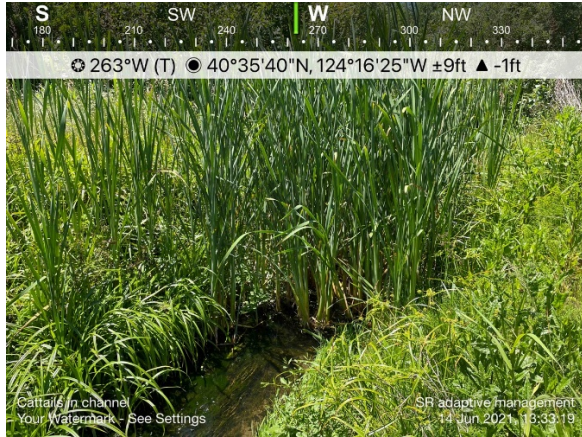
Some beds of cattail (*Typha sp.*) were noted in the channel between the Sediment Management Area and Dillon Road Bridge (Figure 1). This area could slow down water flow, causing deposition within the river channel. It was noted that sections of the channel that had a closed riparian canopy and/or tidal influence did not contain in-channel vegetation. Further vegetation concerns regard large arroyo willow branches growing down and across the channel. Multiple areas within 100 to 400 meters upstream of the Sediment Management Area showed accumulated wood debris amongst the willow branches (Figure 2). However, no apparent channel erosion was observed in the immediate area.

Figure 1. Cattails growing in Salt River channel approximately 100 meters upstream of Dillon Road Bridge.

In-channel vegetation, such as the cattails, should be observed following the 2021/22 winter to determine if the beds persisted after higher winter flows. Maintenance of the in-channel vegetation may need to be addressed by removal if the vegetation persists and/or spreads.

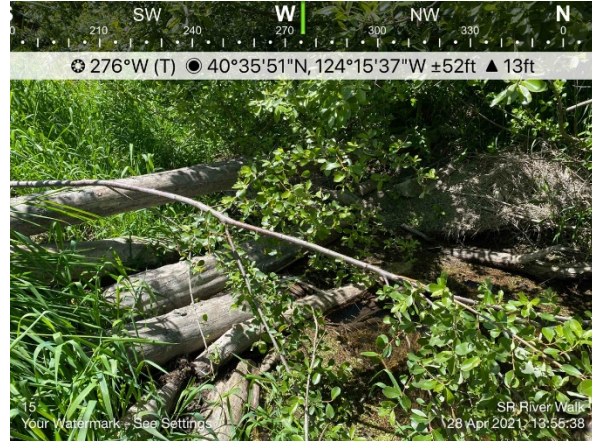
Figure 2. Accumulated wood debris in Salt River channel approximately 400 meters above the confluence with Francis Creek-Sediment Management Area.

Accumulated wood debris due to willow branches growing into the channel merit removal or close observation after the winter period to determine if excessive scour or river flanking is occurring.
