Channel Profile Report: Salt River Ecosystem Restoration Project

Phase Two- Year 2020

Prepared by: Doreen Hansen (Humboldt County Resource Conservation District) and Peter Duin (Natural Resources Conservation Service)

February 2021

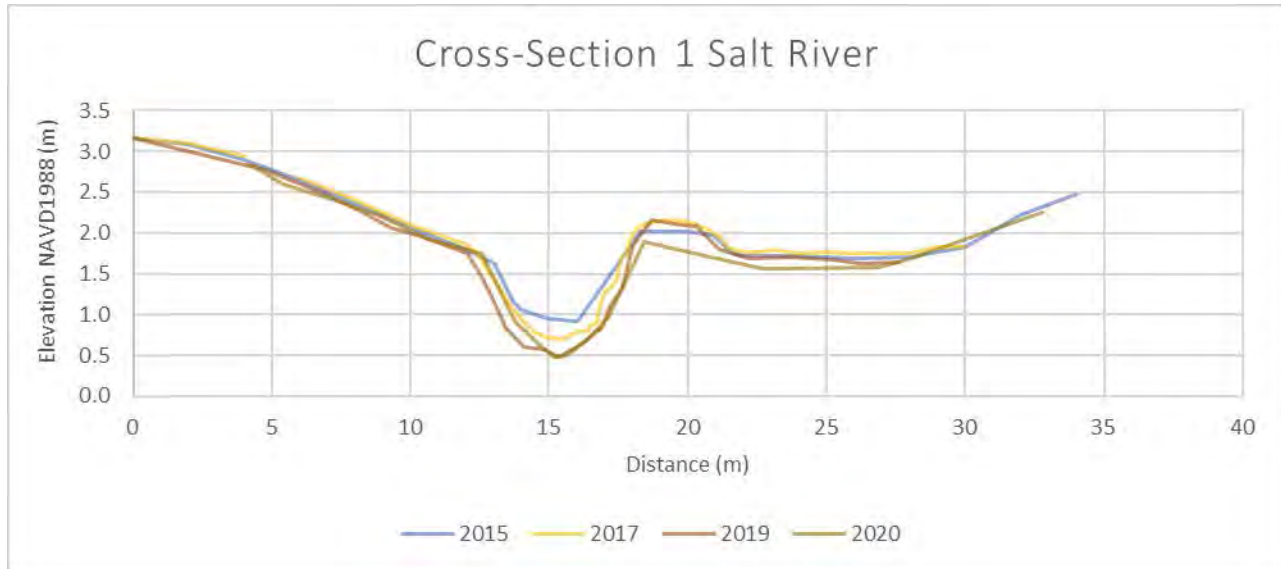
Figure 2: Cross-section one profile for years 2015 to 2020.

The profile for cross-section one (fig. 2) indicates some possible deposition on the left side of the channel since 2019, however is consistent with surveyed channel morphology in previous years. Channel bottom elevation is consistent with the 2019 survey. Since the original survey in 2015, the channel elevation has dropped by 0.42 meters. The coarse resolution on the active channel berm, above the right side of the channel, does not capture the relief of the feature. Possible minor scour and elevational lowering of 0.14 meters occurred on the floodplain compared to previous years.

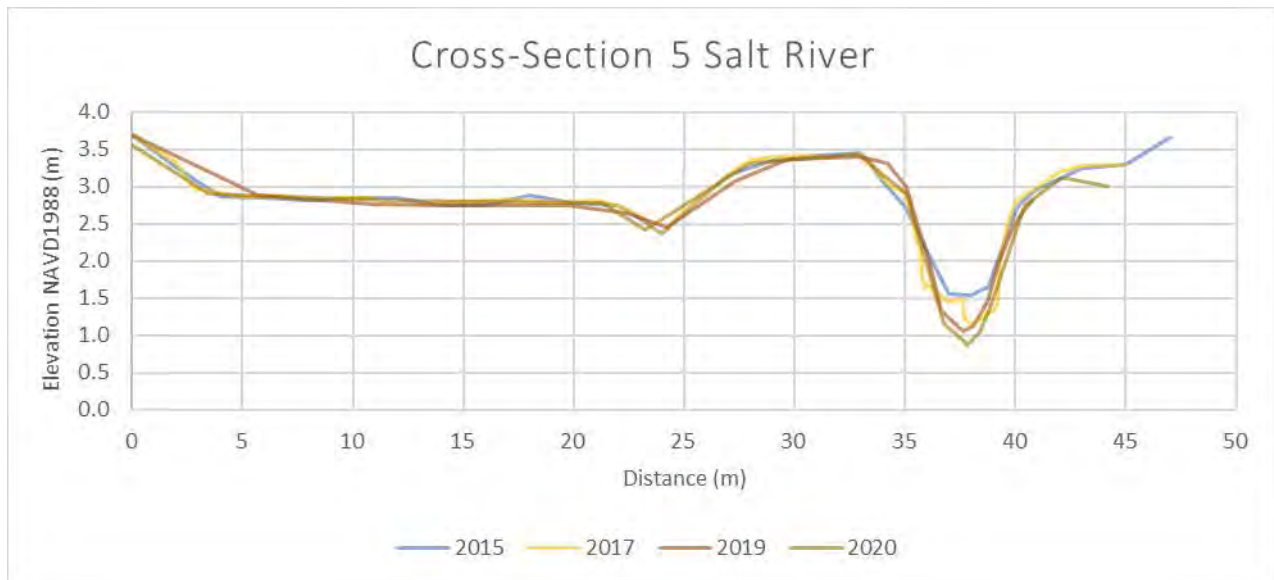
Figure 3: Cross-section five year 2018-2019.

Cross-section five closely maintained a similar configuration with 2019's survey, with a decrease in thalweg elevation of 0.19 m from the previous year (fig.3). Overall, the channel bottom has decreased by 0.57 meters since 2015. The cross-sectional profile shows floodplain elevations consistent with previous survey years.

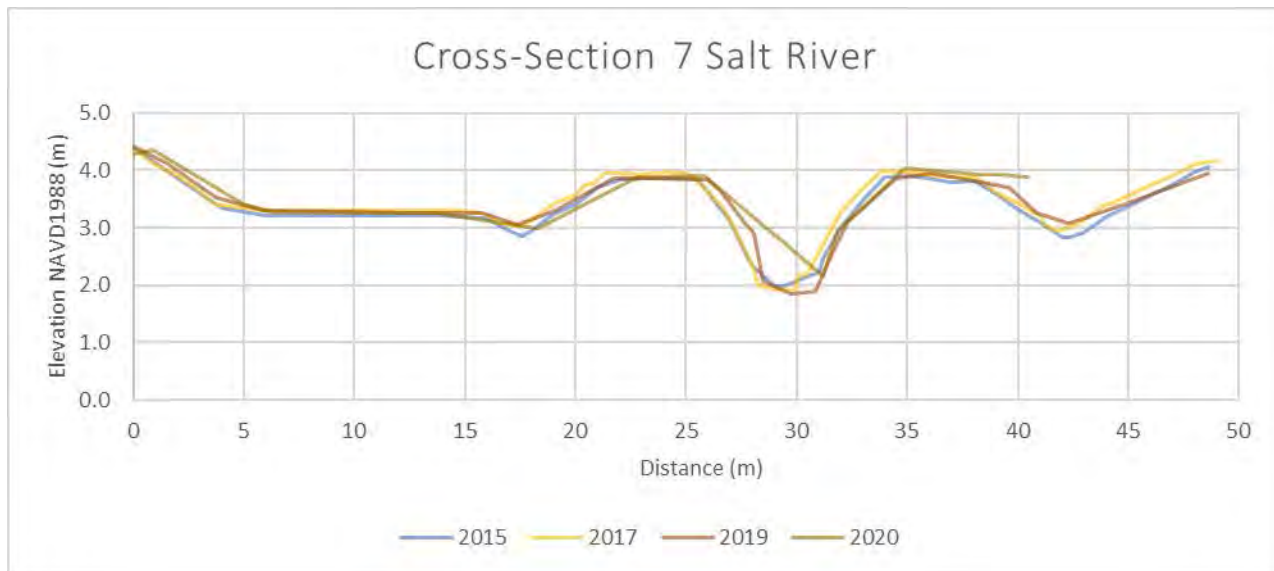
Figure 4: Cross-section seven years 2015-2019.

Current and previous surveys show consistent floodplain and active berm elevations for cross-section seven. However, the collection of the 2020 active channel data points are far too coarse to compare them to previous surveys. This may have been due to high water levels in the channel (photo 1). Some deposition appears to have occurred in 2019 on the left side of the channel and scour on the right channel bottom and side, resulting in slight widening and decrease in thalweg

elevation of 0.26 m compared to 2018 (fig.4). Channel geometry remains relatively stable with potential for more lateral migration based on visual observation in the field of slumping on the right bank.

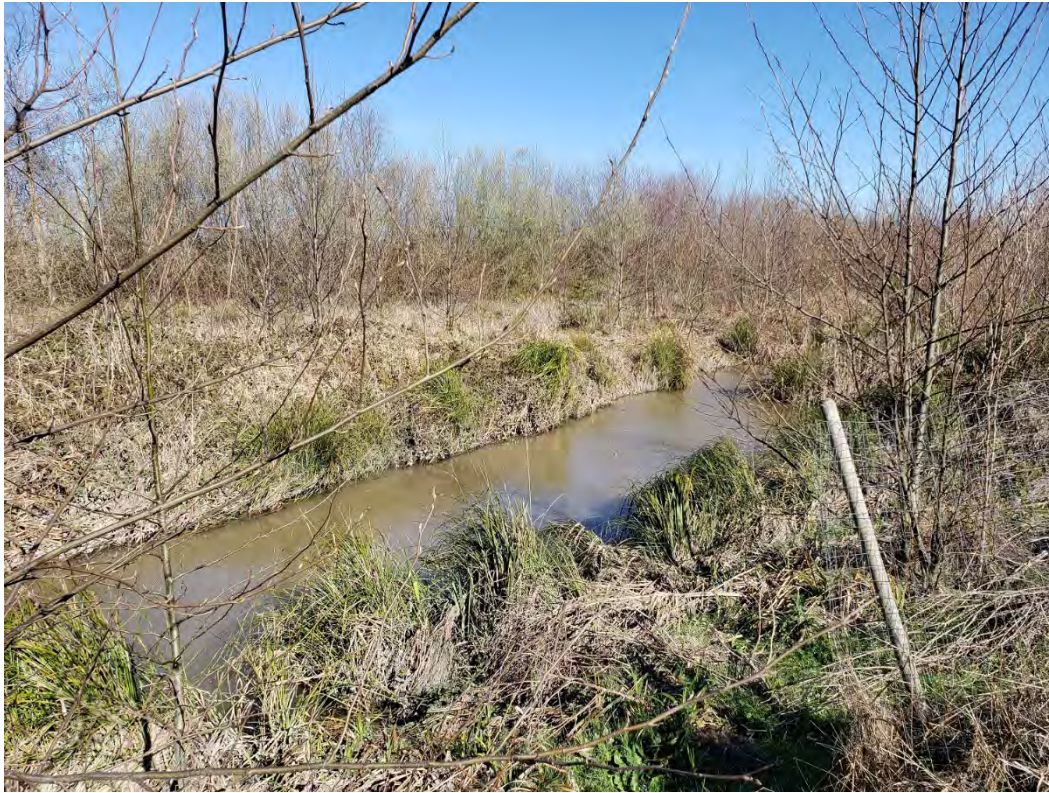
Photo 1: Phase 2 main Salt River active channel near cross-section 7

Future geomorphic surveys are required. It is recommended that surveys occur in the late fall when water levels are at their lowest in order to collect sufficient points for high resolution depiction of the active channel and when tree leaf vegetation is sparse to not interfere with equipment collecting data.

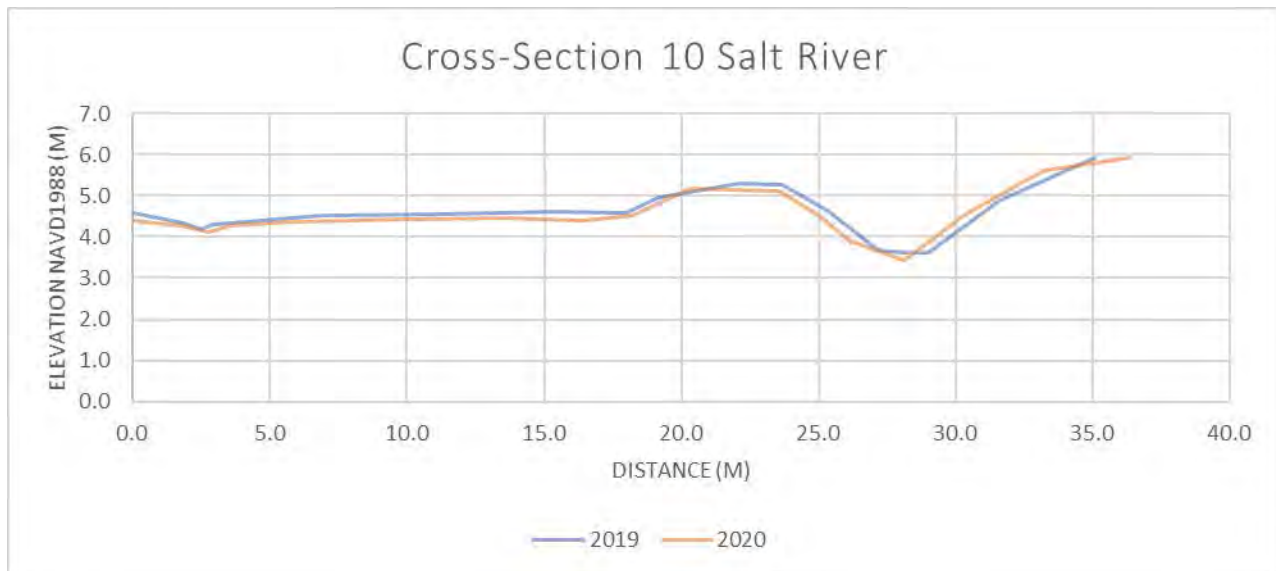
Figure 5: Cross-section ten years 2019 and 2020

Cross-section ten was established in 2019 on a reach of the restored Salt River that was constructed in 2018. The Salt River constructed upstream of cross-section ten is not connected to perennial water source as of 2021. Therefore, water entering the system upstream of cross-section ten is surface runoff during winter rain events. The deviations of surveyed points between years maybe due to typical surveying error, though some scour may have occurred in the channel bottom (0.19 meters). Deposition is unlikely.

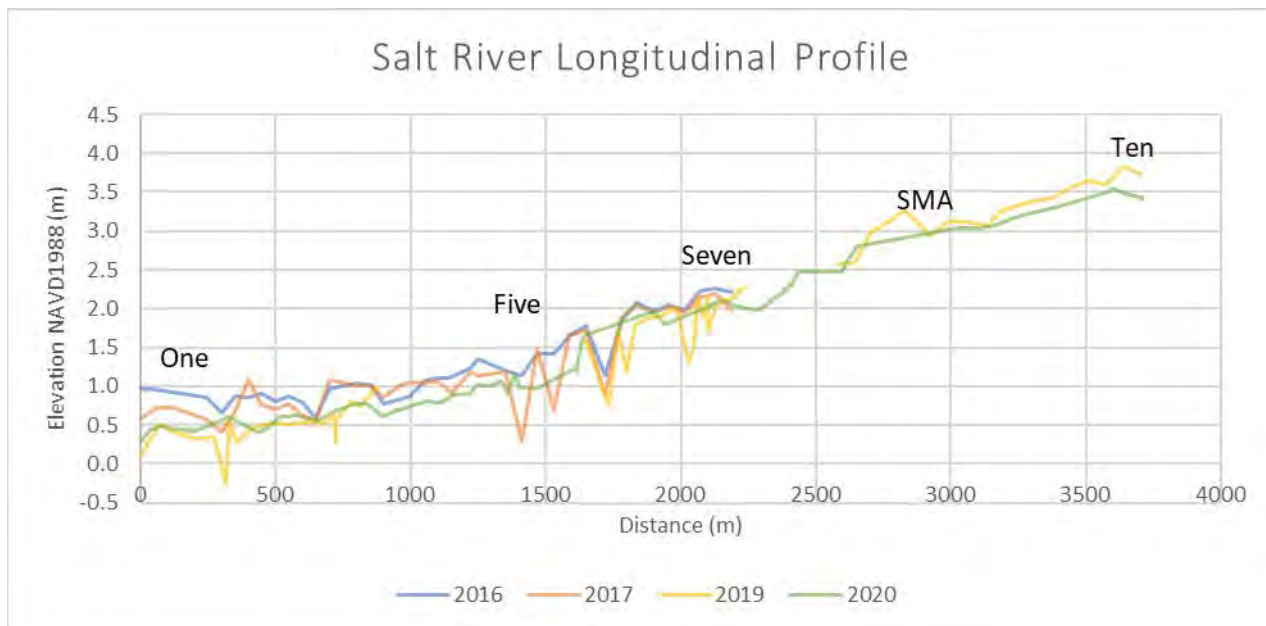
Figure 6: Phase 2 longitudinal profile of the main active channel of the Salt River.

In agreement with cross-sectional surveys, the longitudinal profile shows a dominant trend of scouring as illustrated by reductions in elevation throughout majority of the channel. However,

the 2020 survey did not capture the scour holes between 400 meters to 2,200 meters. This may be due to the increased water level heights during the time of the survey. Notably, the 2019 deposition immediately downstream of the SMA was not captured in the 2020 profile due to lack of data points taken in that reach. In-channel vegetation in that reach was thick and in late 2020 vegetation was removed in a 150-foot reach in that area. Overall, the 2020 profile was consistent with the recent 2019 survey (fig. 6).

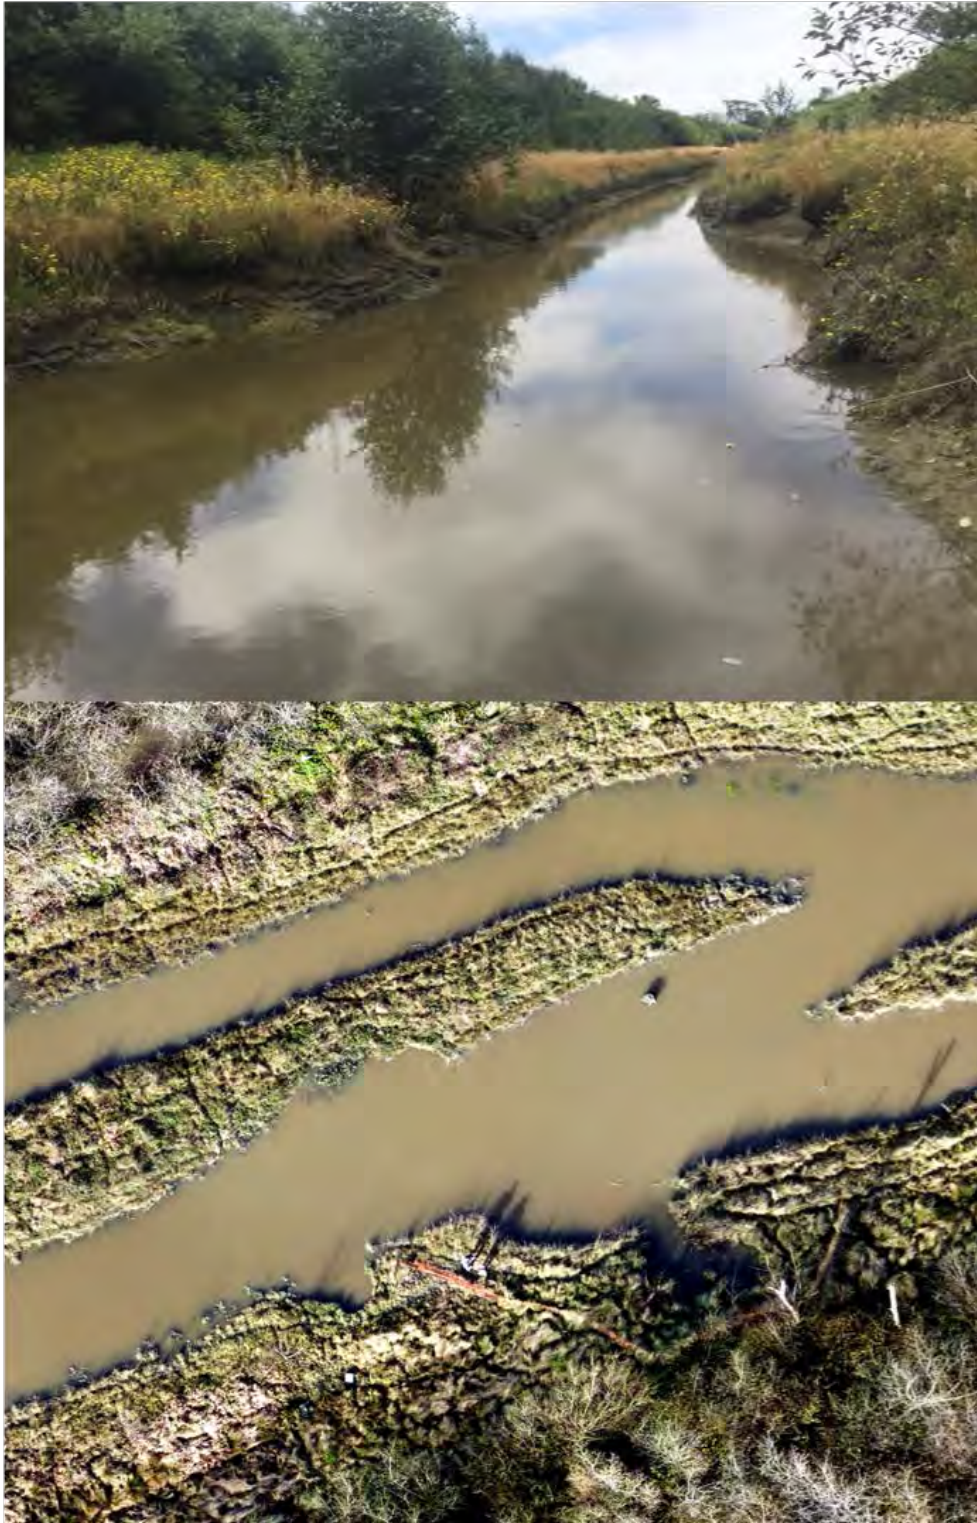
Figure 9: Channel (top, 2019) and aerial view (bottom, 2018) of bank slumps approximately 240 meters upstream of cross-section one. In addition to lateral erosion, vertical scour has occurred throughout survey years as shown by consistent deepening of a pool in the area (fig. 6).

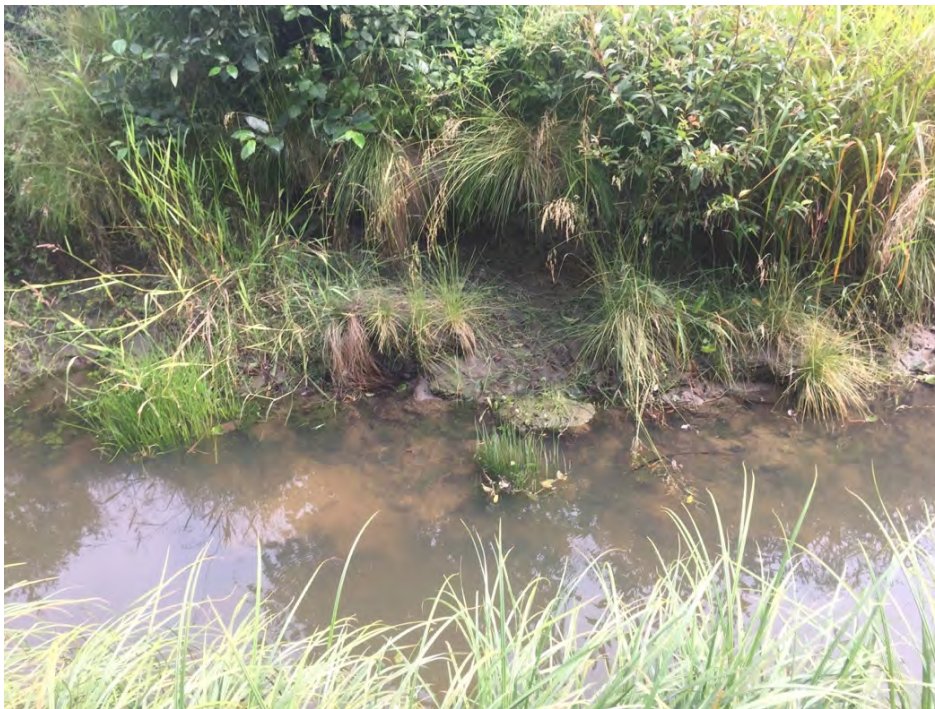
Figure 12: Bank failure downstream of cross-section five (2019).

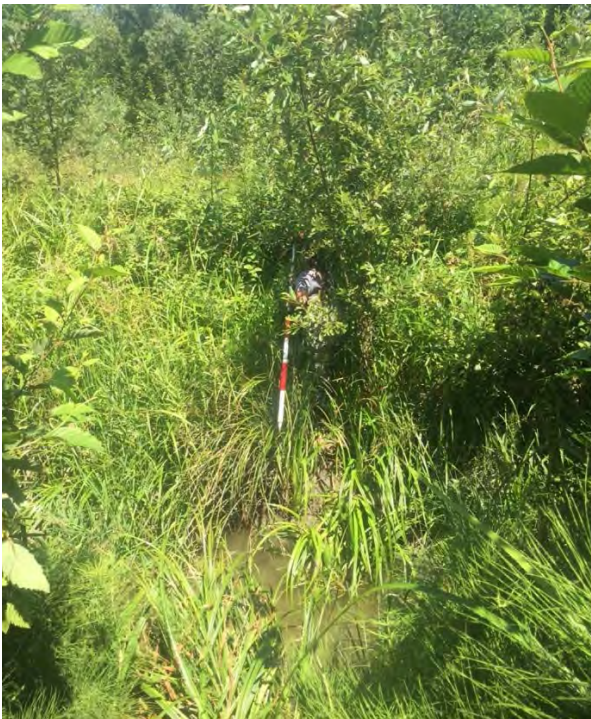
Figure 14: Cross-section seven looking north across the channel transect, note dense riparian and in-channel vegetation (2019).
