Salt River Ecosystem Restoration Project

Habitat Mitigation and Monitoring Plan Monitoring Report 2018

Finalized February 2019

Prepared by the Humboldt County Resource Conservation District

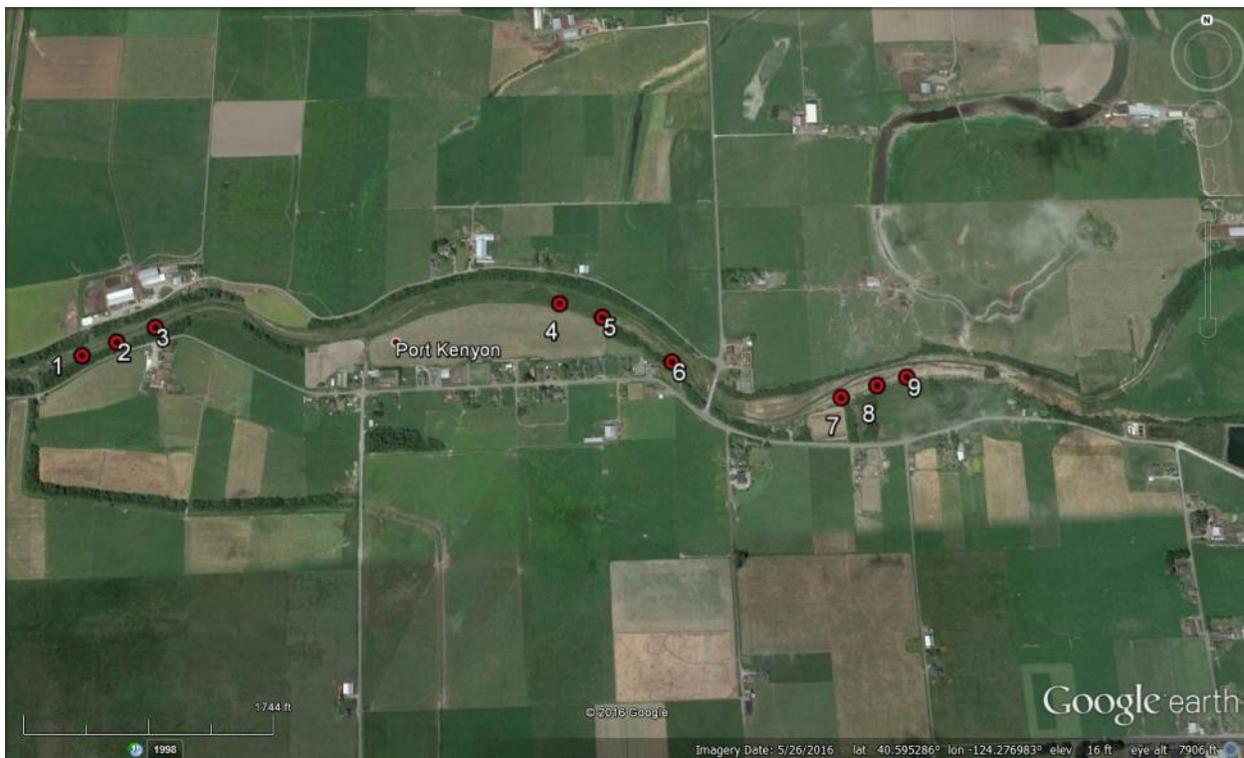
Figure 25: Salt River Phase 2 Cross-Section Sites

Results and Discussion: Nine cross-sections sites were re-occupied and surveyed in the 1.5 miles of the 2014 and 2015 restored reach of the Salt River (Figure 25). The nine sites are divided into three groups or “Units”, each Unit consisting of three sites. Unit 1 contains sites 1, 2, and 3 (tidally influenced); Unit 2 contains sites 4, 5, and 6 (tidally influenced); and Unit 3 contains 7, 8, and 9 (freshwater). The following graphs

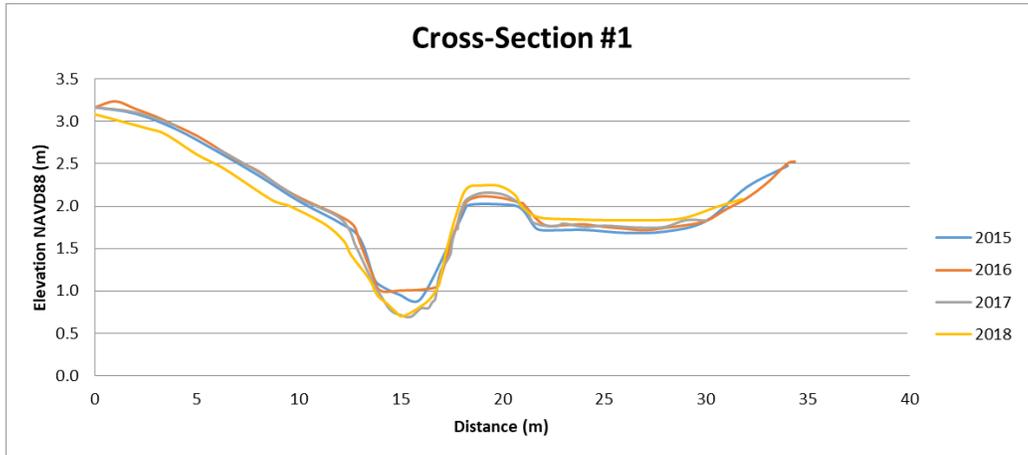
Figure 26: Unit 1 - Site 1 from 2015 to 2018

Comparing the cross-sectional graphs provides a visual indication on how the channel responds to winter periods. The 2015/16 winter was relatively mild, yet typical with a flood event. The 2016/17 winter was extremely wet winter in northern California (NOAA 2017), which included multiple large flood events. This past year’s 2017/2018 winter was wetter than the average year by nine inches. In the graphs above, each year’s cross-section is compared to the previous.
