# Salt River Ecosystem Restoration Project

## Monitoring Report 2015

Finalized September 2016

Prepared by the Humboldt County Resource Conservation District

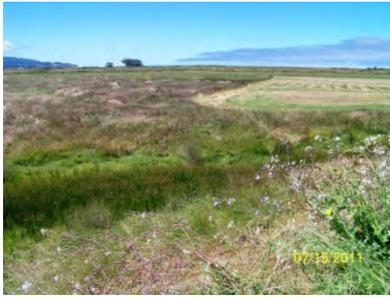
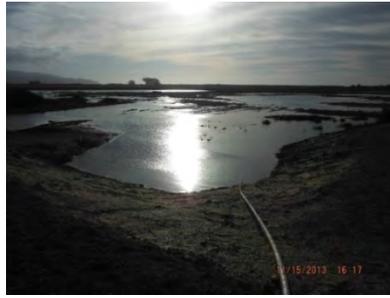
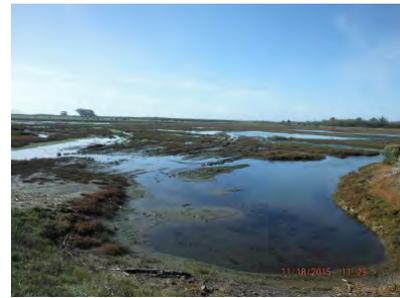
Photo Point 145

PP145 – SW – July 2011

PP145 – SW – November 2013

PP145 – SW – November 2015

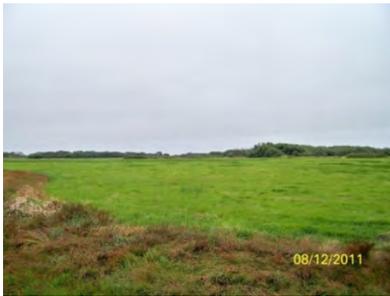
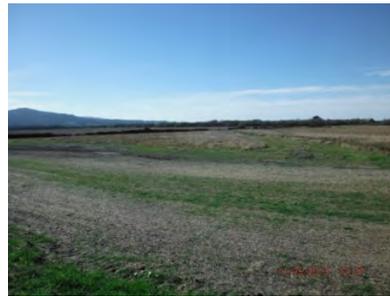
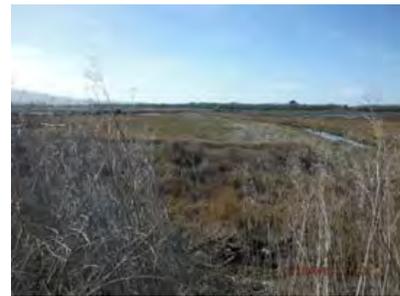
Photo Point 160

PP160 – West – July 2011

PP160 – West – November 2013

PP160 – West – November 2015

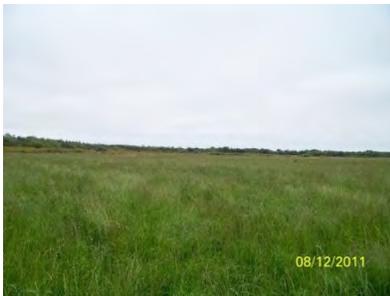
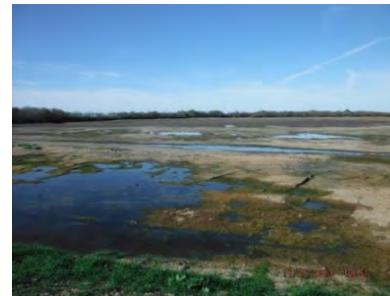
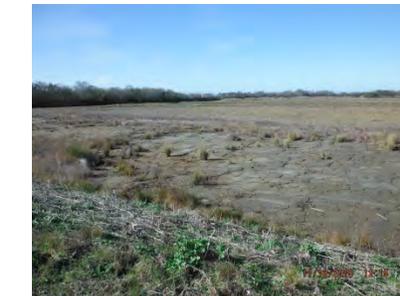
Photo Point 163

PP163 – NW – July 2011

PP163 – NW – November 2013

PP163 – NW – November 2015

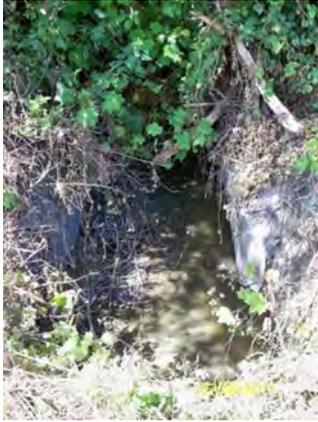
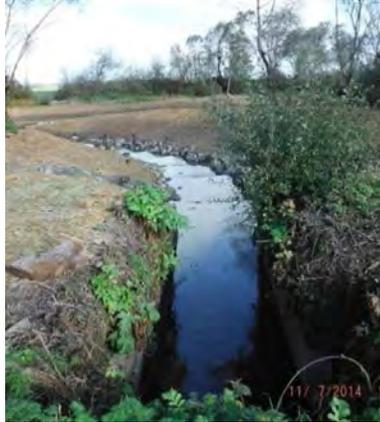
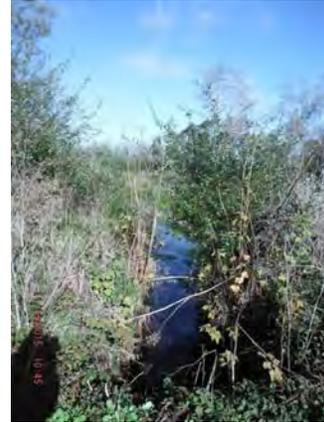
### Photo Point 115

PP115 – Reas Cr – Jul 2011

PP115 – Reas Cr – Nov 2014

PP115 – Reas Cr – Nov 2015

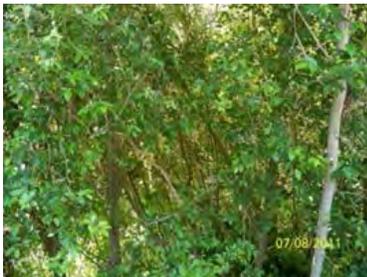
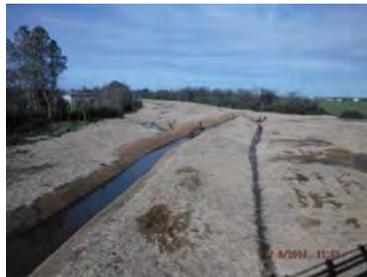
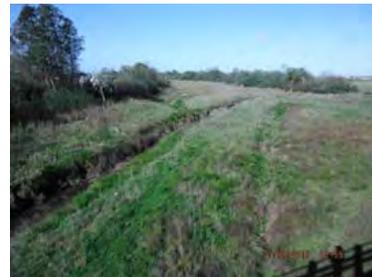
### Photo Point 109

PP109 – Dillon Br W – Jul 2011

PP109 – Dillon Br W – Nov 2014

PP109 – Dillon Br W – Nov 2015

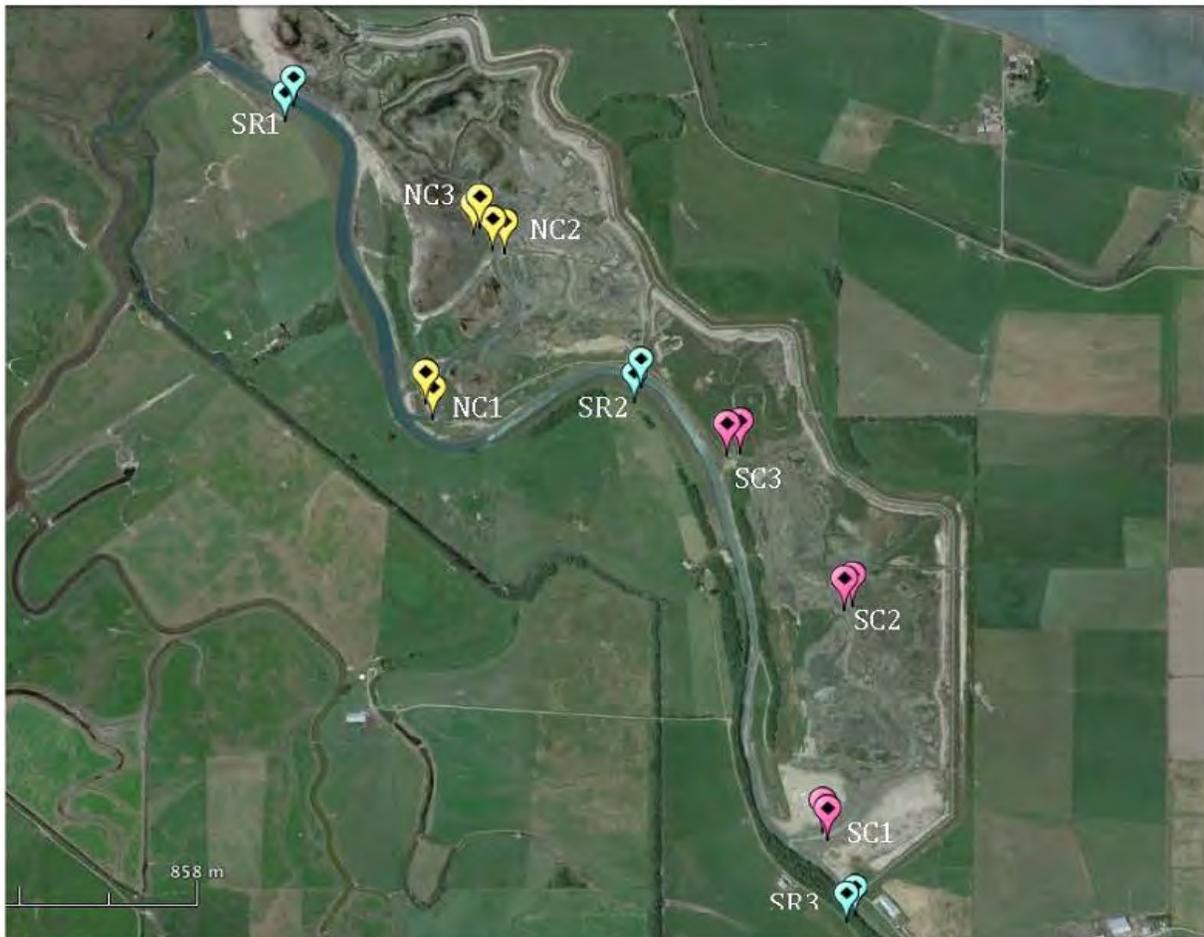
**Figure 1: Location of the cross-section profiles for Salt River Ecosystem Restoration Survey Project, Fall 2014. SR = Salt River cross-sections; NC= new North Channels cross-sections; SC= new South Channel cross-sections.**
