Salt River Ecosystem Restoration Project

Adaptive Management Plan Monitoring Report 2017

Finalized August 2018

Prepared by the Humboldt County Resource Conservation District

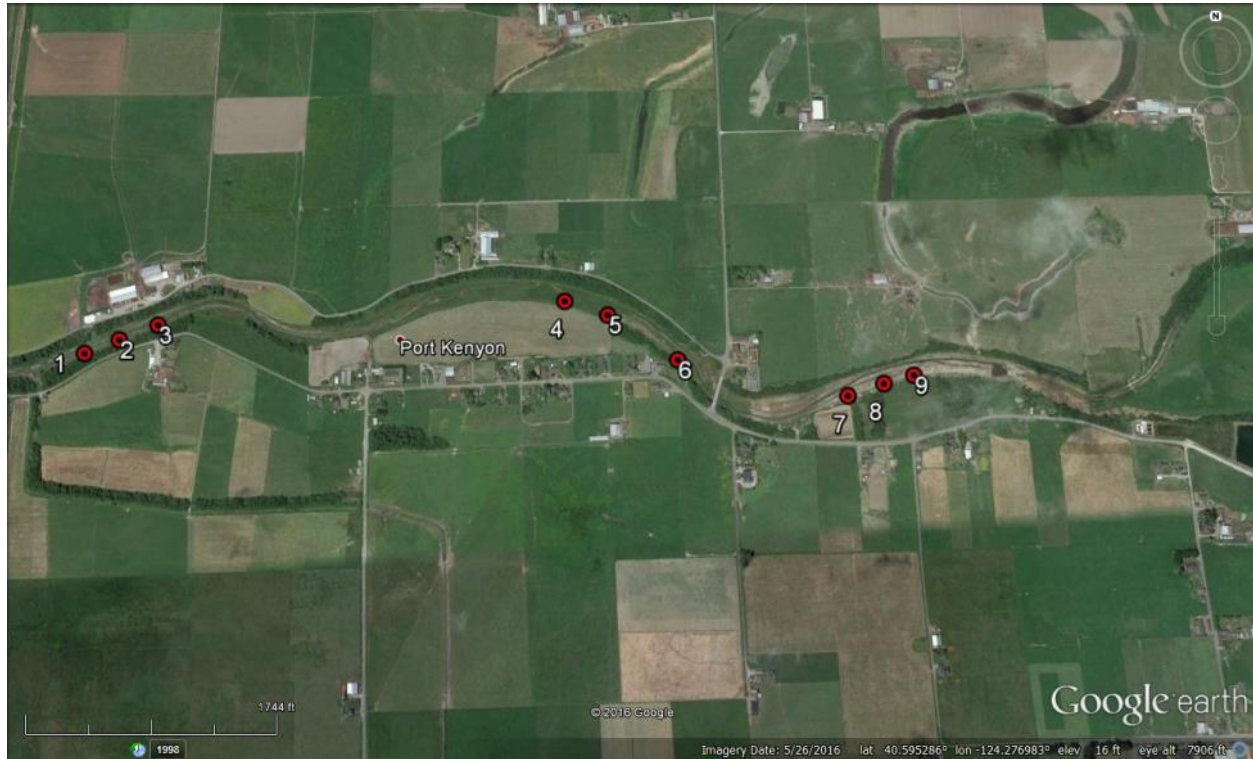
Figure 2: Salt River Phase 2 Cross-Section Sites

Results and Discussion: For the student's Master's thesis, nine cross-sections sites were developed and surveyed in the 1.5 miles of the 2014 and 2015 restored reach of the Salt River. The nine sites are divided into three groups or "Units", each Unit consisting of three sites. Unit 1 contains sites 1, 2, and 3 (tidally influenced); Unit 2 contains sites 4, 5, and 6 (freshwater); and Unit 3 contains 7, 8, and 9 (freshwater) (Figure 2). The following graphs (Figures 3 - 5) show cross-sections from each Unit from two hydrologic years.

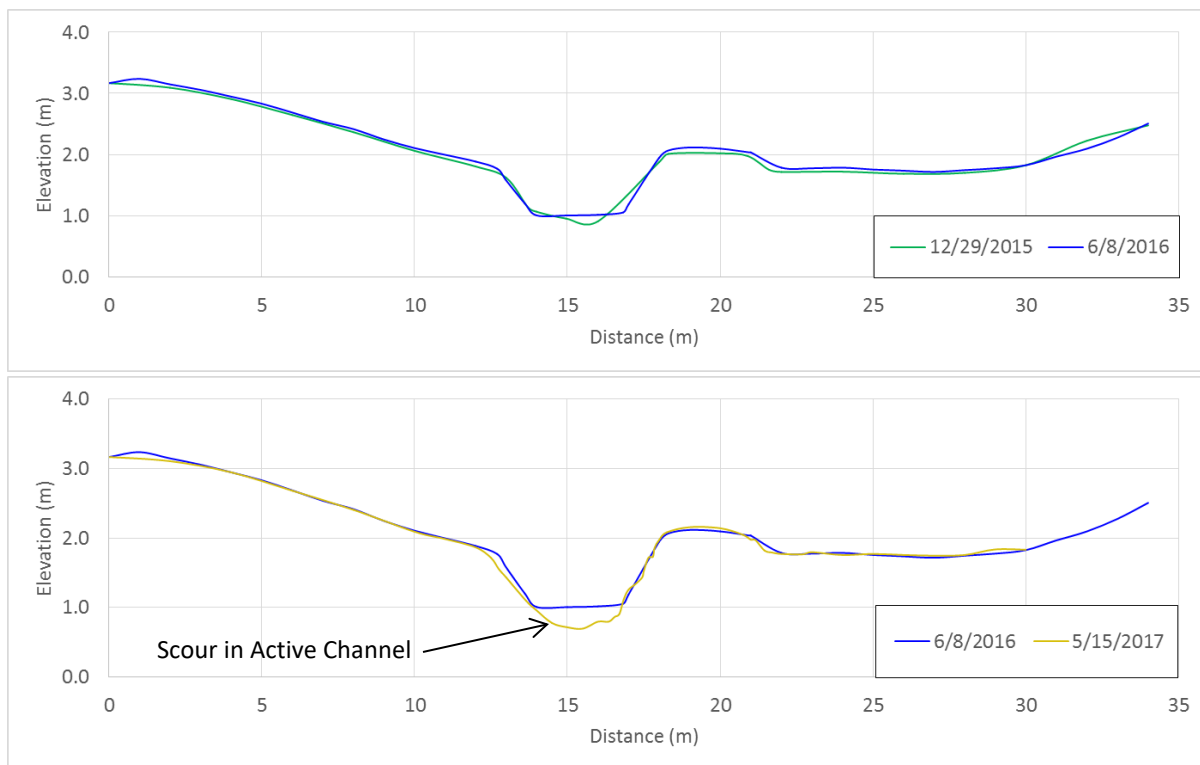
Figure 3: Unit 1 - Site 1 in 2015/16 and 2016/17

Comparing the cross-sectional graphs provides a visual indication on how the channel changed over two winter periods. The 2015/16 winter was a relatively mild, yet typical with a flood event. The 2016/17 winter was the fifth wettest winter recorded, which included multiple large flood events. Each year's cross-section is compared to the previous. In Units 1 and 2, active channel bottom elevations decreased due to channel scour in 2017. However, Unit 3 had a stable active channel elevation through both hydrologic years with deposition on either side of the bank. Looking at all the sites together, more deposition occurred in the 2015/16 winter and more scour was observed in 2016/17. In general, the active channel is primarily scouring vertically (i.e. bottom elevation is decreasing), and increasing channel capacity, which may potentially cause future bank slumping. The active channel is considered overly efficient to transport sediment out of the system; however, at this point in time monitoring, two large tributaries with a significant sediment loads have yet to be re-connected to the system.

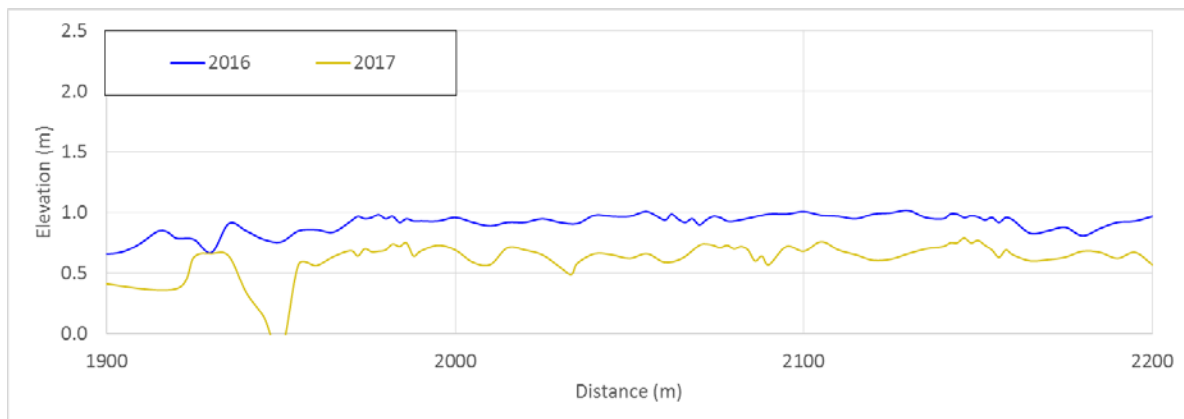
Figure 6: Unit 1 Longitudinal Profile in 2016 and 2017

A longitudinal survey was completed along the constructed Phase 2 footprint. The longitudinal profile graphs presented (Figures 6 - 8) concentrate on Units 1-3. Unit 1 shows topographic heterogeneity and a uniform channel bottom scouring from 2016 to 2017 with a pool development in the upstream section (between 1,900m and 2,000m) (Figure 6). The Unit 2 profile indicates fluctuations between scour and deposition with pool formation in the upstream section (between 700m and 800m) (Figure 7). Unit 3 is primarily stable in elevation, with some pool development in the downstream section (between 200m and 300m) (Figure 8).

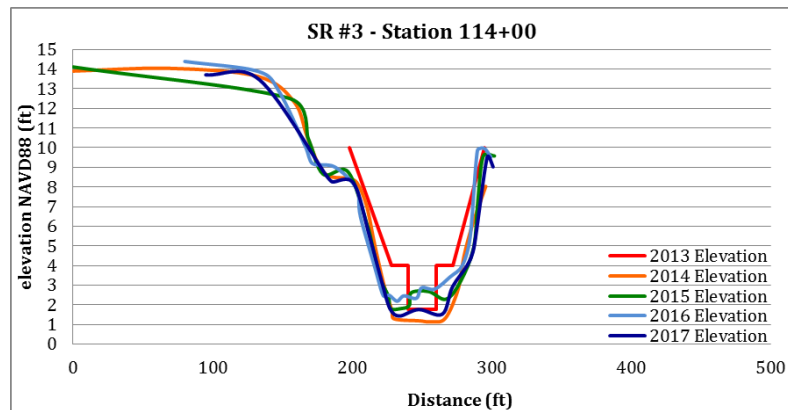
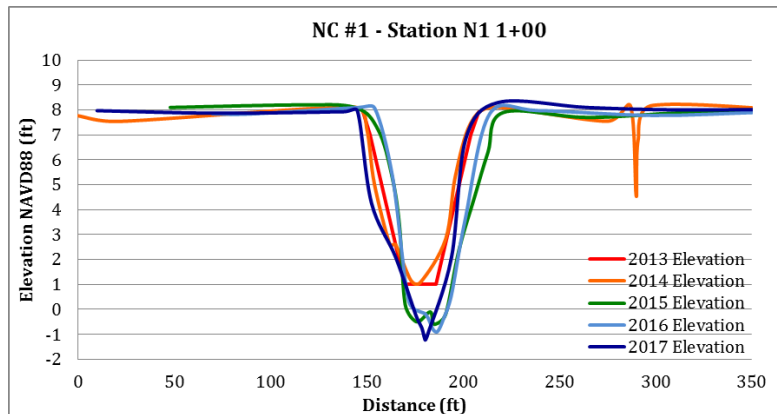
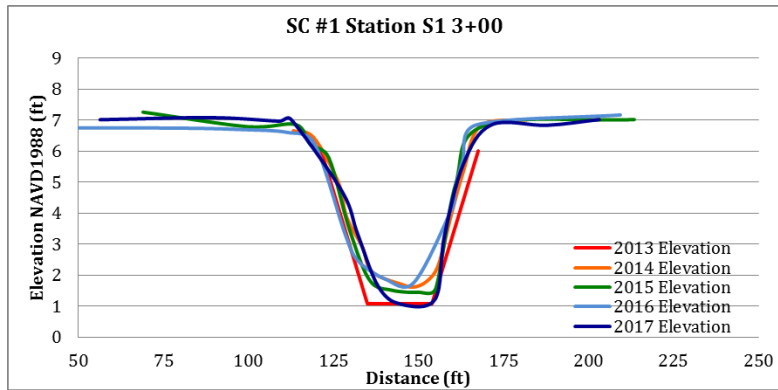
Results and Discussion: Results are summarized from the monitoring report in the following narrative and figures. . Cross-sections determine the width and depth of the channels. Figures 11 – 20 are the cross-sectional and longitudinal profiles for the Salt River main channel and the southern and northern slough channel network.

Patterns of erosion, transport and deposition observed in previous years continued in a similar manner in 2017. The primary difference was channel bed erosion in the lower main stem Salt River, and deposition in the middle to upper sections. Bank erosion and slumping were observed throughout the project area, particularly in the downstream reaches of the SR near the confluences with Cutoff Slough and the northern slough channel (NC). Main channel bed erosion in the Salt River was observed in the lower section of the Salt River channel below NC.

The SRERP's Adaptive Management Plan identifies a 10% change in channel capacity as a trigger level for potential management actions. Seven of the nine cross-sections have experienced an increase in channel capacity since 2014 (Table 1), two of which merit discussion and further monitoring (NC1 and SC2). Two cross-sections (NC3 and SR1) have slightly decreased in capacity beyond the 10% trigger level and further monitoring is recommended. Sediment deposition in the upstream section of the Salt
