Salt River Ecosystem Restoration Project

Adaptive Management Plan Monitoring Report 2018

Finalized February 2019

Prepared by the Humboldt County Resource Conservation District

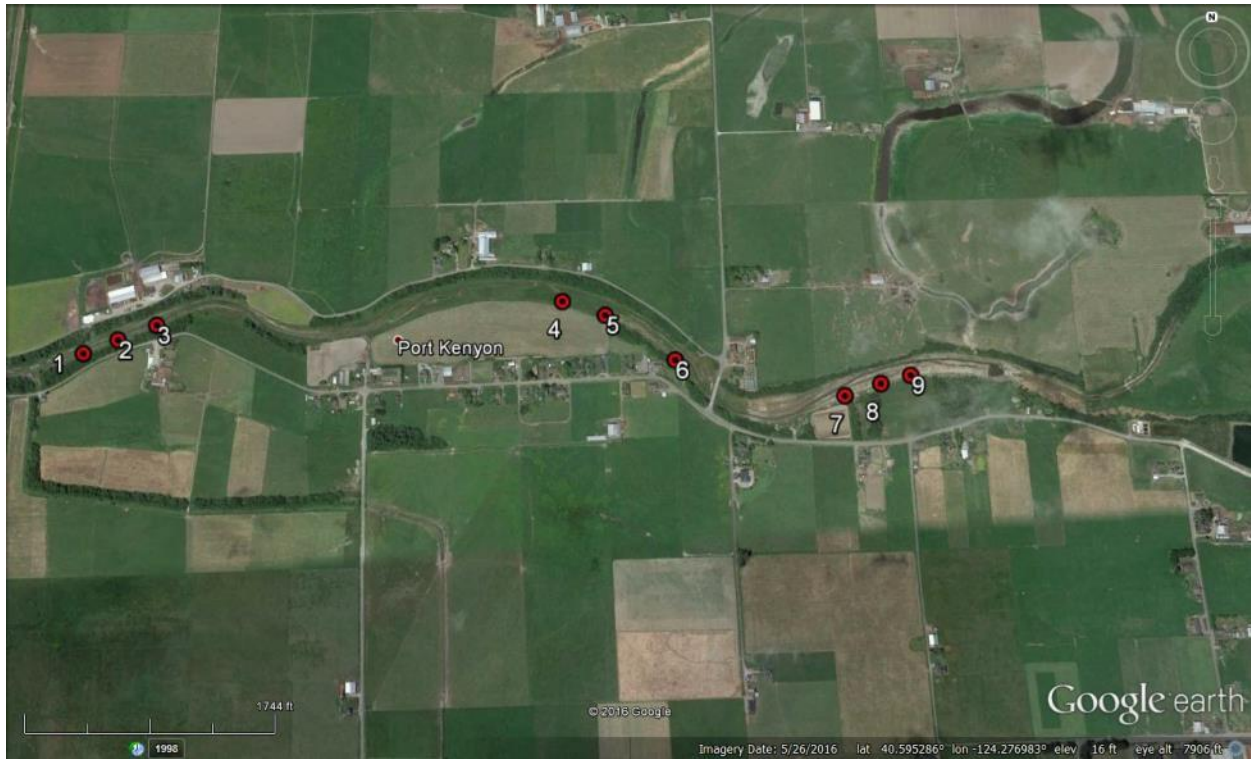
Figure 2: Salt River Phase 2 Cross-Section Sites

Results and Discussion: Nine cross-sections sites were reoccupied and surveyed in the 1.5 miles of the 2014 and 2015 restored reach of the Salt River (Figure 2). The nine sites are divided into three groups or “Units”, each Unit consisting of three sites. Unit 1 contains sites 1, 2, and 3 (tidally influenced); Unit 2 contains sites 4, 5, and 6 (tidally influenced); and Unit 3 contains 7, 8, and 9 (freshwater). The following graphs (Figures 3 to 5) show cross-sections from years 2015, 2016, 2017, and 2018 of sites 1, 5, and 7.

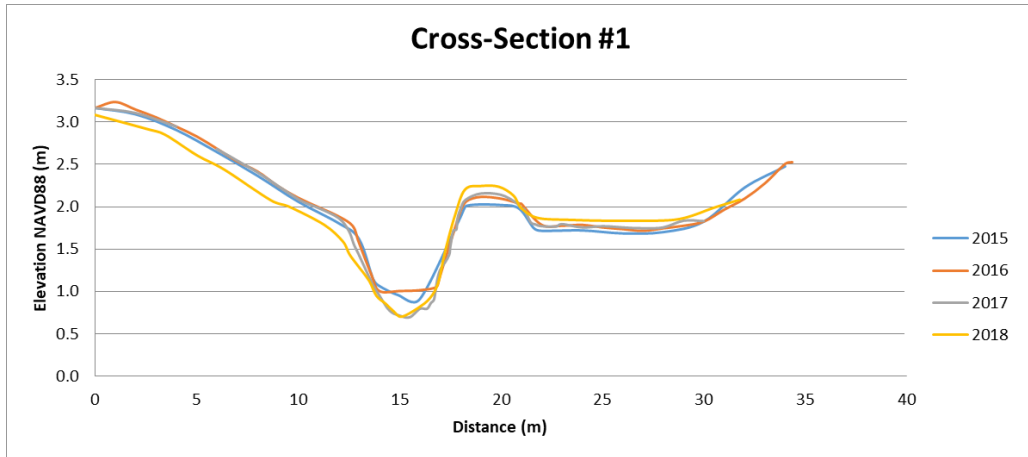
Figure 3: Unit 1 - Site 1 from 2015 to 2018

Comparing the cross-sectional graphs provides a visual indication on how the channel responds to winter periods. The 2015/16 winter was relatively mild, yet typical with a flood event. The 2016/17 winter was extremely wet winter in northern California (NOAA 2017), which included multiple large flood events. This past year's 2017/18 winter was wetter than the average year by nine inches. In the graphs above, each year's cross-section is compared to the previous.

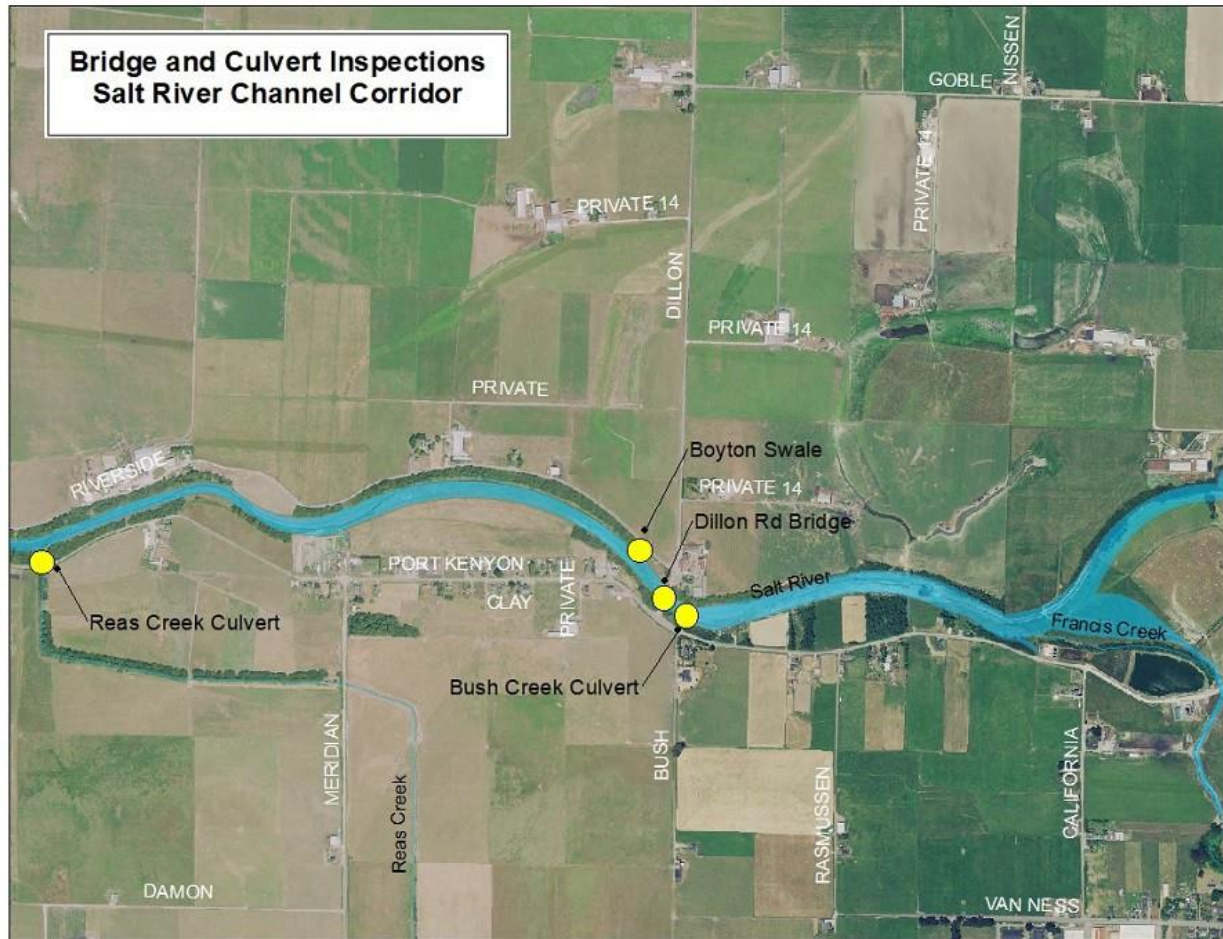
Figure 6: Bridges and Culverts Locations on the Salt River restored corridor

Methods: All culverts and bridges will be visually inspected upstream and downstream, inlet/outlet, at low and high water flows to determine that these structures are functioning as intended and not being occluded by debris or sediment deposition. Erosion factors will also be noted. Dillion Road Bridge is the only bridge spanning the restored Salt River as of 2018 monitoring season. Existing and adjacent culverts at Reas Creek, Boynton Swale, and Bush Street deliver flows to the Salt River (Figure 6).

Results and Discussion: No culverts or bridges were constructed within the Salt River corridor as of the 2018 monitoring period. However, one bridge and three culverts remain along the Salt River post-project construction. Dillon Road Bridge spans the Salt River at its upper tidal prism extent. It has been observed during low and high flows and no debris in the channel or flood plain are racking up on the bridge abutments. Erosion around the footings is not occurring. Some individual red alder (*Alnus rubra*) saplings are growing close to the bridge deck and should be considered for removal. The Reas Creek, Boynton Swale, and Bush Street culverts have been observed during high and low flows and appear to be functioning normally.

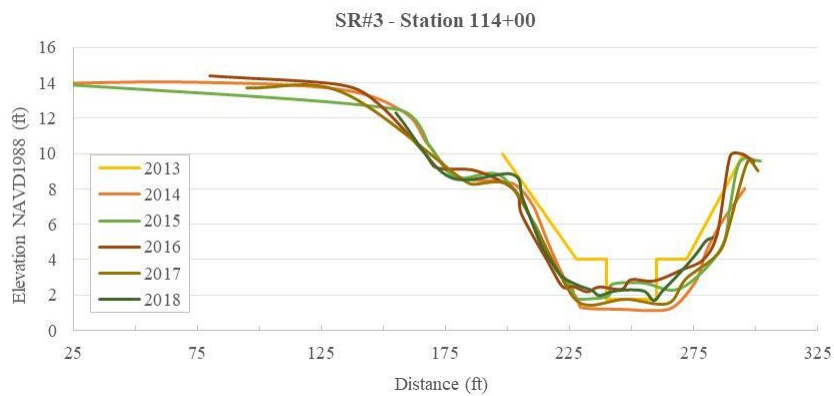
Results and Discussion: Results are summarized from the monitoring report in the following narrative and in Figures 8 – 17. Cross-sections determine the width and depth of the channels. The following are the cross-sectional and longitudinal profiles for the

Salt River main channel and the southern and northern slough channel network from the designed channel in 2013 to the adjusted channel profiles from 2014 to 2018.

The 2018 cross-sectional and longitudinal surveys indicate trends of decreased channel elevation and net sediment transport out of the channel reaches, which is similar to past survey results. Results primarily indicate that channel geometries occurred vertically rather than laterally as the data show smaller variation in cross-sectional channel widths compared to channel depths.

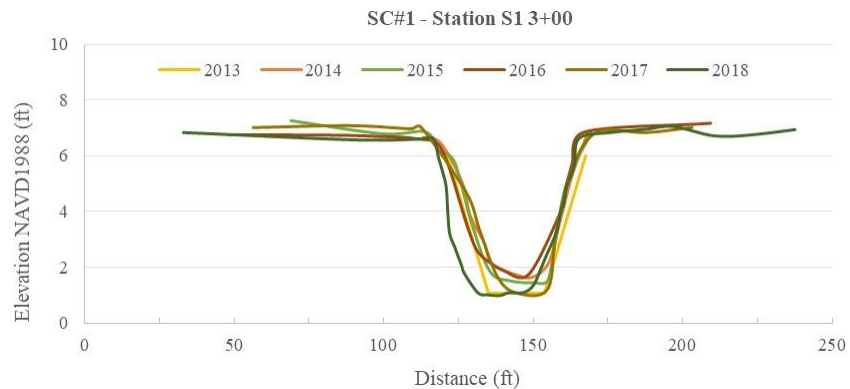
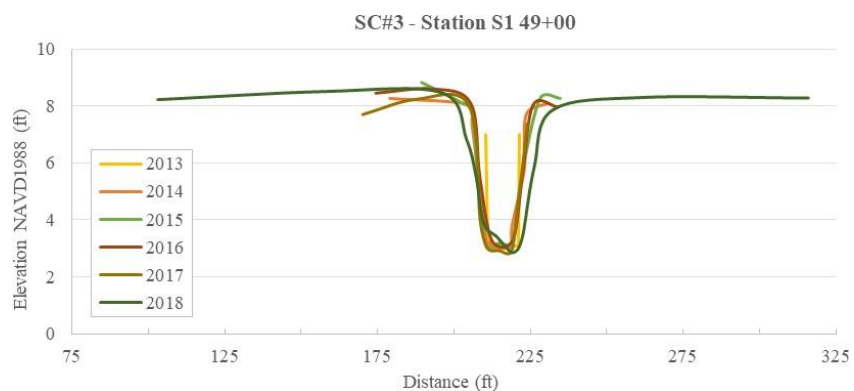
Southern Slough Channels - Scour is consistent through the southern slough channel. Average elevation loss in the longitudinal profile was 4 inches with more pronounced degradation in the upstream half of the reach. SC1 channel bottom elevation appears to be relatively stable, though lateral migration of the west bank occurred; likely due to bank slumping. SC2 had an approximate 5 inches of uniform deposition across the channel bottom while channel width and bank slope remained stable. SC3 experienced little change in channel dimension, though had an average of 2 inches of deposition from mid-channel to left bank.
