Salt River Ecosystem Restoration Project

Adaptive Management Plan Monitoring Report 2019

Finalized April 2020

Prepared by the Humboldt County Resource Conservation District

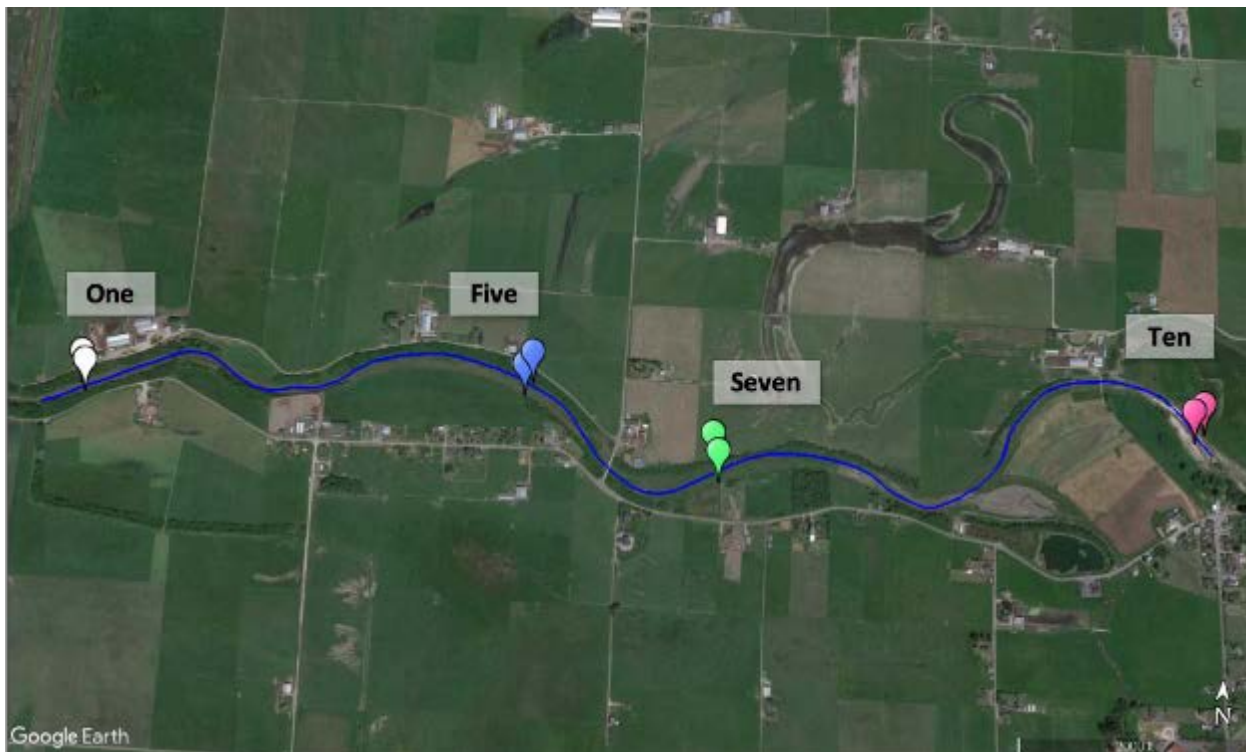
Figure 2: Salt River Phase 2 Cross-Section Sites

Results and Discussion: Four cross-sections sites were surveyed in the 3.5 kilometers of the 2014, 2015, 2017, and 2018 restored reaches of the Salt River (Figure 2). The following graphs (Figures 3 to 6) each show cross-sections from years 2015, 2016, 2017, and 2018 of sites 1, 5, and 7. The following cross-sectional profile graphs are presented looking downstream. The following is an excerpt from the channel profile report that describes the cross-section sites and the longitudinal survey:

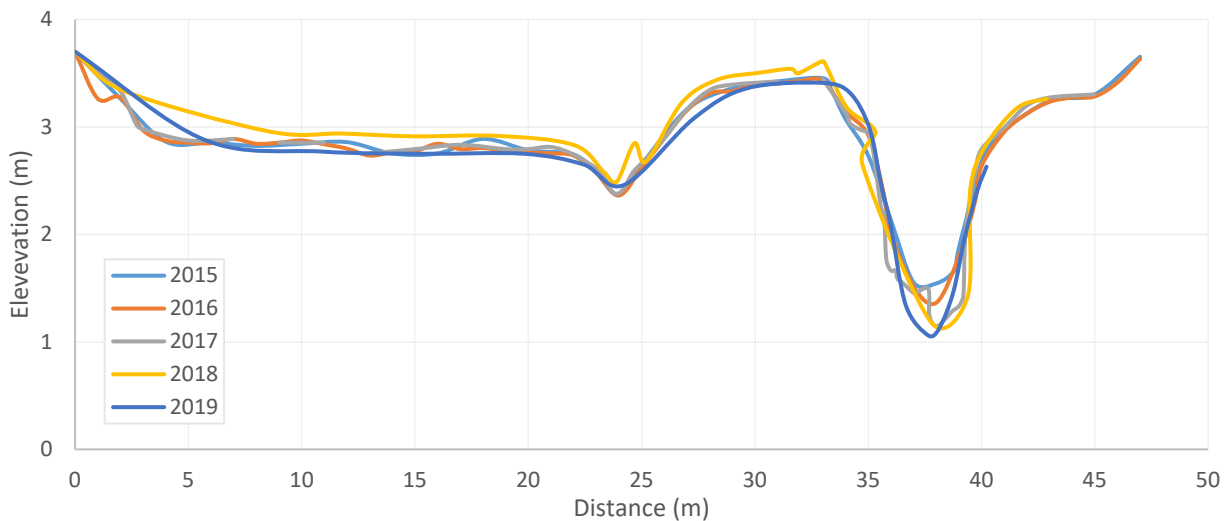
Figure 4: Cross-section five, profile for year 2018-2019.

Cross-section five maintained a similar width-to-depth ratio compared to 2018, with a decrease in thalweg elevation of 0.12 m (Figure 4). The cross-sectional profile shows floodplain elevations consistent with previous survey years but slight aggradation in the side channel (0.08 m).

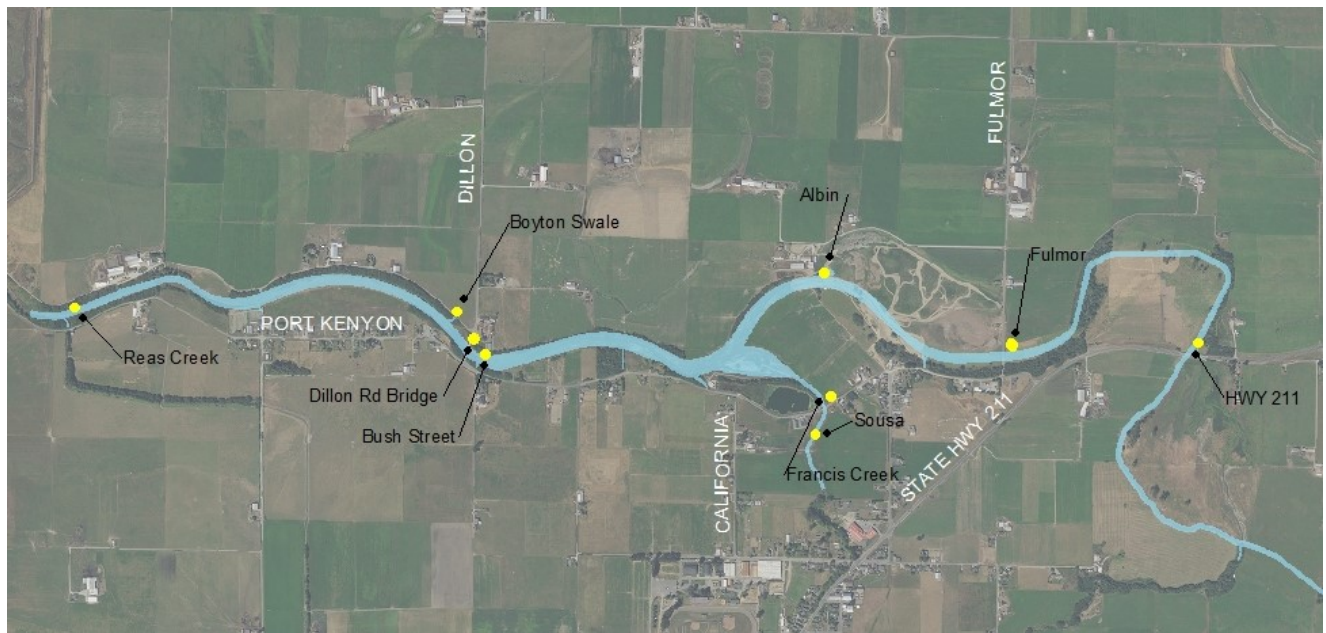
Figure 9: Bridges and Culverts Locations on the Salt River restored corridor

Results and Discussion: Four bridges (Dillion Road, Albin, Sousa, Francis, and Fulmor) span the restored Salt River channel as of the 2019 monitoring period. The Albin, Sousa, and Francis were bridges replaced or constructed as part of the Salt River restoration. All bridges were observed during low and high flows and no debris in the channel or flood plain are racking up on the bridge abutments or installed rock slope protection. Erosion around the footings is not occurring. The Reas Creek, Boynton Swale, and Bush Street culverts have been observed during high and low flows and appear to be functioning normally.
