# Salt River Ecosystem Restoration Project

## Habitat Mitigation and Monitoring Plan Monitoring Report 2017

Finalized July 2018

Prepared by the Humboldt County Resource Conservation District

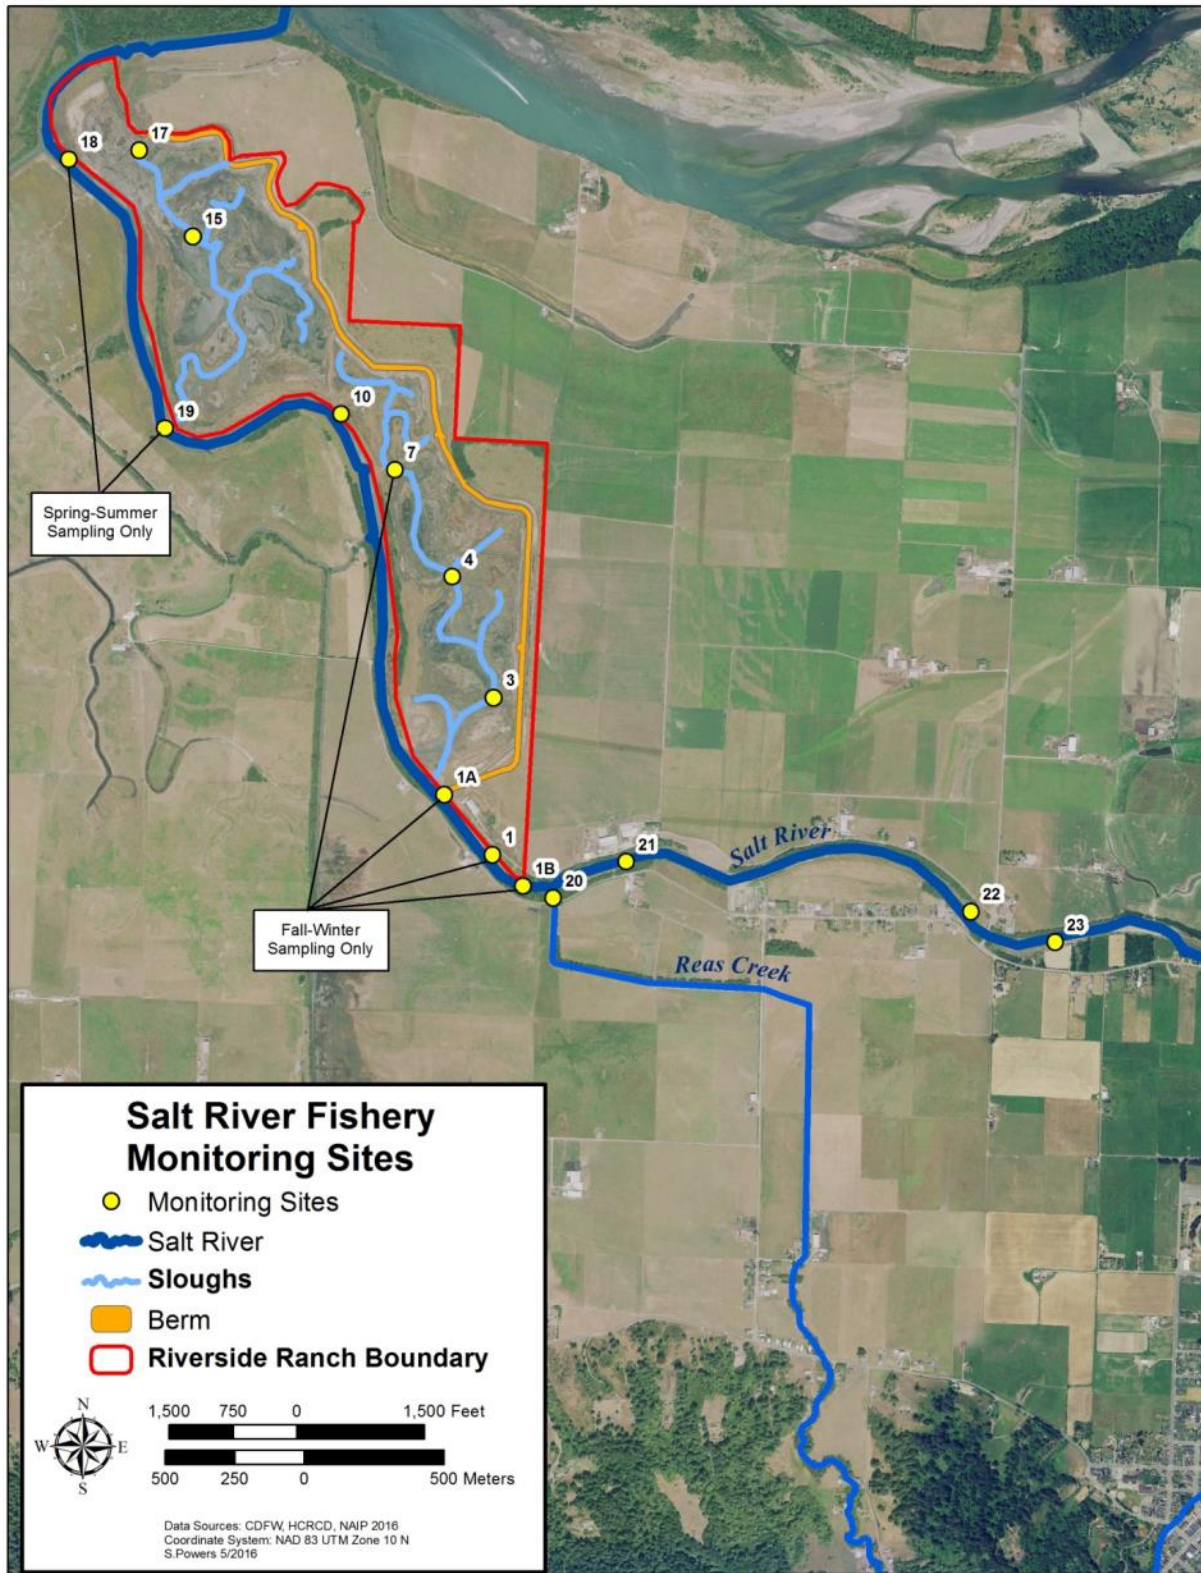
**Figure 7: Fish Monitoring Sites Across Phase 1 and 2 of the Salt River Ecosystem Restoration Project (2017)**

Once a month, from March to August 2017 (except during July 2017 due to availability of a CDFW fisheries biologist), sites distributed across the Phase 1 and Phase 2 (Figure 7) constructed portions of the Salt River Ecosystem Restoration Project were surveyed for salmonids and tidewater gobies during low tide periods. Eleven sites on the Salt River Phase 1 and Phase 2 restoration area were selected for fish presence and distribution monitoring to represent the diversity of channel size and habitats in the main Salt River channel in the slough network. Each tidally influenced site was sampled using a 1/8th inch mesh pole seine net. Typically a single 1/8th inch mesh pole seine pass was made through each site. Sites located further up the river channel were sampled by minnow traps being deployed for at least an hour. These sites were not seined if it was determined ineffective due to narrow channel size. Captured fish were held in aerated buckets, identified to species, counted, and released back into the waterway. Additionally, juvenile salmonids were measured, held in a recovery bucket, and then released back into the waterway. Captured pike minnow were enumerated into 100 millimeter size classes by ocular estimation, and the non-native pike minnow are humanely euthanized and buried via permit requirement. A start time, end time, and air and water temperature, measured by thermometer, were recorded for each minnow trap and seine deployment. In previous years minnow traps were deployed at each site but results did not significantly add further information to the seining effort, thus minnow trapping has since been limited to specific sites.

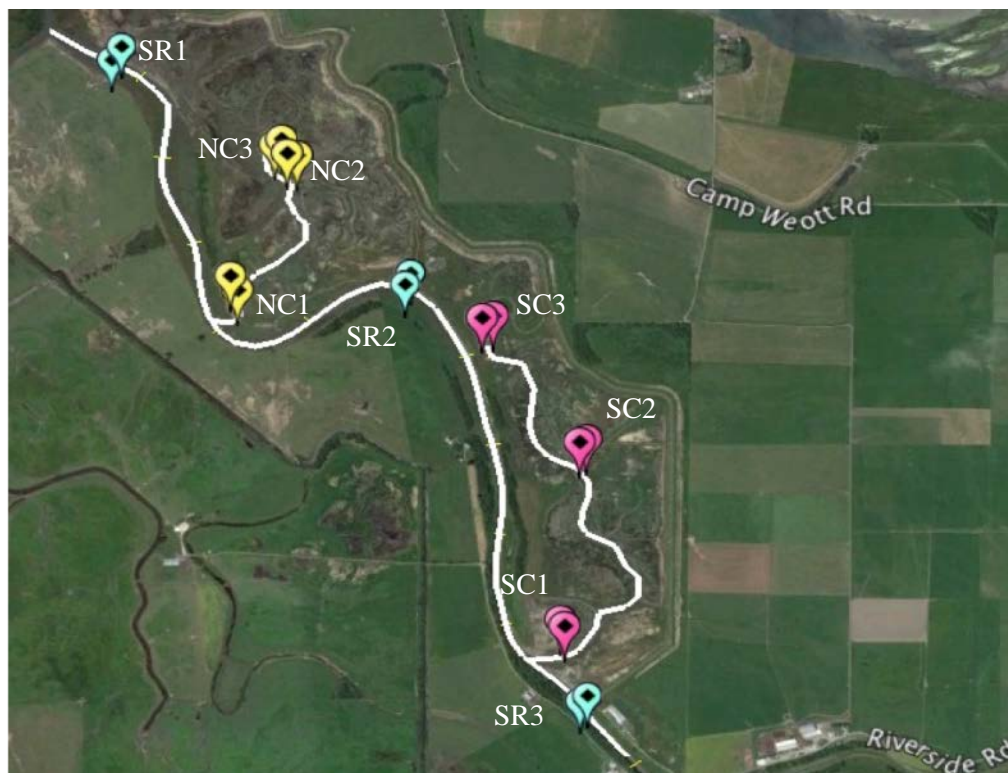
**Figure 9: Location of the cross section and longitudinal profiles for Salt River Ecosystem Restoration Survey Project, Spring 2017.**

The longitudinal profile survey of the main Salt River channel from Cutoff Slough to the Riverside Ranch barn was collected using a Nikon DTM-352 Total Station laser theodolite, tripod, stadia rod, prism pole and single prism. The prism pole was placed in the thalweg approximately every 200-feet with the total station located at one of four locations along the north bank of the main Salt River channel and geo-referenced to the project's survey control points SR11, SR14 and SR12. A total of 48 measurements were taken along 11,789 feet of the Salt River. All elevations are reported in feet using the NAVD88 vertical datum.

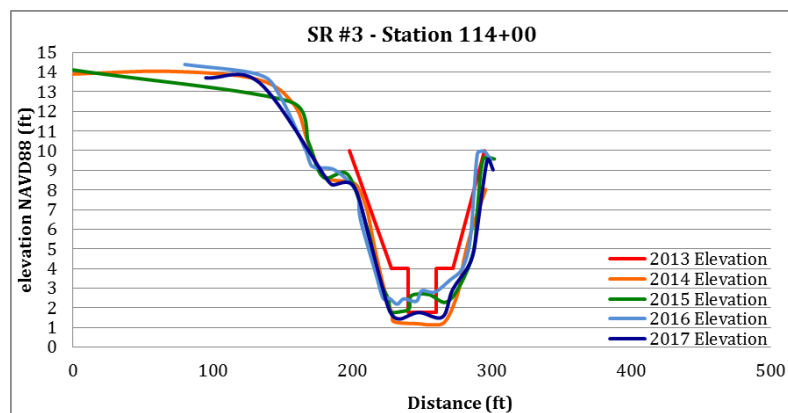
**Figure 10: Salt River Cross-Section #1 (SR1)**

**Figure 11: Salt River Cross-Section #2 (SR2)**

**Figure 12: Salt River Cross-Section #3 (SR3)**

Patterns of erosion, transport and deposition observed in previous years continued in a similar manner in 2017. The primary difference was channel bed erosion in the lower main stem Salt River (SR), and deposition in the middle to upper sections. Bank erosion and slumping were observed throughout the project area, particularly in the downstream reaches of the SR near the confluences with Cutoff Slough (CO) and the northern slough channel (NC). Main channel bed erosion in the Salt River was observed in the lower section of the SR below NC.

The SRERP's Adaptive Management Plan identifies a 10% change in channel capacity as a trigger level for potential management actions. Seven of the nine cross-sections have experienced an increase in channel capacity since 2014 (Table 5), two of which merit discussion and further monitoring (NC1 and SC2). Two cross-sections (NC3 and SR1) have slightly decreased in capacity beyond the 10% trigger level and further monitoring is recommended. Sediment deposition in the upstream section of the Salt River channel between SR2 and SC is seen in the longitudinal profiles (Figure 19) and is likely the result of re-suspension of fine-grain sediments (e.g. silt and clay) that are transported upstream during flood tide then deposited at slack, high water. This system exhibits a net upstream transport of sediment in the Salt River main channel; however, the long-term, net-transport direction and quantity of sediment should be resolved in

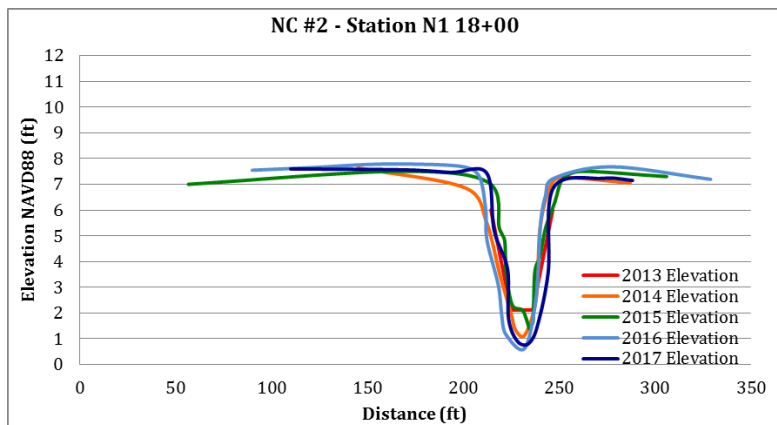
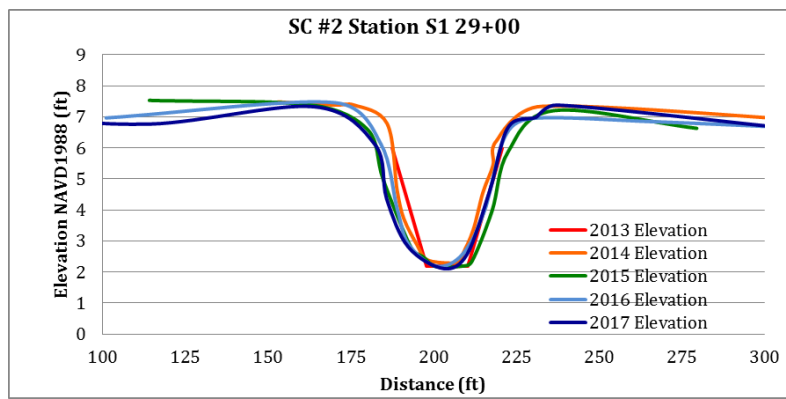
**Results and Discussion:** Results are summarized from the monitoring report in the following narrative and in Figures 10 – 19. Cross-sections determine the width and depth of the channels. The following are the cross-sectional and longitudinal profiles for the Salt River main channel and the southern and northern slough channel network.

**Figure 13: Slough North Channel Cross-Section #1 (NC1)**

**Figure 14: North Slough Channel Cross-Section #2 (NC2)**

**Figure 15: North Slough Channel Cross-Section #3 (NC3)**

**Figure 16: South Slough Channel Cross-Section #1 (SC1)**

**Figure 17: South Slough Channel Cross-Section #2 (SC2)**

**Figure 18: South Slough Channel Cross-Section #3 (SC3)**

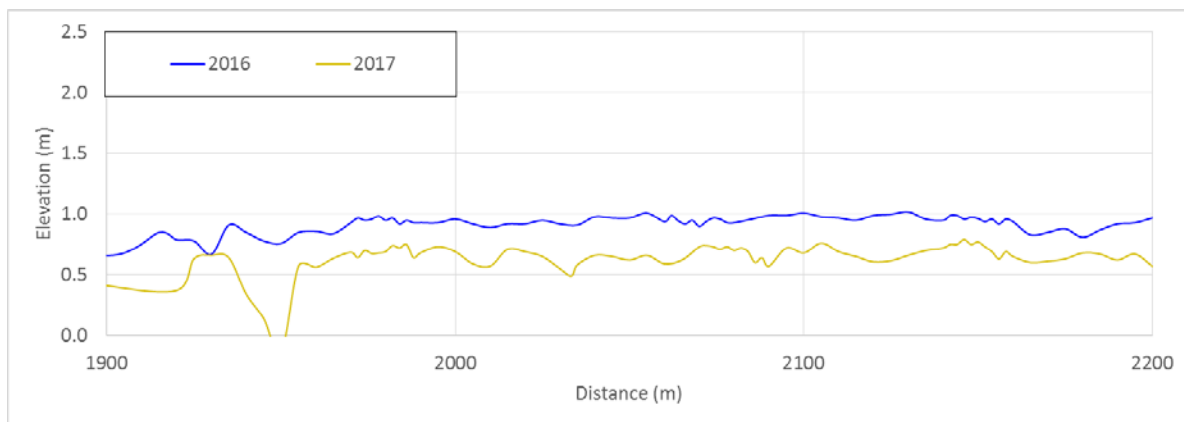
A longitudinal survey was completed along the constructed Phase 2 footprint. The longitudinal profile graphs presented (Figures 24 to 26) concentrate on the three individual Units. Unit 1 shows topographic heterogeneity and a uniform channel bottom scouring from 2016 to 2017 with a pool development in the upstream section (between 1,900m and 2,000m) (Figure 24). The Unit 2 profile indicates fluctuations between scour and deposition with pool formation in the upstream section (between 700m and 800m) (Figure 25). Unit 3 is primarily stable in elevation, with some pool development in the downstream section (between 200m and 300m) (Figure 26).

**Figure 24: Unit 1 Longitudinal Profile in 2016 and 2017**

**Figure 25: Unit 2 Longitudinal Profile in 2016 and 2017**

**Figure 26: Unit 3 Longitudinal Profile in 2016 and 2017**

Other channel considerations include a number of identified bank failures due to groundwater seepage or sand pockets. Unit 1 has a very large bank failure due to groundwater seepage. This failure occurred immediately after 2014 construction and is being monitored. Unit 2 has numerous bank failures caused by large pockets of sand composing a majority of the right bank. Much of this sand is being transported to the Unit 2 floodplain bench. Unit 3 has two bank failures that merit further monitoring. All bank failures will be assessed and determined if each will be allowed to stabilize on their own or if intervention is needed.
