Salt River Ecosystem Restoration Project

Habitat Mitigation and Monitoring Plan Monitoring Report 2019

Finalized February 2019

Prepared by the Humboldt County Resource Conservation District
5630 South Broadway
Eureka, CA 95503
707.442-6058 ext. 5
hcrd@gmail.com

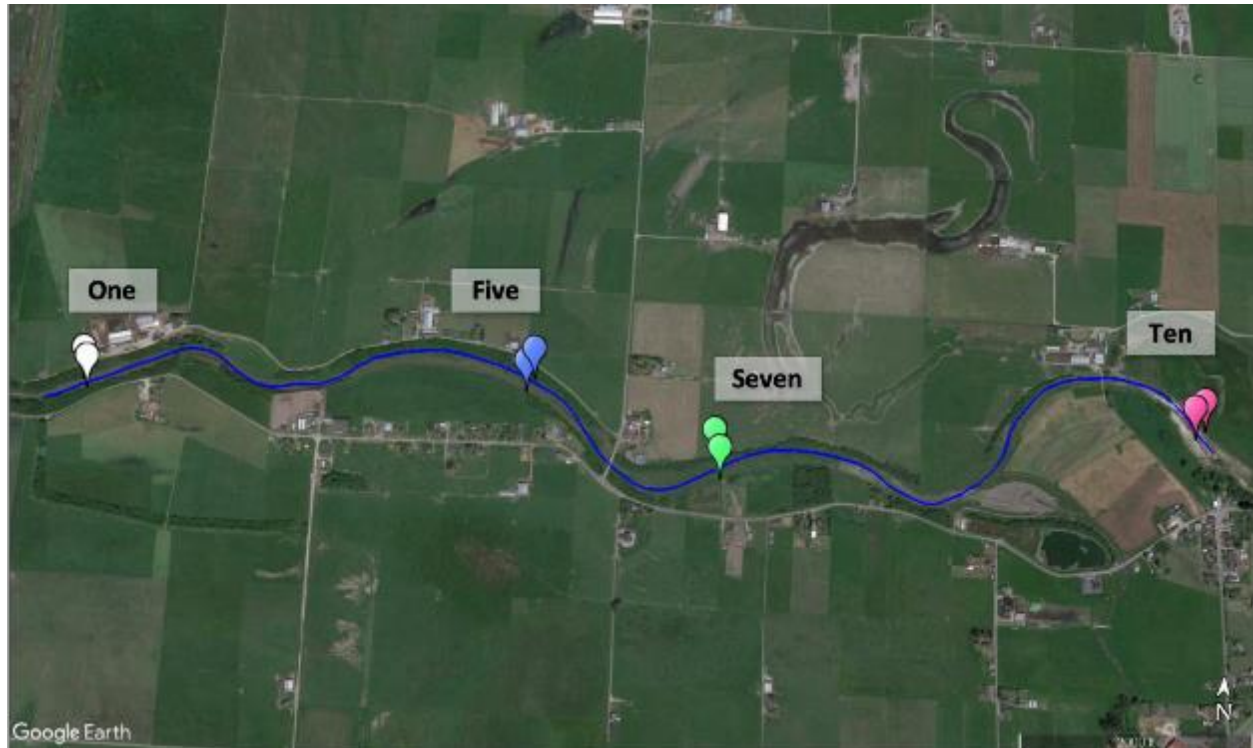
Figure 10: Salt River Phase 2 Cross-Section Sites

Results and Discussion: Four cross-sections sites were surveyed in the 3.5 kilometers of the 2014, 2015, 2017, and 2018 restored reaches of the Salt River (Figure 10). The following graphs (Figures 11 to 14) show cross-sections from years 2015, 2016, 2017, and 2018 of sites 1, 5, and 7. The following cross-sectional profile graphs are presented looking downstream. The following is an excerpt from the channel profile report that describes the cross-section sites and the longitudinal survey:

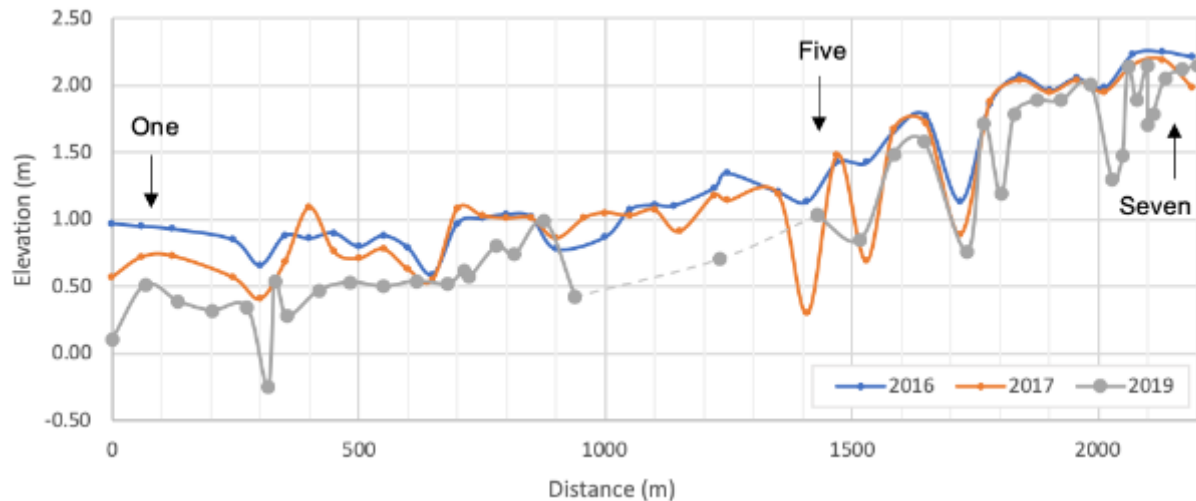
The longitudinal profile spans a distance of 3,700 m and is presented in two segments that cover Phase 2 (Figure 15) and a recently completed section that extends upstream of the Francis Creek sediment retention basin (Figure 16). Data resolution is courser in portions of the reach due to dense vegetation and channel incision that prevented sighting of the prism. The distribution of elevation points is illustrated by markers to show areas with less data, notable sections include between 1,000 and 1,500 m (Figure 15) as well as from 2,300 to 2,600 m (Figure 16). Results for these segments are not presented due to the low confidence interval in making topographic comparisons with a small sample size.

Figure 15: Section of longitudinal profile for the Phase 2A portion of the SRERP with locations of cross sections labeled. The dashed line for 2019 indicates a segment with course data resolution that may not accurately reflect trends in channel morphology.
