# Salt River Ecosystem Restoration Project

## Habitat Mitigation and Monitoring Plan Monitoring Report 2020

Finalized February 2021

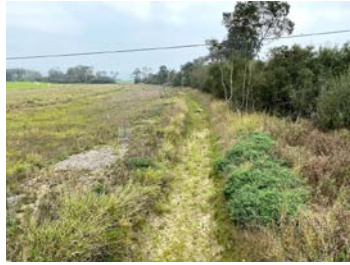
PP9 – Fulmor Br E – Oct 2018    PP9 – Fulmor Br E – Oct 2020

Photo documentation indicates that vegetation continues to establish on Phase 1 and 2 where seed mixes are persisting and natural recruitment of natives, non-natives, and, in some cases, invasives are evolving. Some sites are experiencing increasing canopy cover.

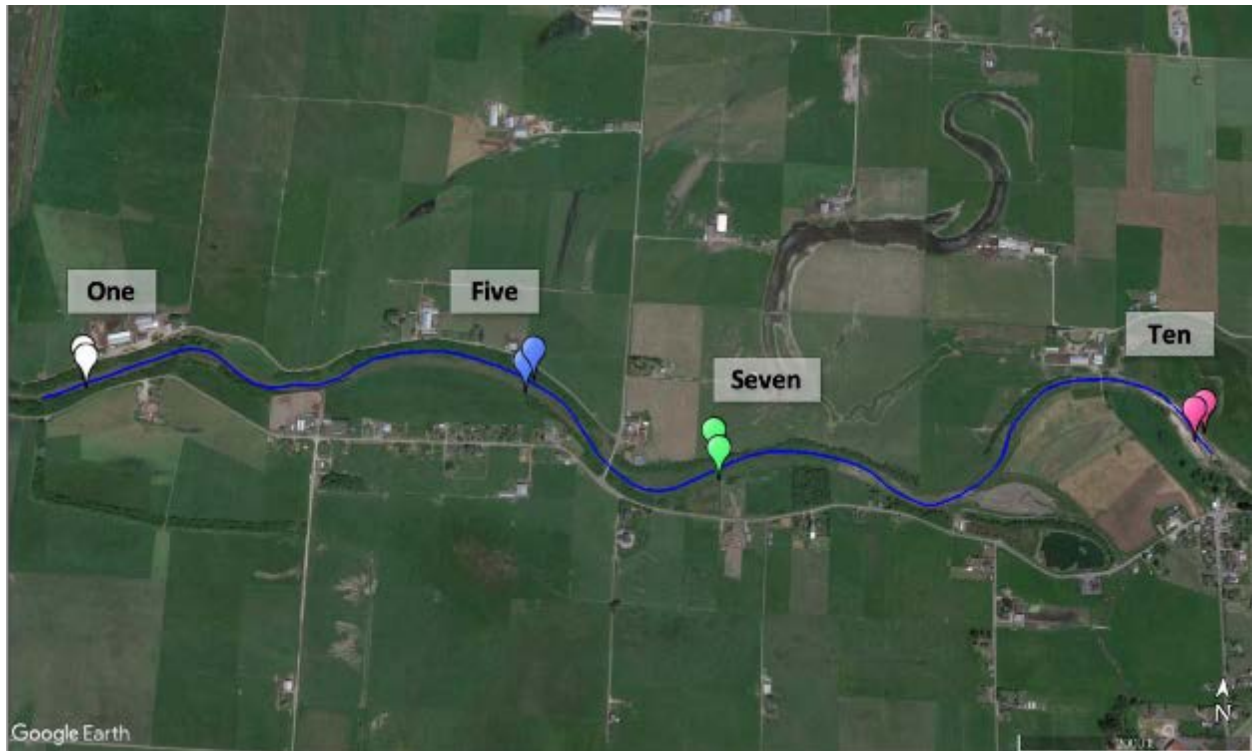
Figure 16: Salt River Phase 2 Cross-Section Sites

**Results and Discussion:** Four cross-sections sites were surveyed in the 3.7 kilometers of the restored reaches of the Salt River (Figure 16). The following graphs (Figures 17 to 21) show cross-sections from 2020 and previous years. Excerpts and results from the Phase 2 2020 report are provided below:
