# SALT RIVER ECOSYSTEM RESTORATION PROJECT

## FISH MONITORING PROGRAM

Results of Fish Species Presence and Distribution Monitoring Conducted  
From March to August, 2017 within the Salt River, Eel River Estuary,  
Phase 1 and 2 Project Areas, Humboldt County California

Prepared By: Doreen Hansen (Humboldt County Resource Conservation District)

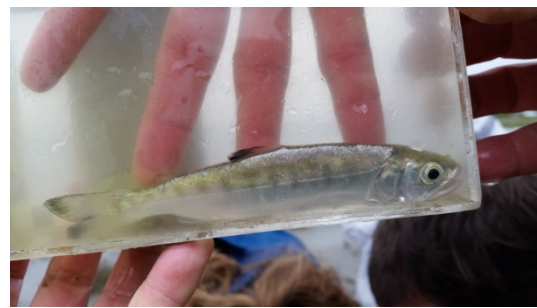
Figure 3. Coho captured at site #18 in April

Ten Coho salmon (*Oncorhynchus kisutch*) juveniles were present during the March and April sampling months (Fig. 3 and 4) as well as one Chinook salmon (*Oncorhynchus tshawytscha*) (Fig. 2). Salmonids were captured in the tidal marsh area and in the main channel Salt River.

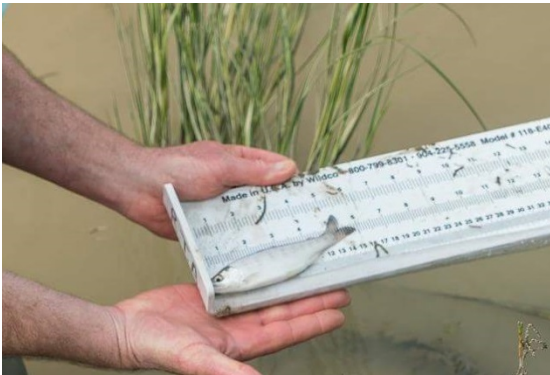
Figure 4. Coho captured at site 20 in March 2017

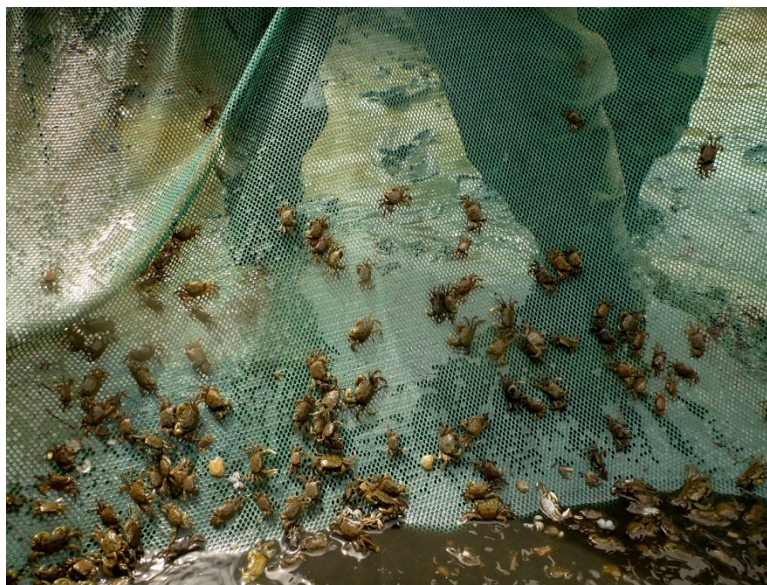
Figure 5. Unidentified shore crab (Yellow or Lined) in June 2016 at site #8

Significant numbers (212) of staghorn sculpins (*Leptocottus armatus*) were captured in 2017. This is the second year of increased staghorn sculpin numbers in the project area. Three-Spined Stickleback continue to be captured in the thousands of individuals. The number of Sacramento Pike Minnow has increased alarmingly in 2017 as compared to previous years. This may be due to the higher precipitation through the winter and spring providing suitable low salinity habitat throughout a majority of project area, whereas previous years the region was in a drought and the marine environment stayed highly saline throughout the winter and spring. In June of 2016, a highly abundant species of shore crab (yellow or lined) was first seen in the estuary since restoration was completed in 2013 (Fig 5). For this sampling season, the crabs have reduced from numbers in the thousands in 2016 to just a few individuals in 2017.
