# SALT RIVER ECOSYSTEM RESTORATION PROJECT

## SPRING-SUMMER FISH MONITORING PROGRAM

Results of Fish Species Presence and Distribution Monitoring Conducted  
From March to August 2019 within the Salt River, Eel River Estuary,  
Phase 2 Project Area, Humboldt County California

Prepared By: Doreen Hansen (Humboldt County Resource Conservation District)

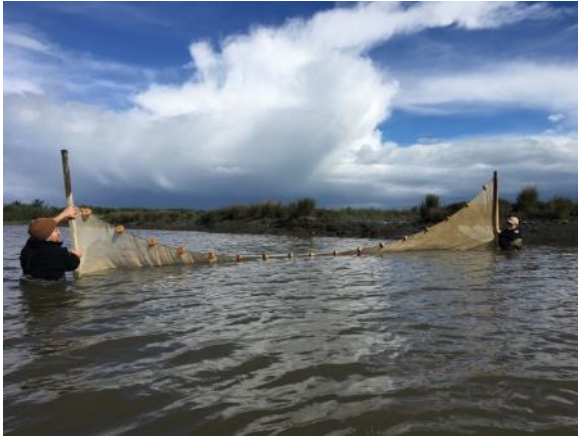
Figure 2. Seining at site 10

- Site 10 is on the main stem Salt River between the mouths of the two sloughs. Seine 150 feet of the river channel (Fig. 2).
- Site 14 is located on a branch of the N1 Slough. Seine last 150 feet of the channel and has been **ABANDONED**.

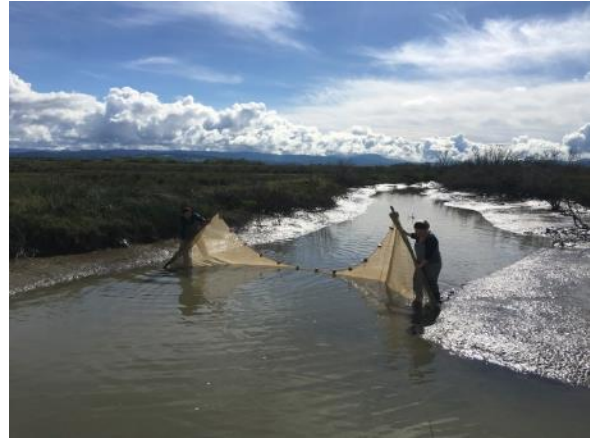
Figure 3. Seining at site 15

- Site 15 is on main stem of the N1 slough upstream of the second left bank branch. Seine 150 feet above confluence with slough branch (Fig. 3).
- Site 17 is associated with a piece of placed LWD on the main stem of the N1 Slough. Seine 100 feet on both sides of the LWD.
