Channel Profile Report: Salt River Ecosystem Restoration Project

Phase Two- Year 2019

Prepared by: Melissa Kobetsky (Humboldt State University)

December 3, 2019

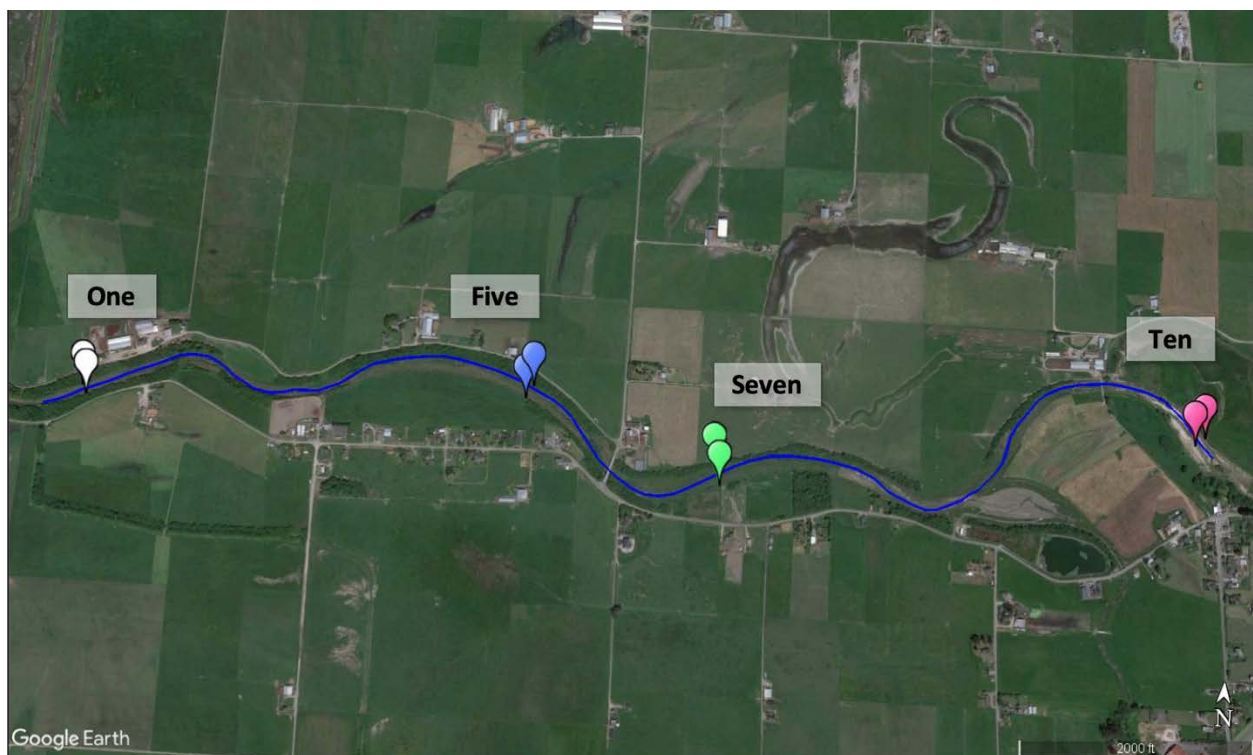
Figure 1: Locations of cross-section and longitudinal profile for phase two of the Salt River Ecosystem Restoration Project, 2019.

Elevation surveys in the Phase two project area for the 2019 monitoring year consisted of four cross-sections and a longitudinal profile (fig.1). The longitudinal profile spans a distance 3.5 kilometers from the confluence of Reas Creek to just upstream of cross-section ten. Cross-sections one, five, and seven were established in 2015 (Medel 2017) and cross-section ten was established this year to include the most recent completed portion of channel construction. Only the monument for cross-section seven was

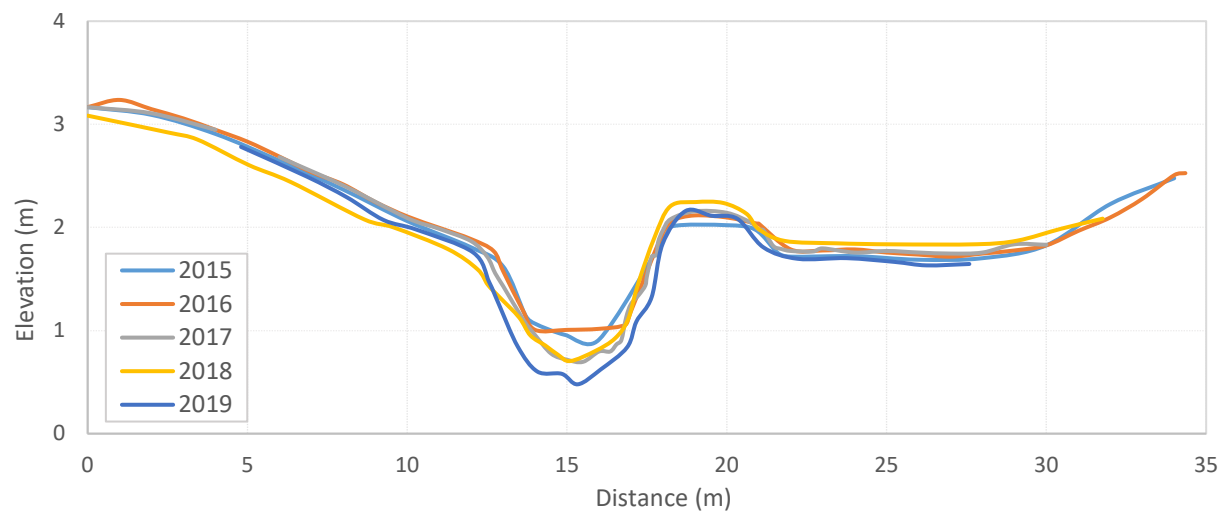
Figure 2: Cross-section one profile for years 2015-2019.

Cross-sectional profiles are presented looking downstream in the westerly direction, and start on the south side of the channel (left bank) and extend to the north (right bank) (fig. 1). The profile for cross-section one (fig. 2) indicates both widening and deepening in the main channel but nominal elevation change in the active bench and floodplain. Degradation was relatively uniform across the channel, with a decrease in thalweg elevation of 0.23m compared to 2018.

Channel degradation is the dominant trend across transects; particularly in cross-sections one and five, which have decreased in thalweg elevation by almost a half a meter since 2015 (table 1). Cross-section one has been more dynamic throughout the five survey years and experienced deposition in 2016 and 2018 whereas cross-section five shows a more consistent trend of elevation loss. Unit seven also shows a trend toward erosion in the channel but of less overall magnitude than the other cross-sections.

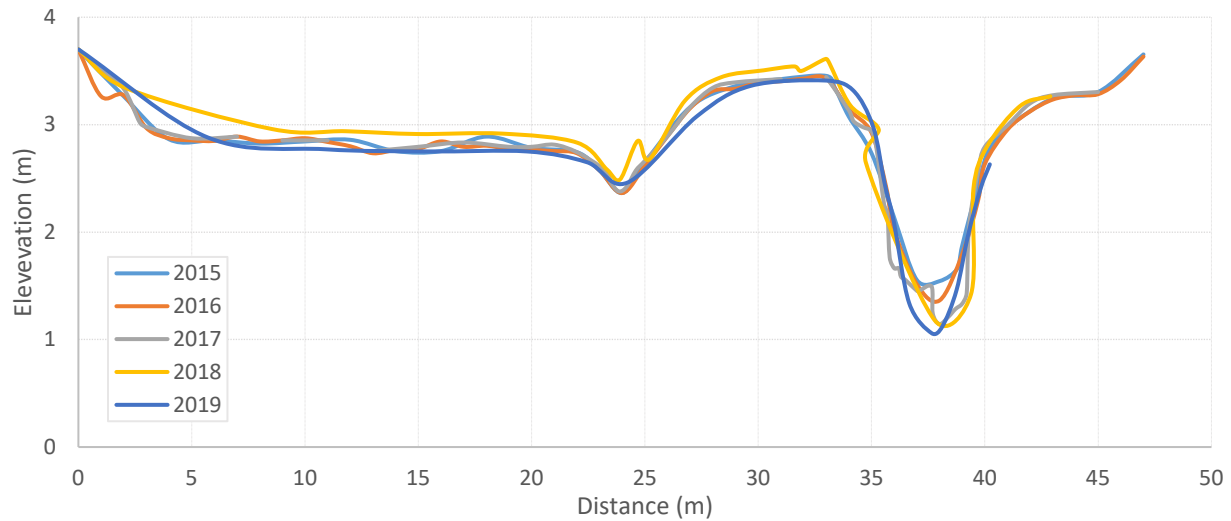
Figure 3: Cross-section five year 2018-2019.

Cross-section five maintained a similar width-to-depth ratio compared to 2018, with a decrease in thalweg elevation of 0.12 m (fig.3). The cross-sectional profile shows floodplain elevations consistent with previous survey years but slight aggradation in the side channel (0.08 m).

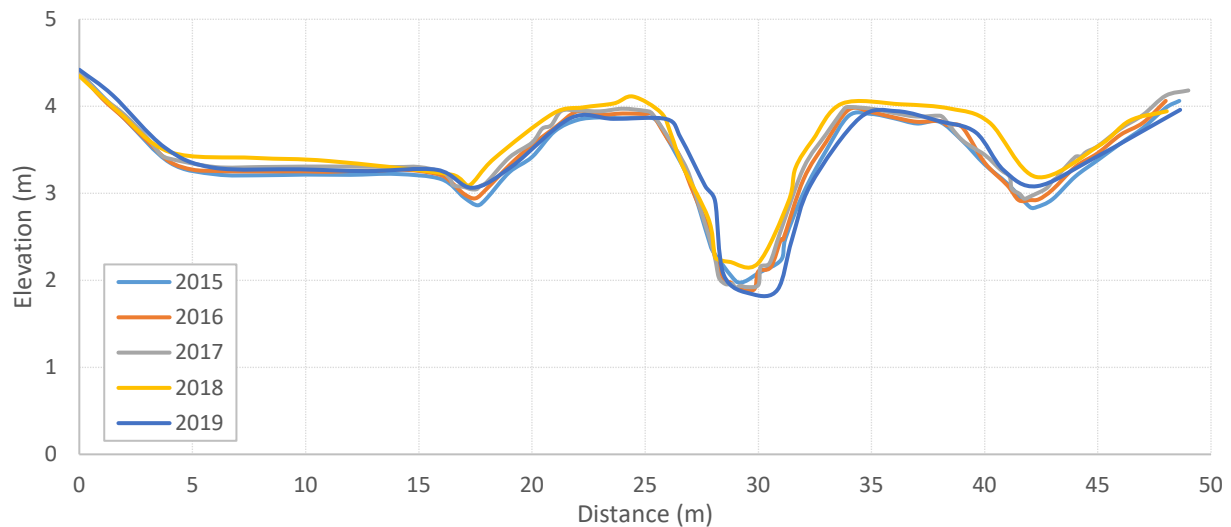
Figure 4: Cross-section seven years 2015-2019.

The channel in cross-section seven experienced scour towards the right bank, resulting in slight widening and decrease in thalweg elevation of 0.26 m compared to 2018 (fig.4). Channel geometry remains relatively stable with potential for more lateral migration based on visual observation in the field of slumping on the right bank.

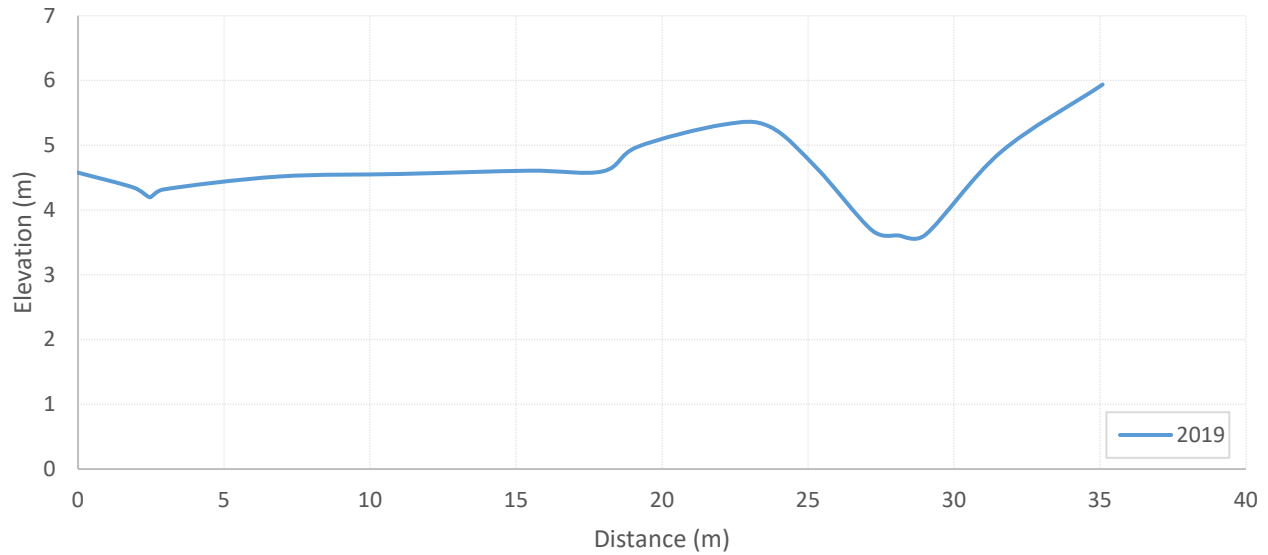
Figure 5: Cross-section ten was established to capture the most recent phase of the SRERP and the 2019 cross-sectional profile serves as baseline data serves as baseline data.

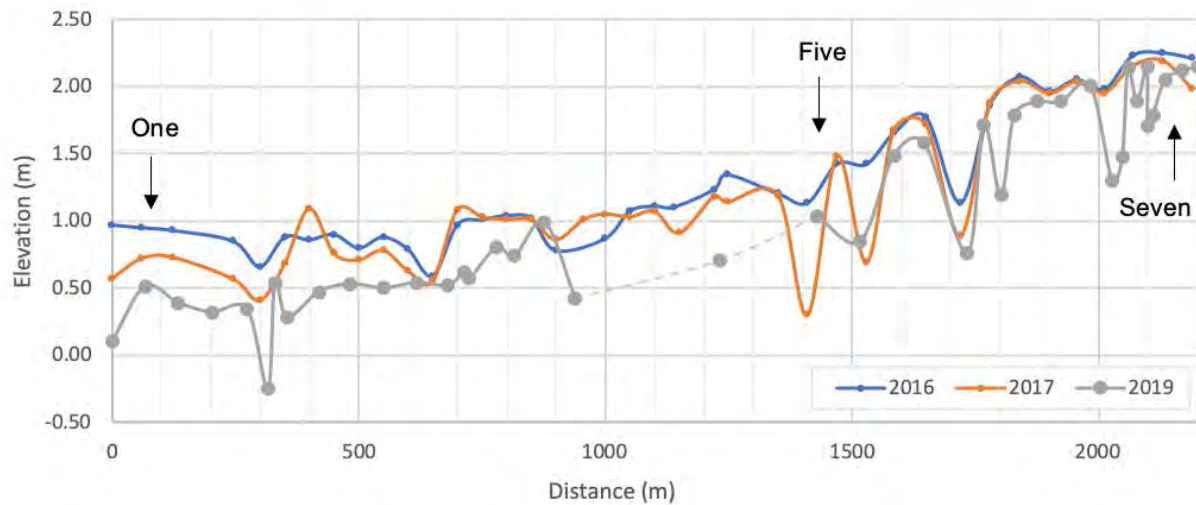
Figure 6: Section of longitudinal profile for the Phase 2A portion of the SRERP with locations of cross sections labeled. The dashed line for 2019 indicates a segment with course data resolution that may not accurately reflect trends in channel morphology.

In agreement with cross-sectional surveys, the longitudinal profile shows a dominant trend of scouring as illustrated by reductions in elevation throughout majority of the channel. The downstream portion (0-950 m) had the greatest overall erosion compared to other channel segments. The first 875 m displayed relatively uniform bed lowering, with a mean elevation decrease of 0.31 m. An existing pool at approximately 300 m continued to scour, but at a higher magnitude compared to previous years with a decrease in elevation of 0.66 (fig.6).

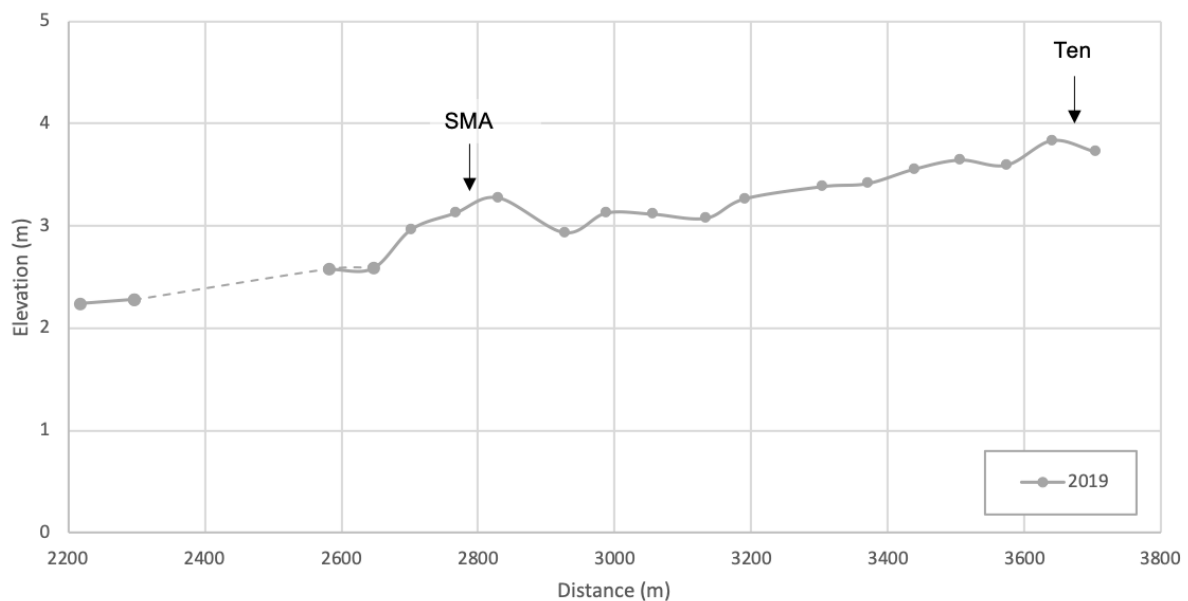
Figure 7: New section of the longitudinal profile that continues upstream from previous years surveys. Cross-section ten and the sediment management area (SMA) at the confluence with Francis Creek are labeled. The dashed line indicates a segment with course data resolution that might not accurately reflect trends in channel morphology.

The upstream portion (1,400-2,200 m) displayed variable erosion dynamics with more scouring compared to other survey years and a mean elevation 0.13 m lower than in 2017. The most downstream pool deepened slightly with a decrease in thalweg elevation of 0.12 m. Two incipient pools formed that deepened the channel thalweg elevation by approximately 0.85 m. Minor deposition (0.15 m) occurred upstream of the sediment management area, but the average relief of the channel downstream of the SMA decreased at a rate relatively consistent with the rest of the channel.

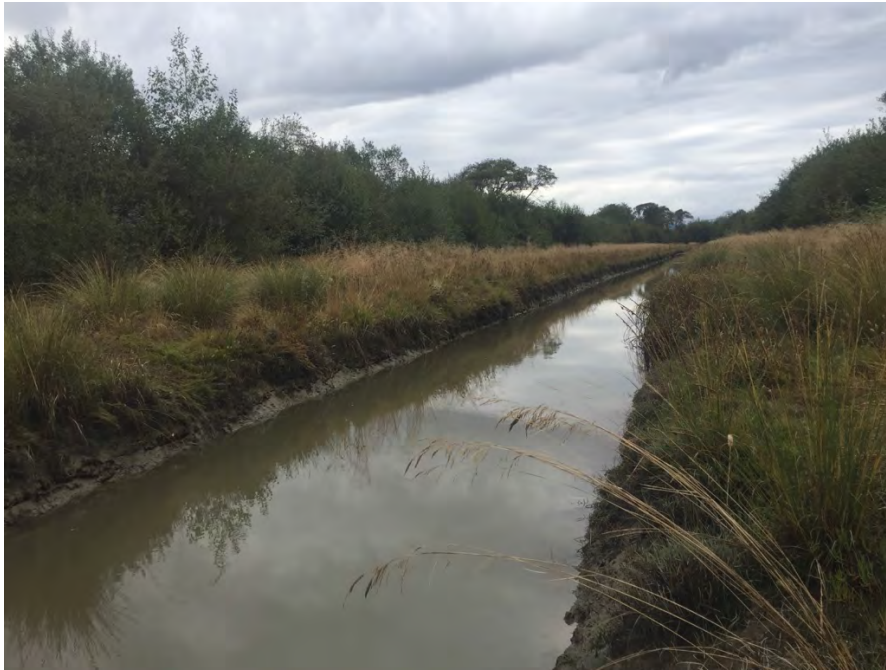
Overall, the data shows trends of decreased channel elevations and potential net sediment transport out of the project area, which is consistent with past survey years. Channel degradation is most prominent in the downstream portions; as indicated by mean bed lowering in the longitudinal profile and lower thalweg elevations in cross-sectional profiles compared to previous years. The downstream section had relatively uniform bed lowering, whereas the upstream portion had more variable scour patterns leading to incipient pool formation and greater morphological complexity. Two new pools were formed in the upstream portion spanning between 60 and 80 meters in length. A prominent pool upstream of cross-section one (where an anabranching channel reconnects with the main channel) continued to deepen and lateral erosion on both sides of the bank was observed (Appendix, fig. 8 & 9).

Figure 8: Salt River main channel looking east in the upstream direction from cross-section one. .

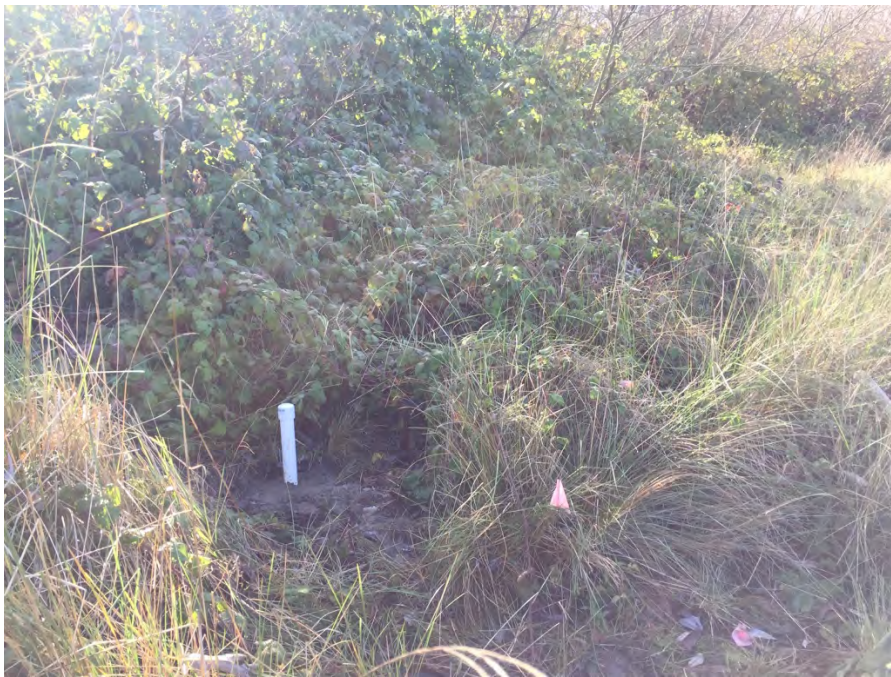
Figure 9: Endpin marking the start of cross-section one.

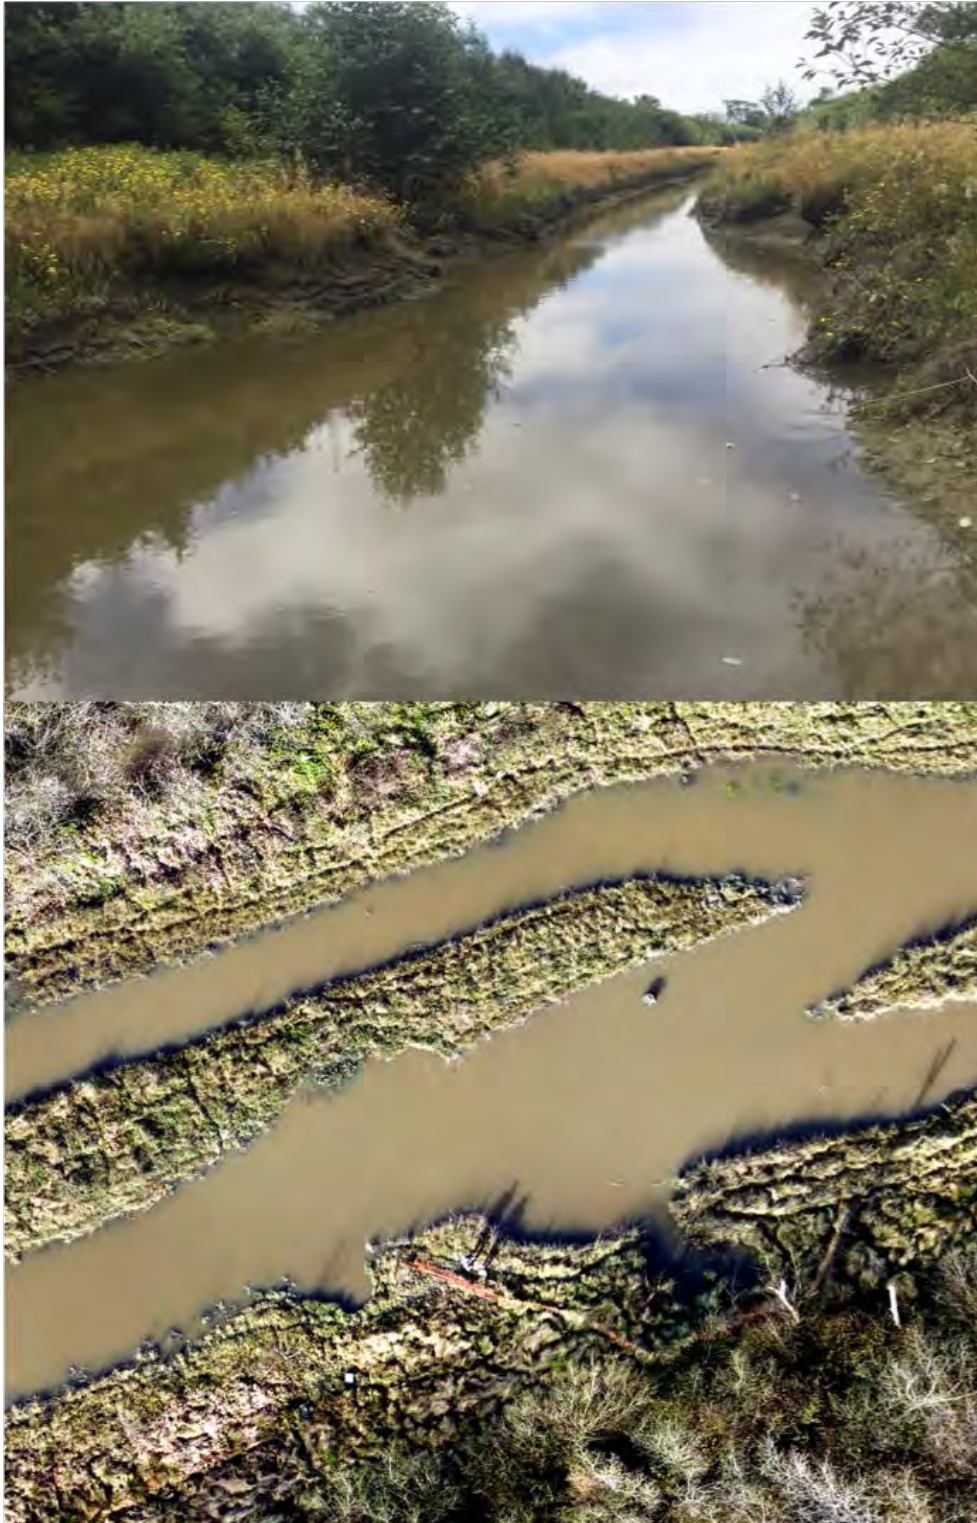
Figure 10: Channel (top, 2019) and aerial view (bottom, 2018) of bank slumps approximately 240 meters upstream of cross-section one. In addition to lateral erosion, vertical scour has occurred throughout survey years as shown by consistent deepening of a pool in the area (fig. 6).

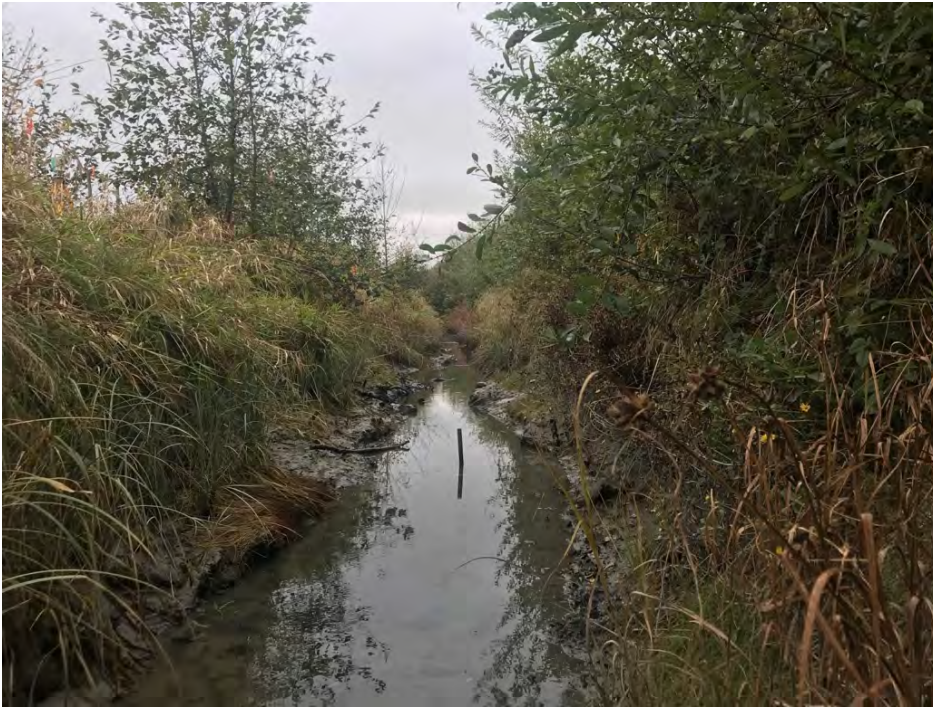
Figure 11: Cross-section five looking west in the downstream direction.

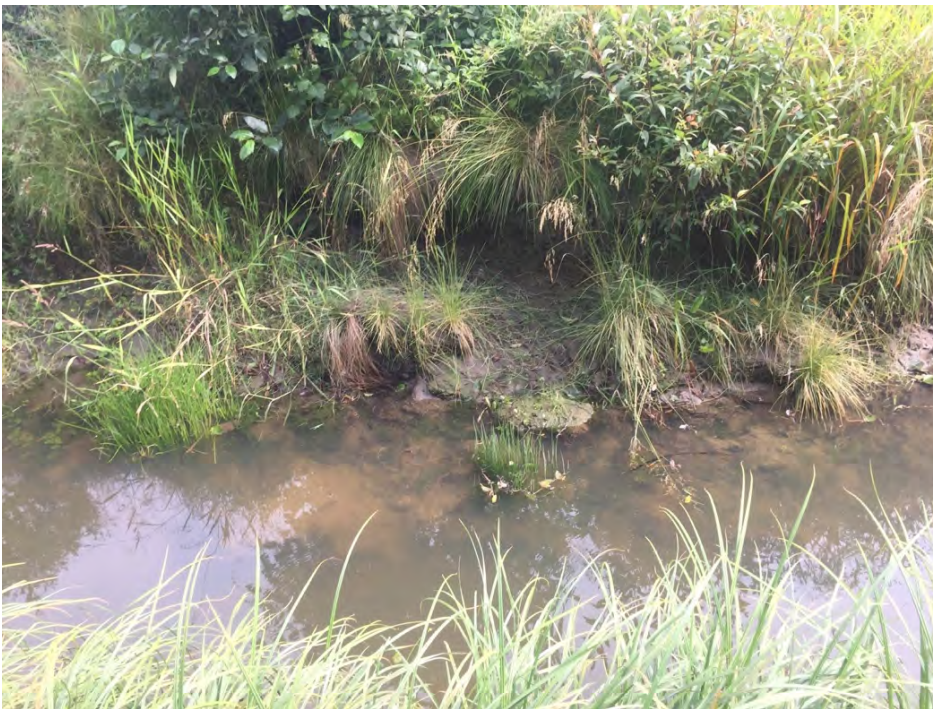
Figure 12: Bank failure downstream of cross-section five.

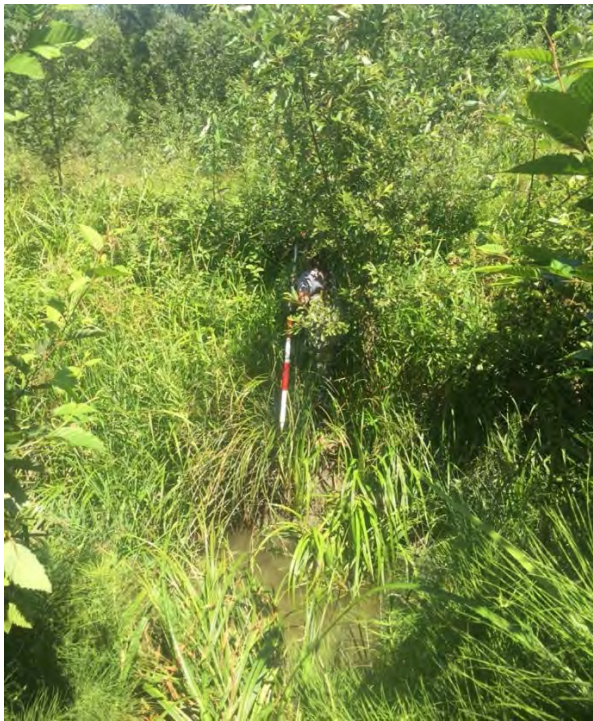
Cross-sectional profiles indicate more lateral erosion in the lower portion compared to the upper portion. This could partially be due to several factors; vegetation was anecdotally observed to have propagated more rapidly in the upstream portion (Appendix, fig. 14), these reaches are also dominated by a freshwater hydrology regime towards Francis Creek and are less tidally influenced in the middle portions compared to the lower reach near Reas Creek. Increased exposure to fluvial processes, compounded by a lack of root stabilization (as lower bank vegetation is limited in these areas) could be contributing to the higher rates of lateral erosion in the downstream portion. Conversely, riparian vegetation in the upper portions may lead to greater bank stability and less lateral erosion. Additionally, dense in-channel vegetation in the upper portions was observed, potentially causing water velocity to slow and let entrained particles settling out- thus leading to less overall change in channel geometries.

Figure 14: Cross-section seven looking north across the channel transect, note dense riparian and in-channel vegetation.

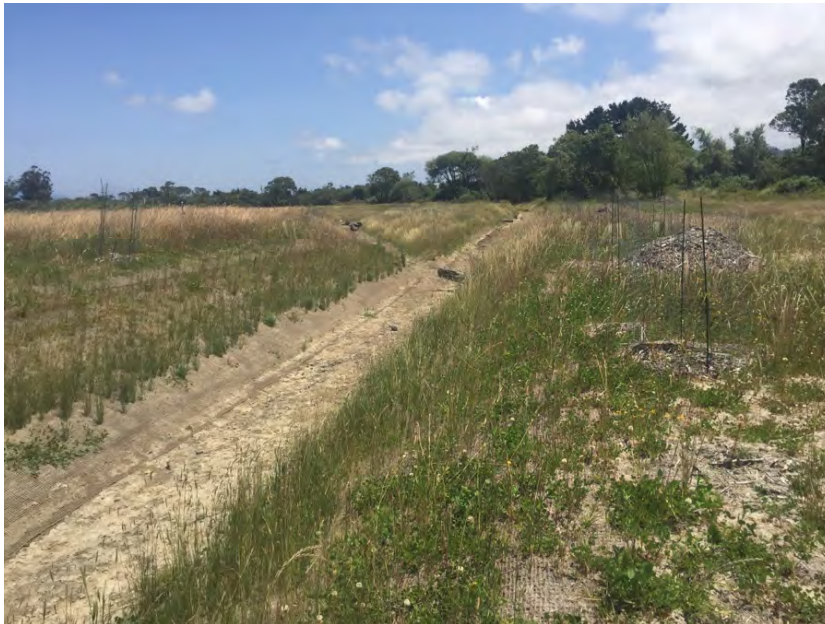
Figure 16: Cross-section ten looking upstream.
