Salt River Ecosystem Restoration Project

Habitat Mitigation and Monitoring Plan Monitoring Report 2021

Finalized February 2021

Prepared by the Humboldt County Resource Conservation District
5630 South Broadway
Eureka, CA 95503
707.442-6058 ext. 5
hcrd@gmail.com

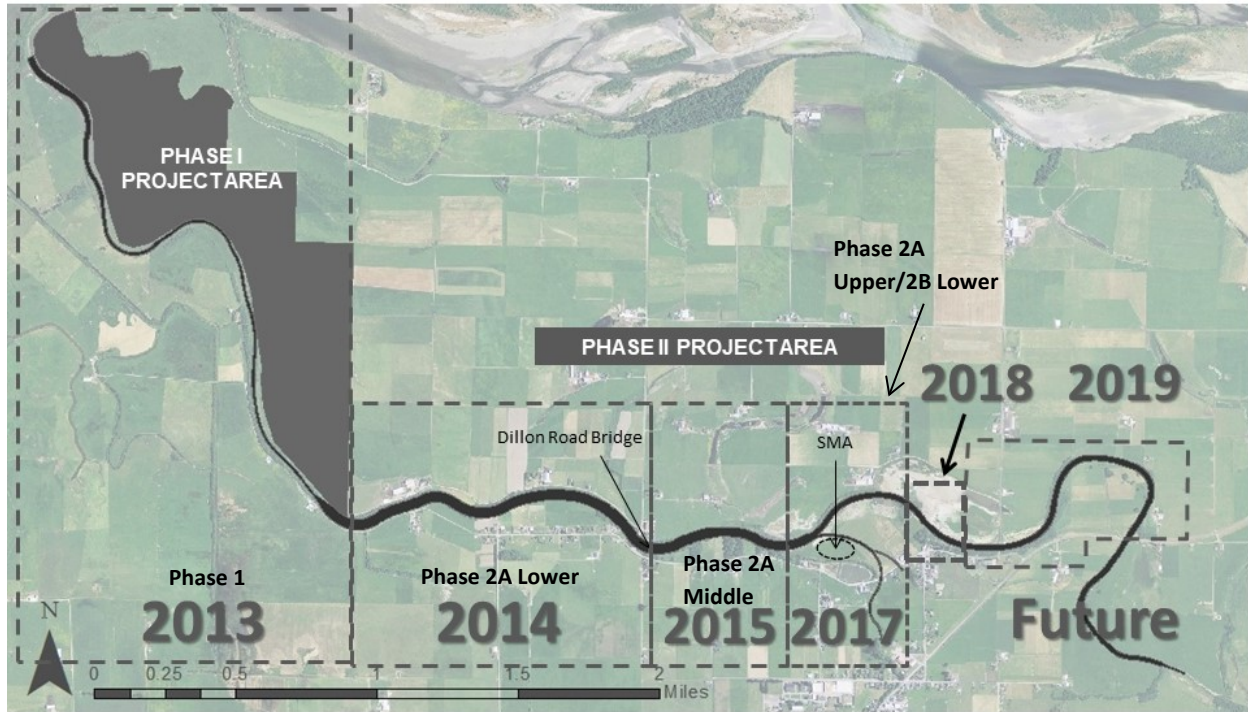
Figure 1: Salt River Ecosystem Restoration Construction Timeline as of 2021

Salt River Ecosystem Restoration Project Permitted Project Area & Implementation Status

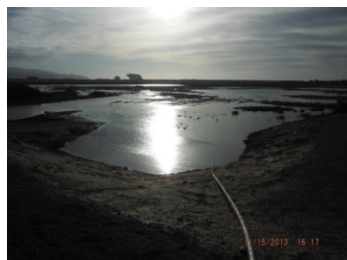
PP145 – SW – Nov 2013

Photo documentation indicates that vegetation continues to establish on Phase 1 and 2 where seed mixes are persisting and natural recruitment of natives, non-natives, and invasives are evolving. Some sites are experiencing increasing canopy cover.
