SEDIMENTATION AND EROSION PATTERNS WITHIN ANABRANCHING
CHANNELS IN A LOWLAND RIVER RESTORATION PROJECT

Phase 2A of the Salt River Ecosystem Restoration Project (SRERP) was implemented to increase transport efficiency of water and sediment through a low gradient river reach to alleviate flooding on adjacent properties. The SRERP utilizes a unique anabranching channel design that concentrates base flows within a single deep, narrow channel overflowing onto an alternating series of higher elevation active benches at flood stages. This paper investigated the performance of the project's hydraulic conveyance and general utility of anabranching channels as a restoration alternative by assessing the distribution and magnitude of deposition and erosion response patterns.

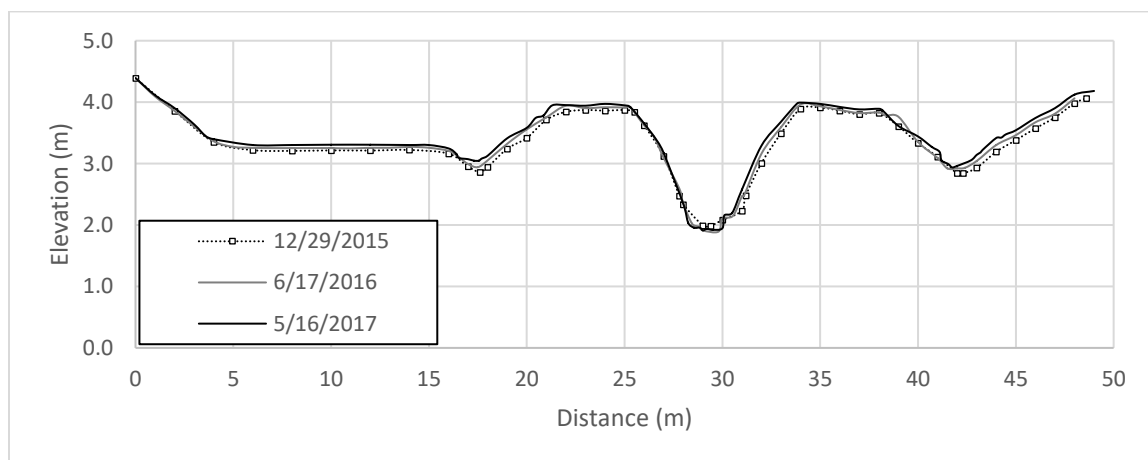
Figure 11. Cross-section profile of Unit 3 backwater transect.

Cross-section profiles of the Unit 3 backwater and middle sections indicate formation of natural levees within the secondary channels. The relatively high magnitude of deposition occurs where open from confined channels to unconfined floodplain areas. As water spills onto the floodplain it reduces in velocity and competency resulting in the deposition of coarser grained sand particles immediately adjacent to the secondary channels. The most significant sedimentation within the project area was located within the upstream reaches of Unit 3, particularly the expansion section, across multiple surveys (e.g. deposition tiles, longitudinal profile, visual observations). The leveeing is most easily identifiable on the Unit 3 expansion cross-section (Figure 13) showing a 0.39 m² cross-sectional area of sand deposited adjacent to the secondary channel.

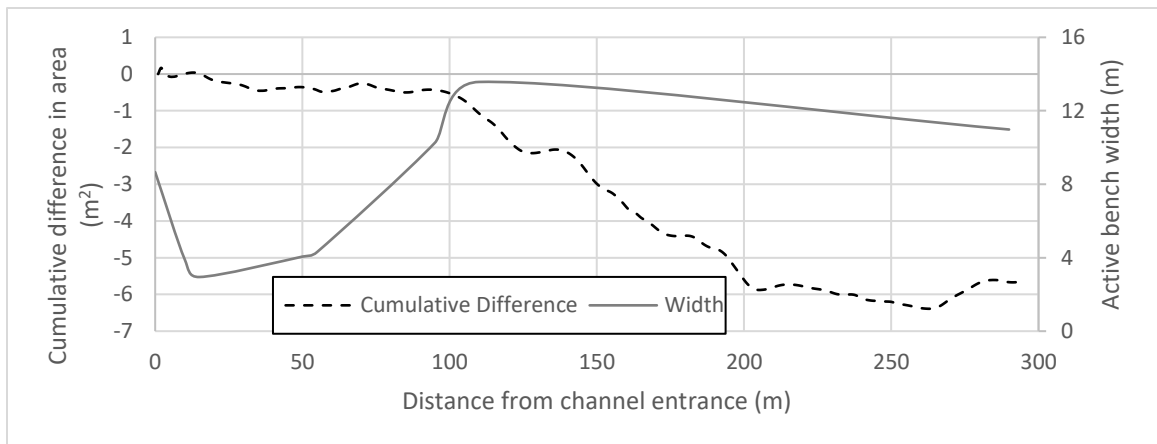
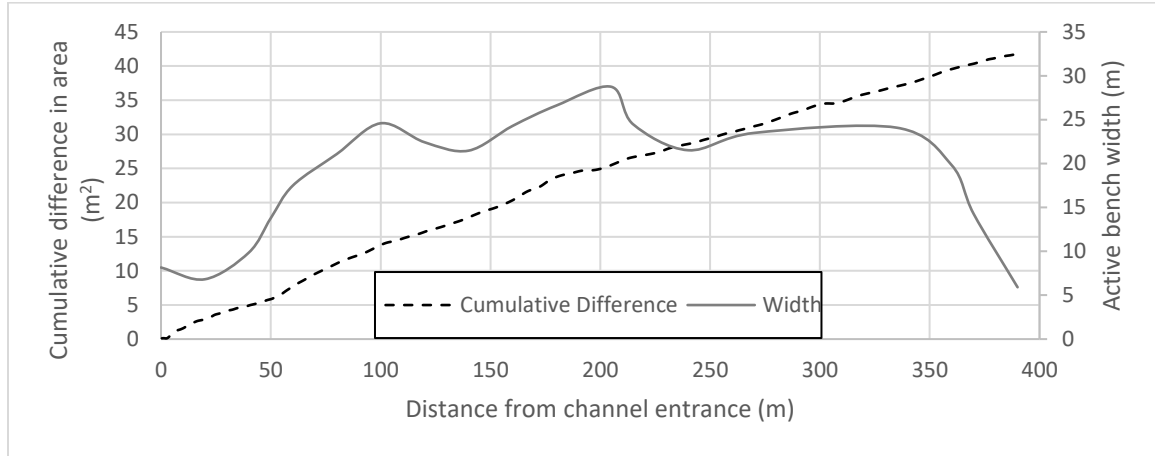
Figure 23. Cumulative difference (i.e. increases indicate deposition and decreases indicate scour) in cross-sectional area and active bench width within the Unit 1 secondary channel. Note the width is displayed on a secondary y-axis.

Figure 24. Cumulative difference (i.e. increases indicate deposition and decreases indicate scour) in cross-sectional area and active bench width within the Unit 2 secondary channel. Note the width is displayed on a secondary y-axis.

Figure 25. Cumulative difference (i.e. increases indicate deposition and decreases indicate scour) in cross-sectional area and active bench width within the Unit 3 secondary channel. Note the width is displayed on a secondary y-axis.

In general, the secondary channels within Units 2 and 3 were characterized by dominant depositional regimes while the Unit 1 side channel remained relatively stable and displayed scouring tendencies where changes were observed. Longitudinal profiles within the side channel of each channel unit were surveyed concurrently with the main channel (Figures 19, 21, and 22). Cumulative difference (i.e. the net change in area from year to year where scour is negative and deposition is positive) in cross-sectional areas were also calculated and presented with longitudinal active bench width to identify changes in the scour and deposition regimes across the range of channel geometries (Figures 23, 24, and
