POST-CONSTRUCTION CHANNEL MONITORING OF SALT RIVER, PHASE ONE

December 2014

Introduction:

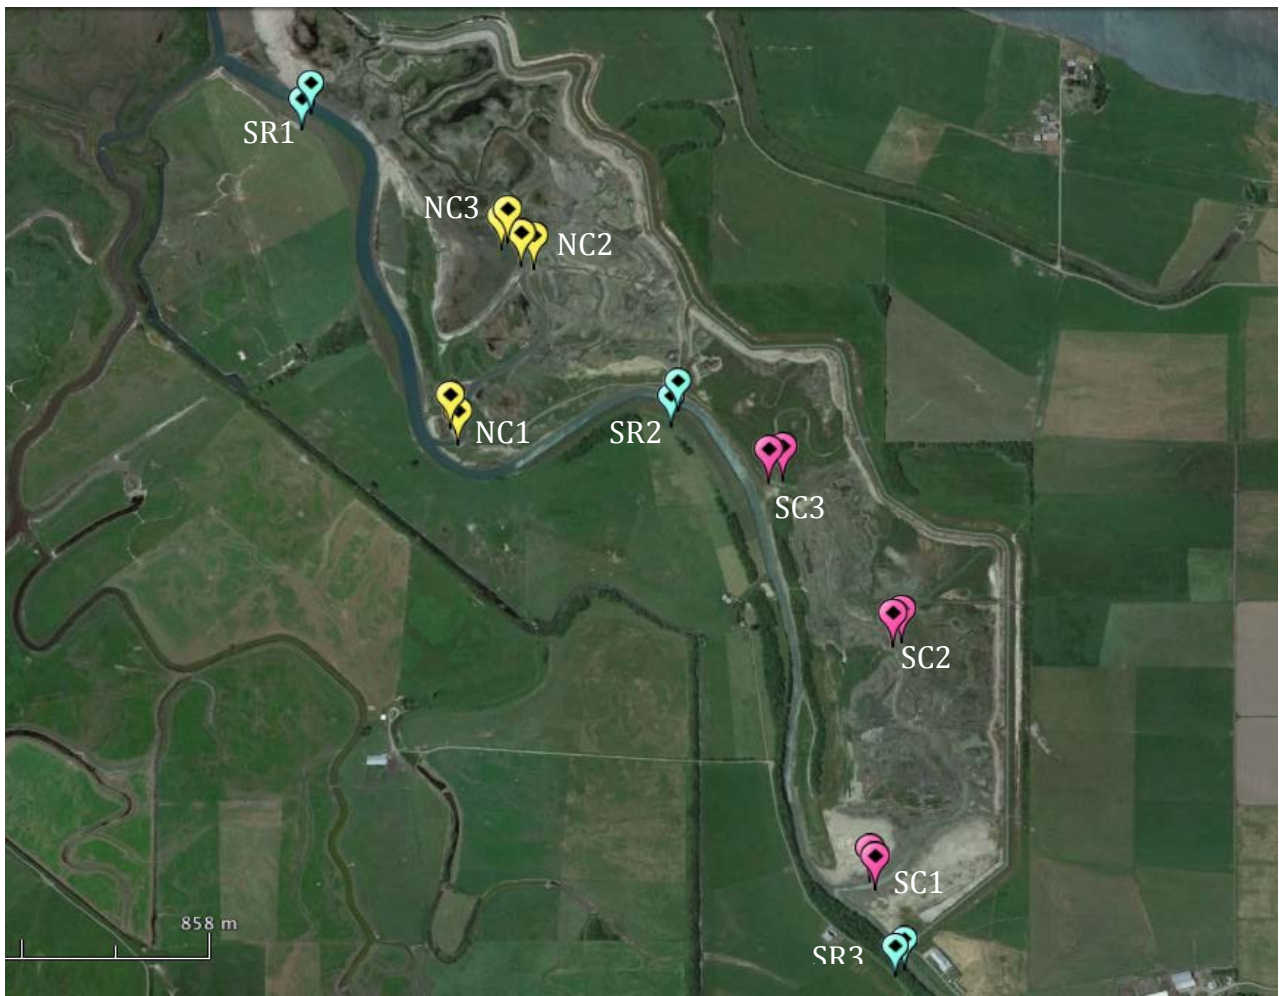
Figure 1: Location of the cross-section profiles for Salt River Ecosystem Restoration Survey Project, Fall 2014.
SR = Salt River cross-sections; NC= new North Channels cross-sections; SC= new South Channel cross-sections.

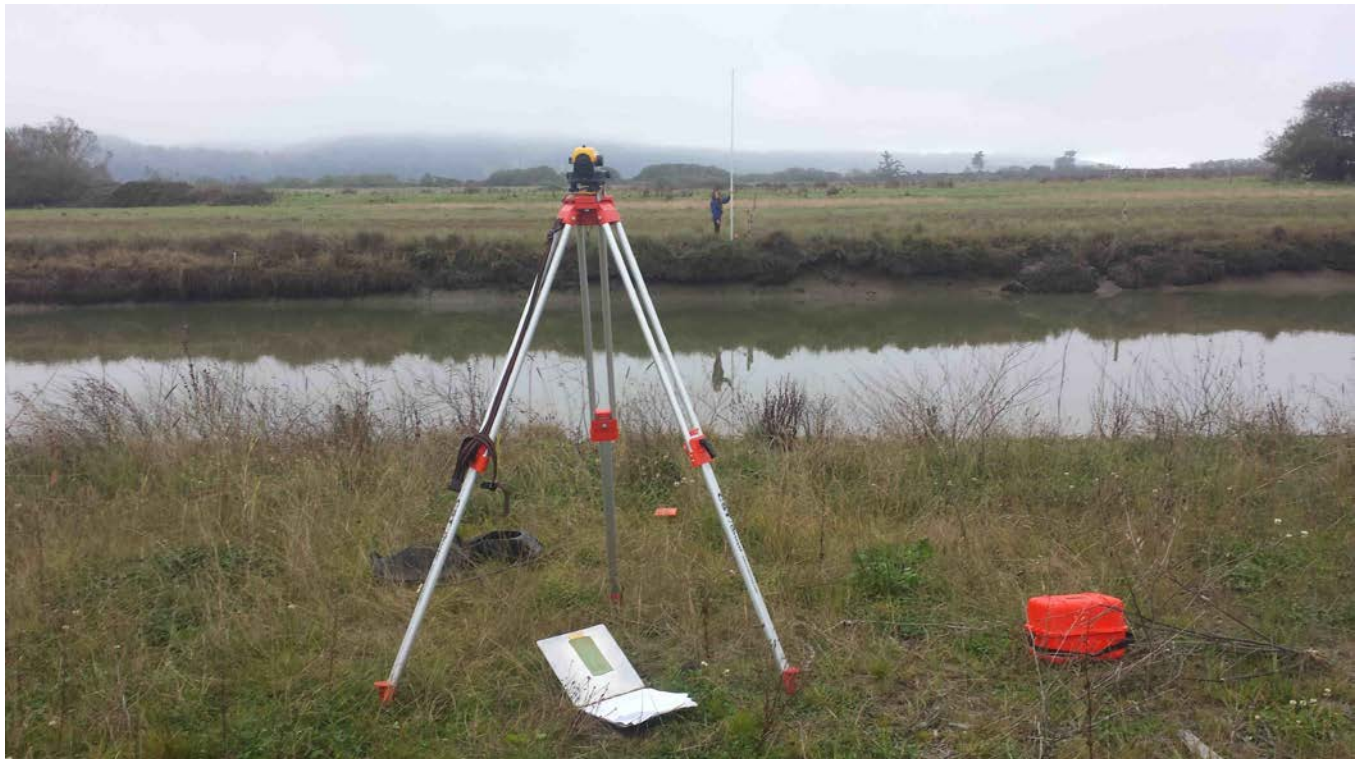
Figure 2: Auto level cross-section survey set up over Salt River SR2. (all photos by D. O'Shea)

Data for three cross-sectional profiles of the main Salt River channel were collected using a CTS/berger automatic level, tripod and stadia rod along the lower, middle and upper sections of the main Salt River channel (Figure 2). Permanent, rebar monuments were set on both sides of the main channel and geo-referenced to the Salt River Restoration Project's survey control points SR12, SR14 and SR11 (Figure 6B). The cross-sectional monuments were established on both sides of the channels using 4-foot lengths of ½"-rebar pounded into the substrate, leaving 3-inches exposed, and topped with labeled end caps (Figure 3). GPS (Garmin GPSMAP 62s) locations were recorded for each monument, along with photo documentation. Fluorescent orange flags were set adjacent to each monument for ease of relocation, however, it was observed at during subsequent surveys that these flags were degraded within several weeks and are unlikely to survive the entire year. All elevations are reported in feet using the NAVD88 vertical datum.

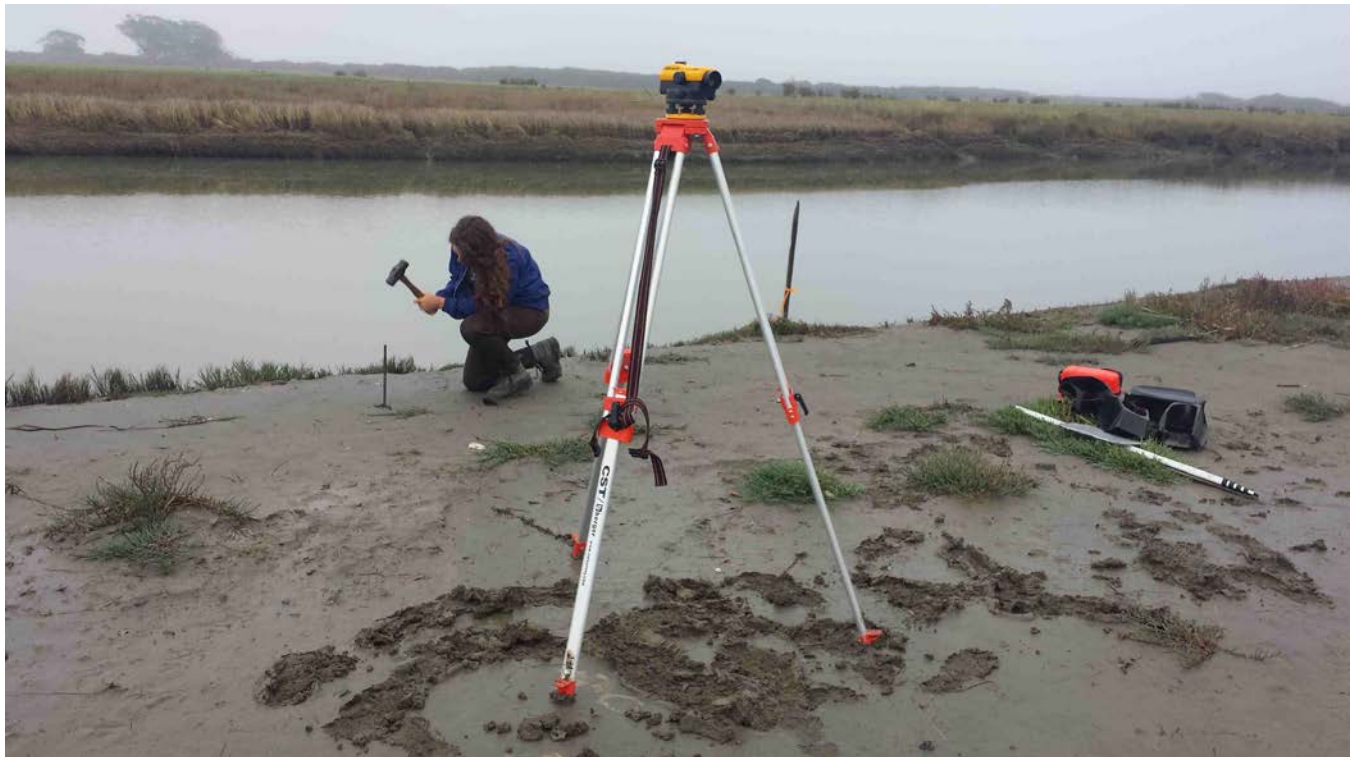
Figure 3: Setting a rebar monument at Salt River cross-section SR1.

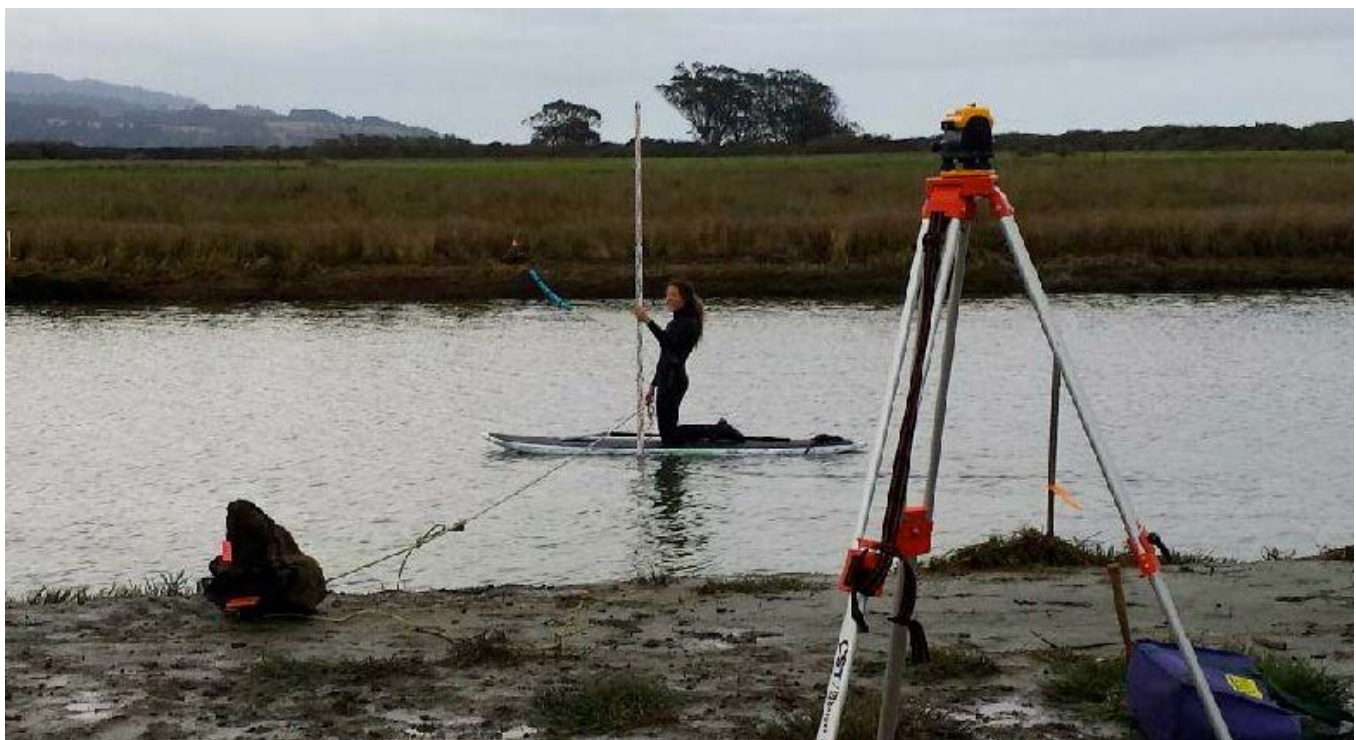
Figure 4: A paddleboard and taut-rope were used when water levels were too high to navigate on foot at the Salt River main channel site SR1 looking toward the southwest.

A combination of circumstances made the surveying more challenging than expected. These included water levels about one-foot higher than predicted, early season rainfall, and diminishing daylight hours during lower-low tides (Figure 6A). When conditions made it impossible to survey using the standard approach of walking the stadia rod across the channel, it was necessary to use wetsuits, stand up paddleboard and a taut-rope stretched between each side of the channel. The surveyor then moved along the rope across the channel while at the same time steadying the stadia rod so the automatic level shot could be recorded (Figure 4).

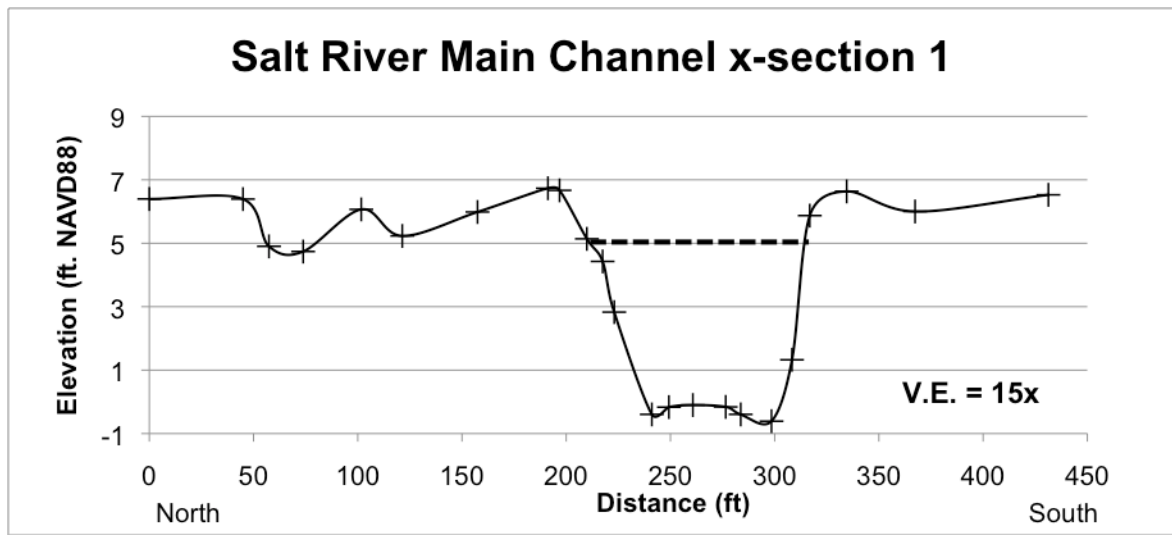
Figure 5A: Salt River Main Channel cross-section SR1. V.E. is the vertical exaggeration.

SR1	
Distance (feet)	Elevation (feet NAVD88)
0.0	6.63
44.9	6.62
57.4	5.13
73.8	4.97
101.7	6.30
121.4	5.46
157.4	6.22
191.2	6.96
196.8	6.90
209.9	5.37
217.5	4.66
223.0	3.06
241.1	-0.17
249.3	0.06
260.8	0.13
276.5	0.07
283.7	-0.17
308.3	1.56
316.8	6.10
334.6	6.87
367.4	6.23
431.3	6.76

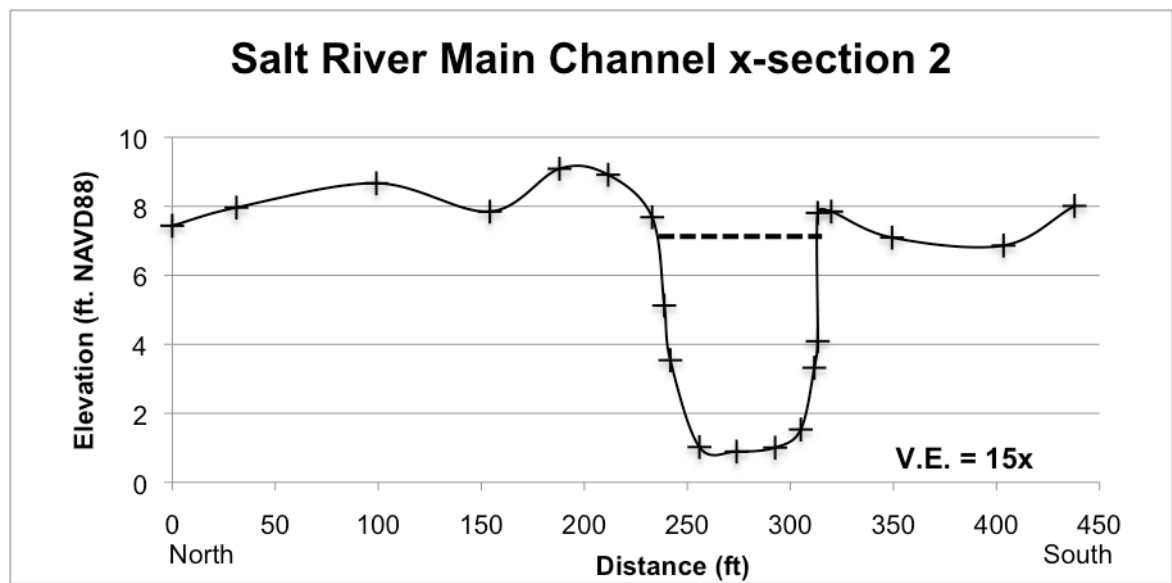
Figure 5B: Salt River Main Channel cross-section SR2.

SR2	
Distance (feet)	Elevation (feet NAVD88)
0.0	7.44
31.2	7.96
99.1	8.67
154.2	7.85
187.9	9.09
211.6	8.91
232.9	7.68
238.8	5.12
241.7	3.54
255.8	1.02
273.9	0.89
292.6	1.01
305.0	1.53
311.6	3.32
313.2	4.09
313.2	7.81
319.8	7.85
349.3	7.09
403.4	6.86
437.9	8.01

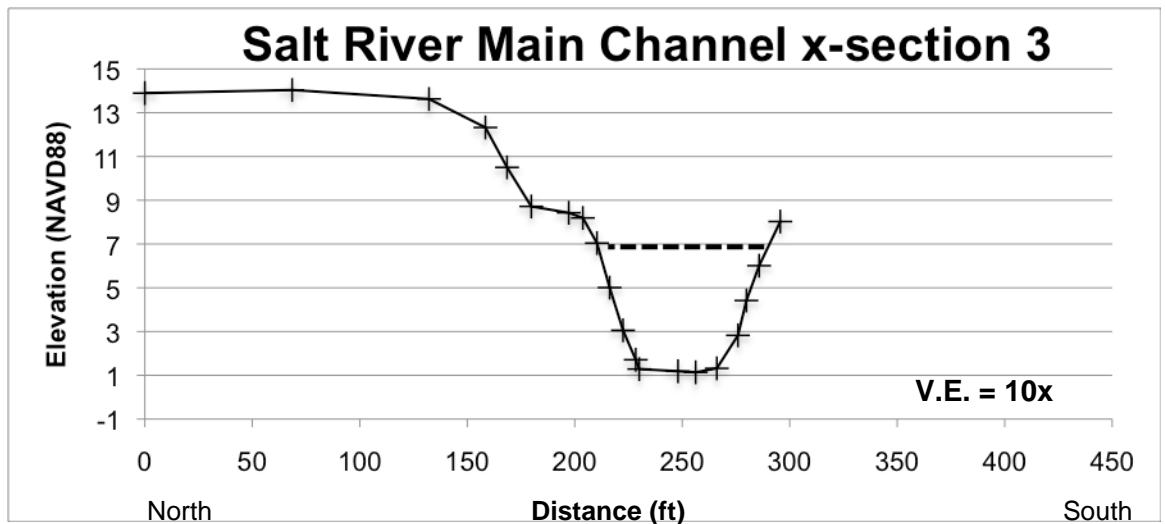
Figure 5C: Salt River Main Channel cross-section SR3.

Elevations and distances were collected at each major break in slope, vegetation edge (dotted line), waters edge, mid-channel, and at least 2 locations on either side of mid-channel. These are indicated by the tick marks (+) on the cross-section graphs. Flood plain measurements were collected approximately 200-feet on either side of the main channel. Cross-section profiles are viewed from the west or north with the zero-point on the left-side of the graph and extending 450 feet toward the south and east. The only exception was Salt River cross-section, SR3, where dense vegetation obscured visibility on the south side of the channel (Figure 5C).

SR3	
Distance (feet)	Elevation (feet NAVD88)
0.0	13.90
68.5	14.04
132.2	13.63
158.4	12.33
168.5	10.50
179.8	8.72
197.2	8.43
203.8	8.19
210.3	7.04
216.2	5.01
222.5	3.06
228.4	1.71
230.0	1.29
248.0	1.19
256.2	1.14
266.1	1.32
275.9	2.83
279.9	4.42
285.8	6.01
295.6	8.03

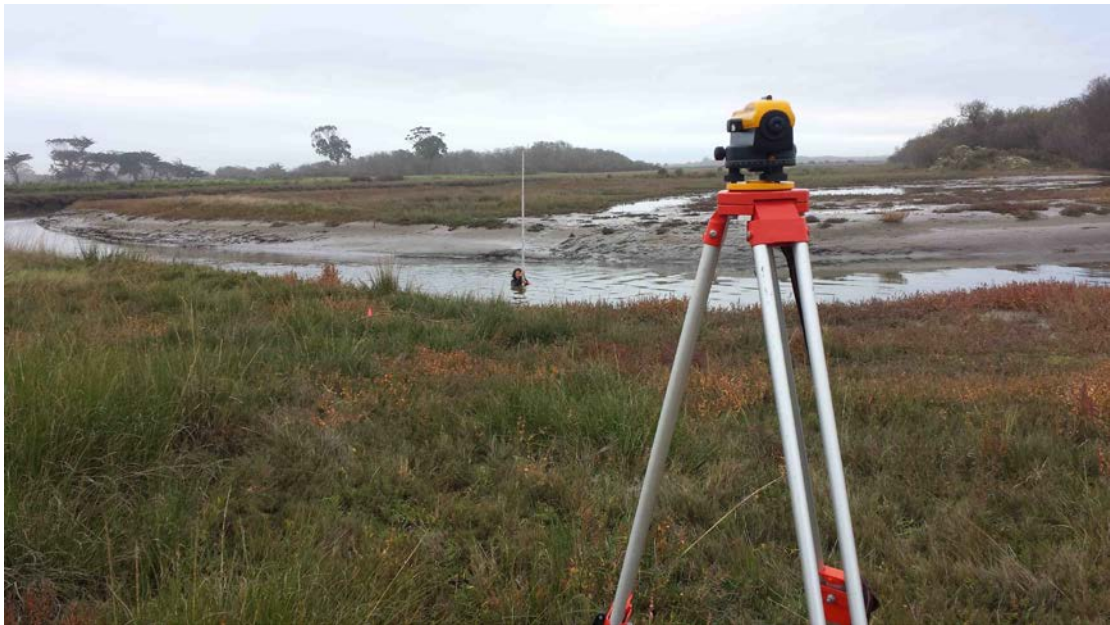
Figure 6A: New channel cross-section site NC1 approximately 3,800-feet upstream from Cutoff Slough looking toward the Northwest. Note surveyor, with stadia rod, chest deep in new slough channel.

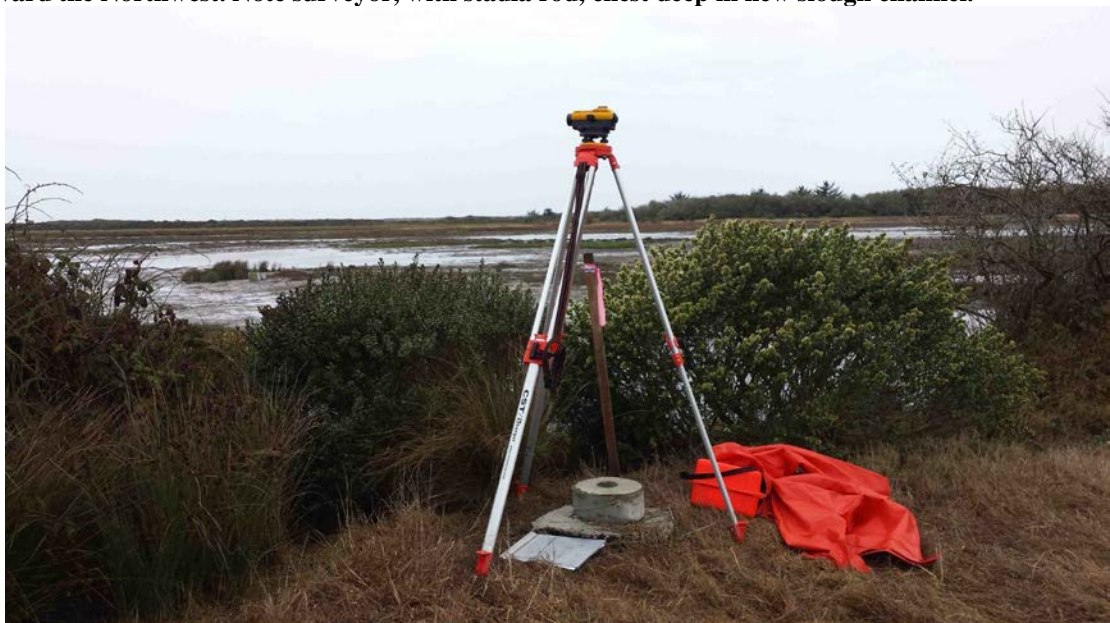
Figure 6B: Auto level set up at the Salt River Restoration Project survey control point SR12 used to geo-reference the cross-section and longitudinal profiles.

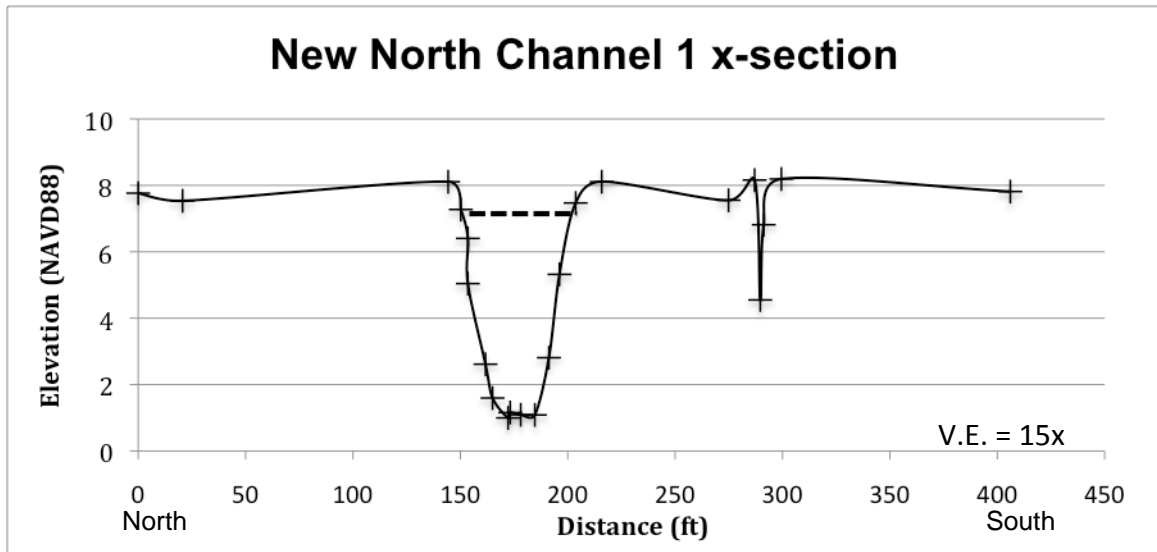
Figure 7A: New North Channel cross-section NC1

NC 1	
Distance (feet)	Elevation (feet NAVD88)
0	7.77
21	7.54
144	8.11
150	7.27
154	6.40
154	5.04
162	2.61
165	1.60
173	1.16
178	1.09
191	2.81
196	5.32
204	7.47
216	8.11
275	7.55
287	8.16
290	4.55
291	6.81
299	8.19
406	7.81

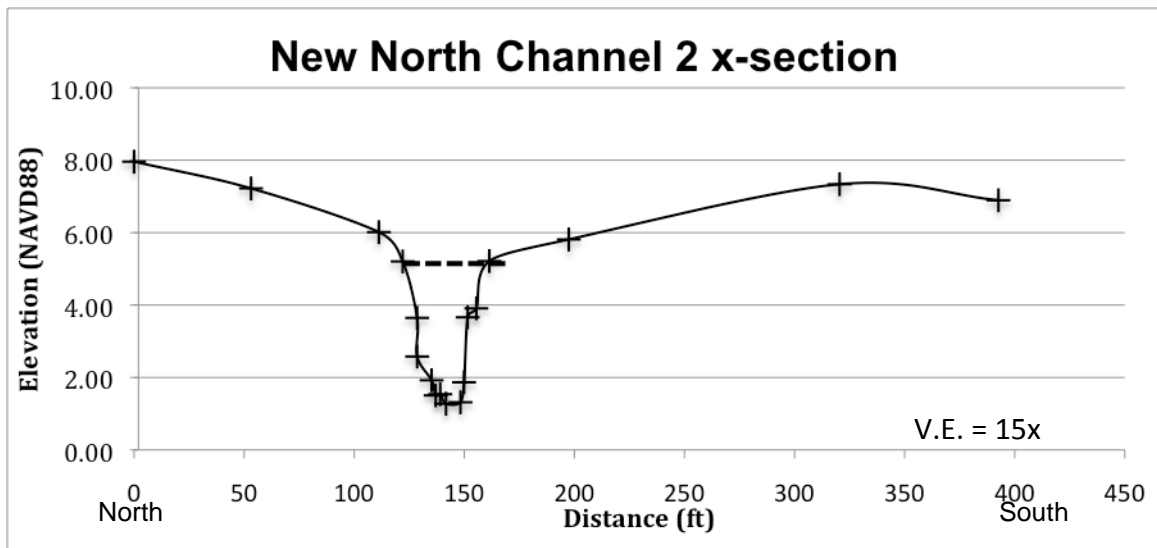
Figure 7B: New North Channel cross-section NC2

NC2	
Distance (feet)	Elevation (feet NAVD88)
0	4.91
53	5.65
111	6.85
122	6.45
129	4.89
129	3.82
135	2.17
137	0.74
142	0.97
148	1.56
150	3.11
152	4.91
155	5.15
161	6.46
197	7.24
320	5.35
393	5.79

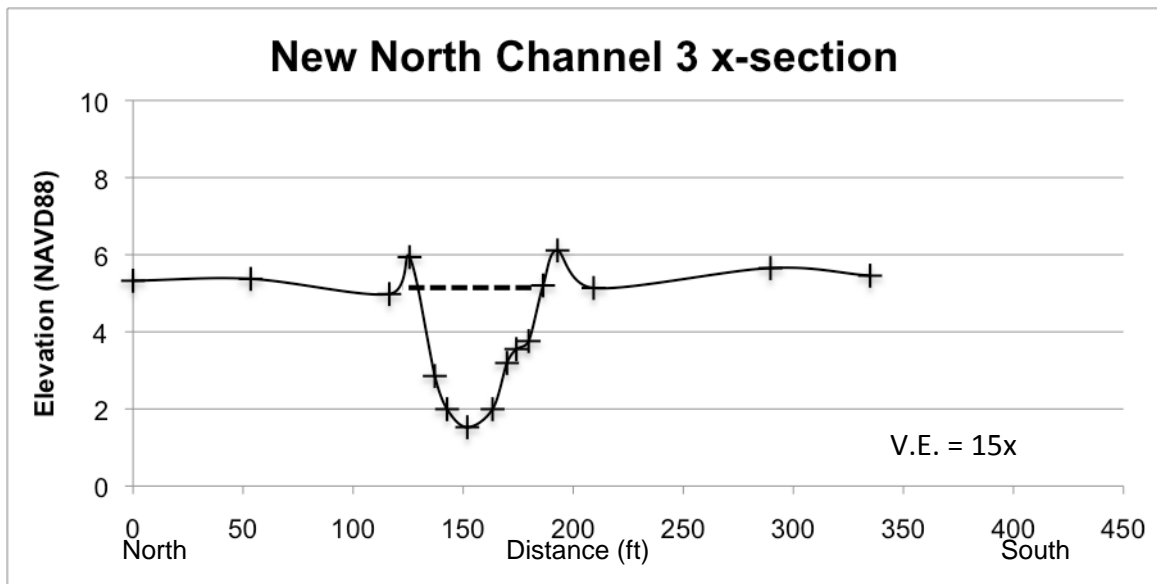
Figure 7C: New North Channel cross-section NC3

NC3	
Distance (feet)	Elevation (feet NAVD88)
0	5.32
53	5.37
116	4.98
126	5.94
137	2.85
143	1.99
152	1.53
163	1.99
170	3.19
174	3.55
180	3.76
186	5.20
193	6.11
209	5.14
290	5.65
335	5.46

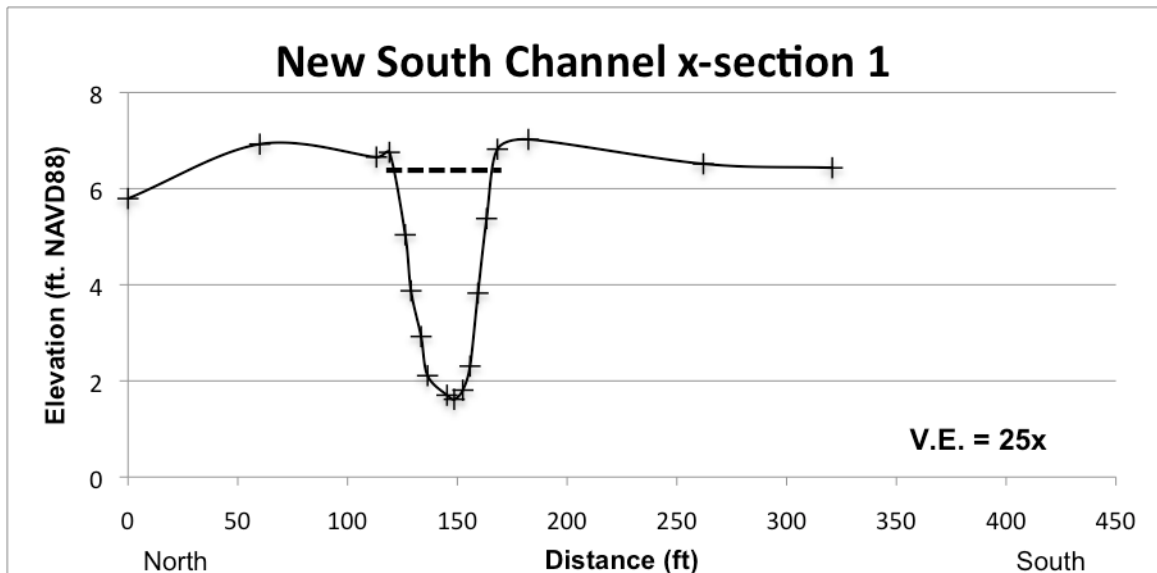
Figure 8A: New South Channel cross-section SC1

SC1	
Distance (feet)	Elevation (feet NAVD88)
0.0	5.79
60.0	6.93
113.2	6.66
119.1	6.75
126.3	5.04
128.9	3.87
133.5	2.92
136.4	2.11
145.3	1.70
148.6	1.62
152.5	1.81
155.8	2.31
159.4	3.83
163.3	5.38
168.3	6.82
182.4	7.02
262.1	6.52
320.8	6.43

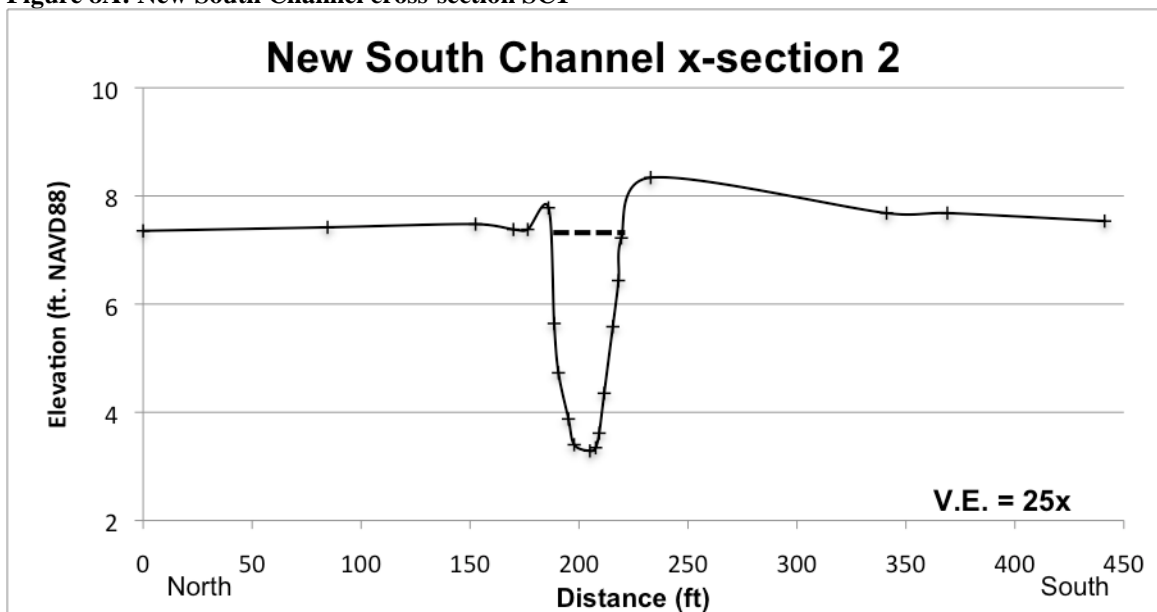
Figure 8B: New South Channel cross-section SC2

SC2	
Distance (feet)	Elevation (feet NAVD88)
0	7.35
85	7.42
153	7.48
170	7.38
176	7.38
186	7.78
189	5.64
191	4.73
195	3.88
198	3.40
205	3.29
208	3.35
209	3.61
212	4.35
215	5.58
218	6.44
219	7.22
233	8.34
341	7.68
369	7.68
441	7.53

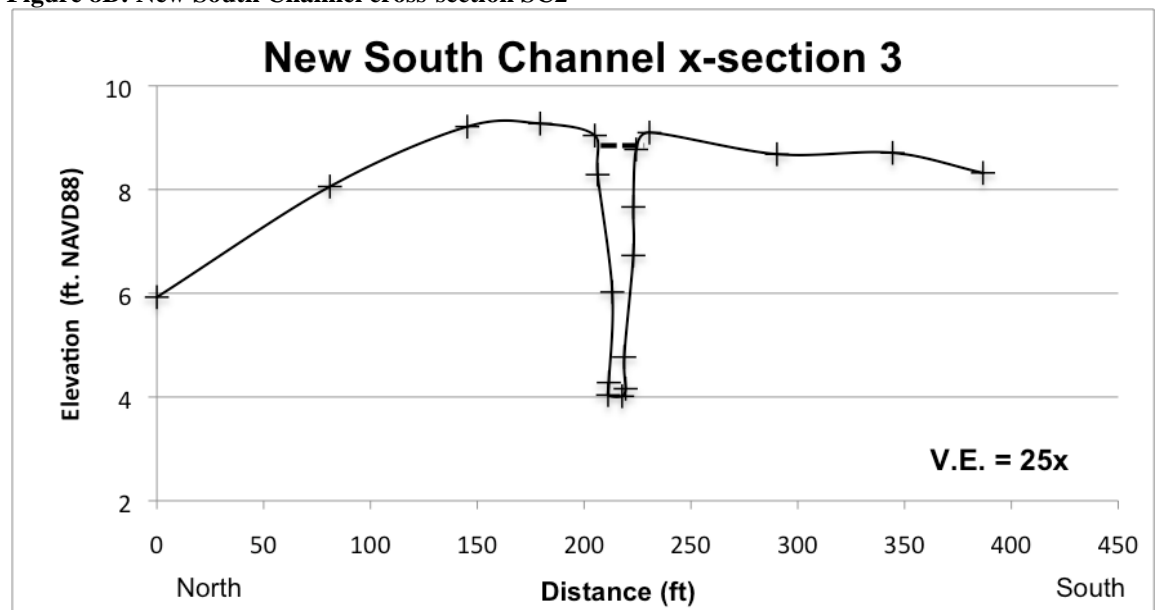
Figure 8C: New South Channel cross-section SC3

SC3	
Distance (feet)	Elevation (feet NAVD88)
0	5.93
81	8.06
145	9.21
179	9.27
205	9.04
206	8.29
213	6.02
212	4.28
211	4.04
218	4.02
219	4.16
219	4.77
223	6.73
223	7.66
224	8.77
231	9.10
290	8.68
344	8.71
387	8.32

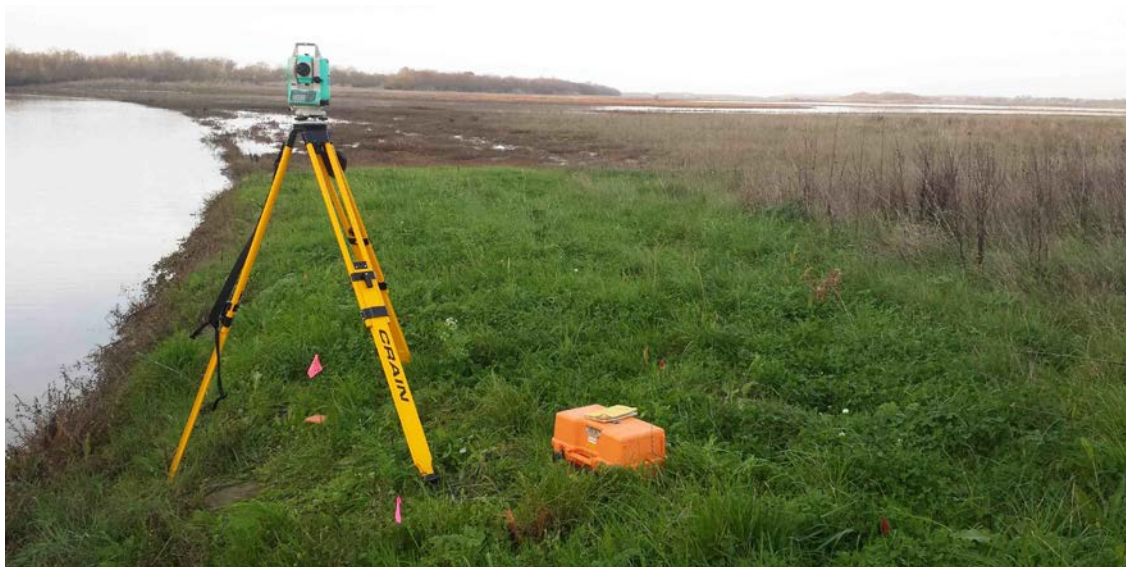
Figure 9: Total station set up at SR3 (near the River Ranch barn) used for the longitudinal profile.

The longitudinal profile survey of the main Salt River channel from Cutoff Slough to the Riverside Ranch barn was collected using a Nikon DTM-352 Total Station laser theodolite, tripod, stadia rod, prism pole and single prism. Due to the aforementioned adverse surveying conditions, wetsuits and a standup paddleboard were used to locate the thalweg during the 2-day survey. The prism pole was secured to the stadia rod at a height of 10.28 feet to account for the deep-water conditions at the time of the survey. The prism pole was placed in the thalweg approximately every 200-feet with the total station located at one of four locations along the north bank of the main Salt River channel and geo-referenced to the Salt River Restoration Project's survey control points SR11, SR 14 and SR 12. A total of 48 measurements were taken along the Salt River. All elevations are reported in feet using the NAVD88 vertical datum.

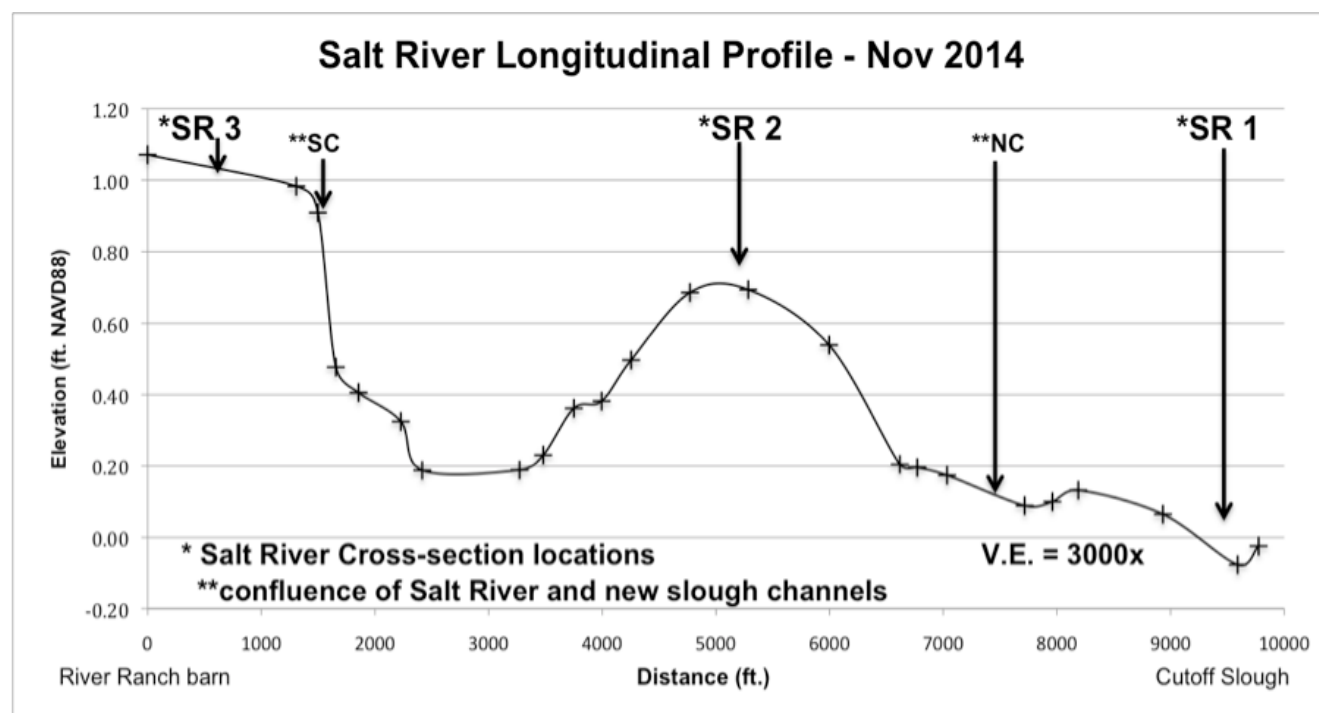
Figure 10: Longitudinal profile of the main channel of the Salt River – November 2014 from River Ranch barn to Cutoff Slough. The locations of Salt River main channel cross sections, and the confluence with the new South Channel (SC) and North Channel (NC) are indicated.

The total relief on the 9775-foot section of the lower, main Salt River channel surveyed, from River Ranch barn to the confluence with Cutoff Slough, is 1.1 feet. Longitudinal profiles of the new North and South slough channels were not collected, however, based on the cross-section data for the sections surveyed, the relief on the new North Channel slough is 0.9 feet, the relief on the new South Channel slough is 2.4 feet. Poor visibility, high water levels and very soft sediment in the Salt River, and two newly excavated slough channels, made locating the thalweg challenging, particularly while completing the longitudinal profile. These conditions, combined with lack of sufficiently low tides during daylight hours, necessitated creative methods for collecting data, making it impossible to survey the longitudinal profiles for the two new slough channels within the time constraints of this project. Future surveys should be initiated earlier in the summer to maximize efficiency.

Distance (feet)	Elevation (feet NAVD88)
0	1.071
1308	0.983
1498	0.909
1656	0.477
1856	0.406
2228	0.325
2416	0.188
3273	0.189
3481	0.231
3750	0.362
3994	0.382
4254	0.497
4772	0.686
5284	0.694
5995	0.539
6618	0.205
6771	0.196
7034	0.174
7716	0.089
7960	0.100
8188	0.132
8933	0.065
9590	-0.076
9774	-0.024

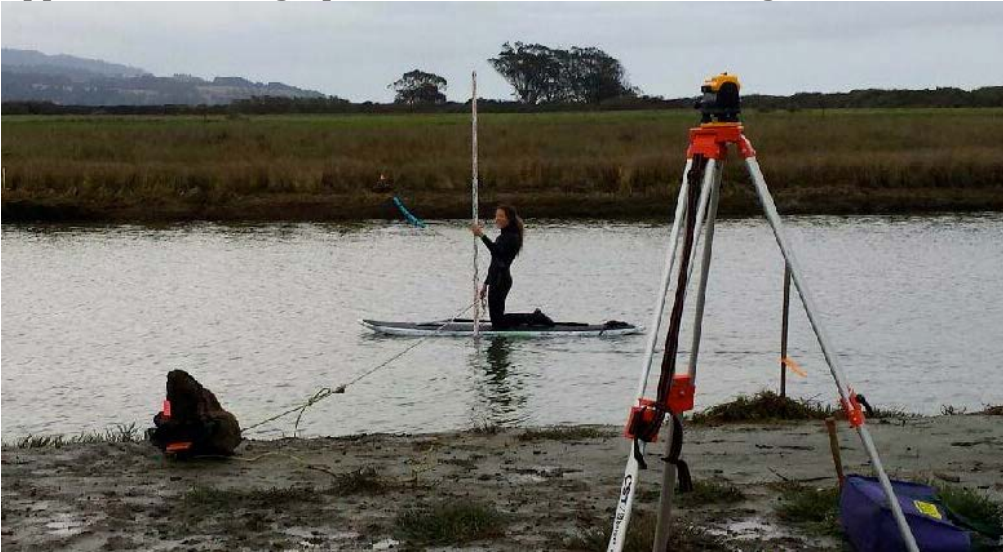
Salt River Channel Cross section 1 –SR1. View is looking south.

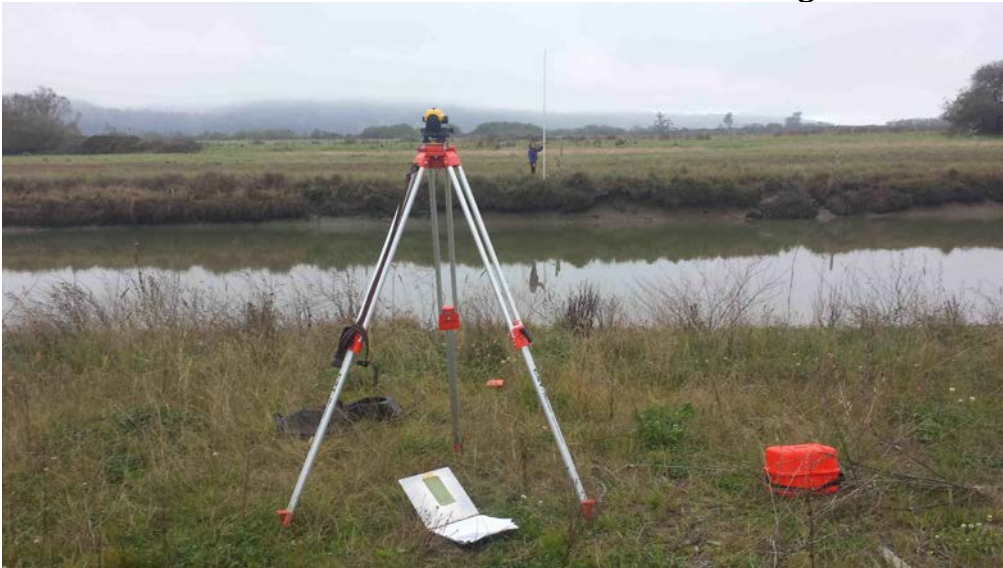
Salt River Channel Cross section 2 –SR2. View is looking south.

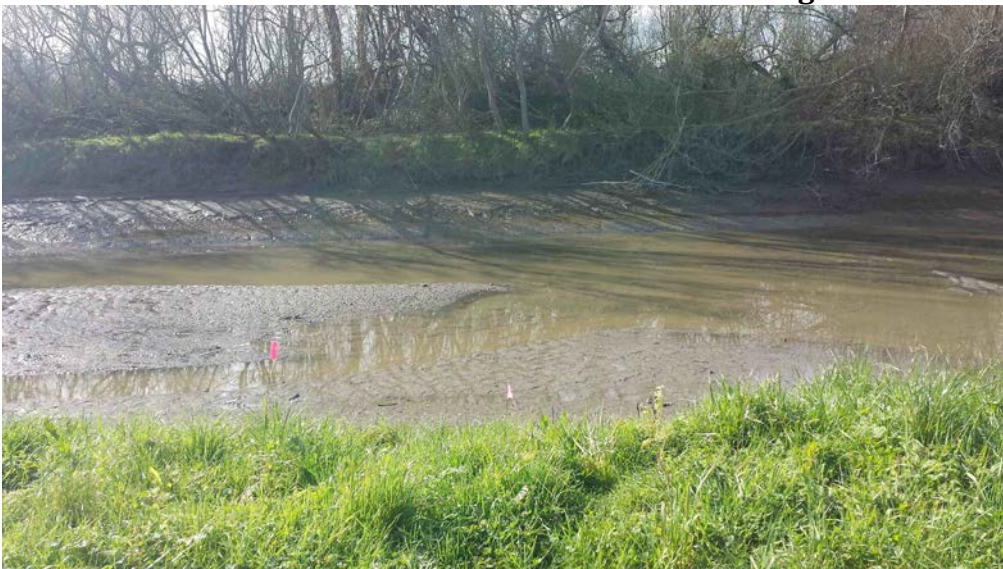
Salt River Channel Cross section 3 –SR3. View is looking south.

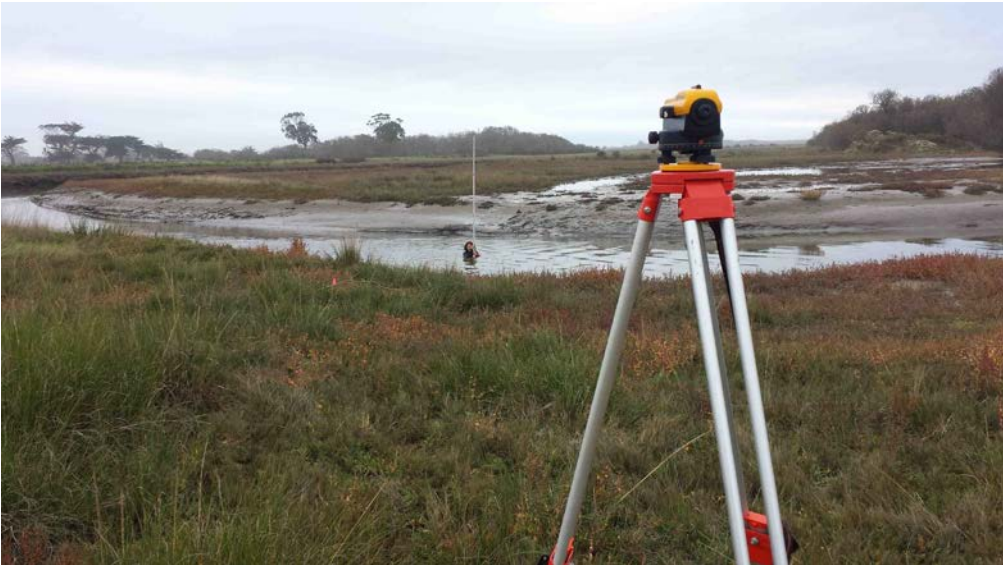
New North Channel Cross section 1 -NC1. View is looking west.

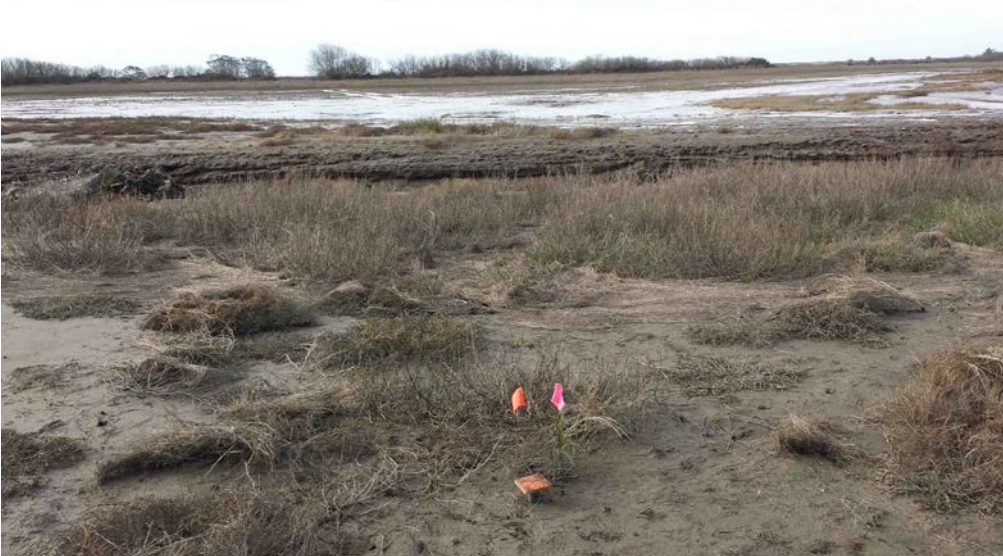
New North Channel Cross section 2 -NC2. View is looking west.

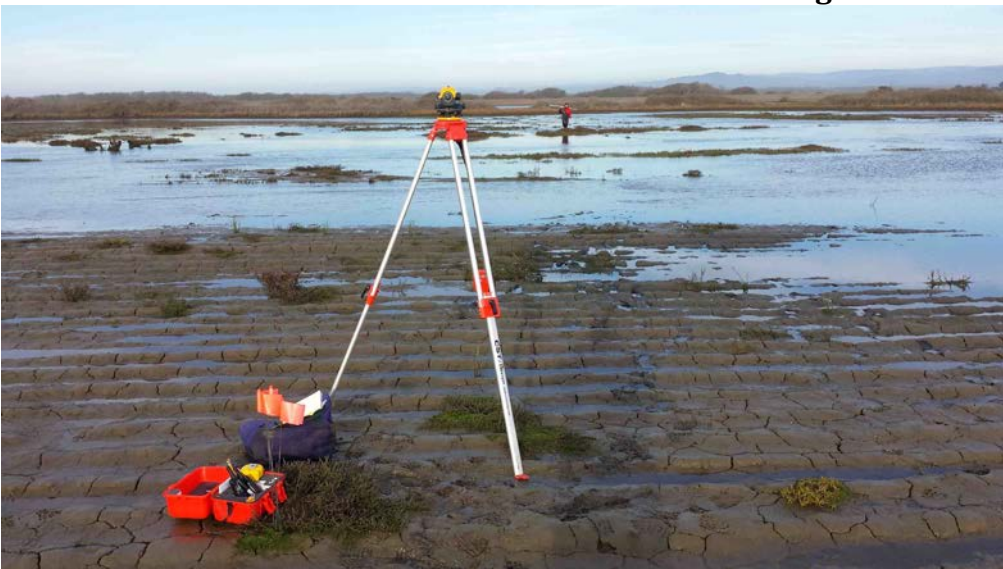
New North Channel Cross section 3 -NC3. View is looking north.

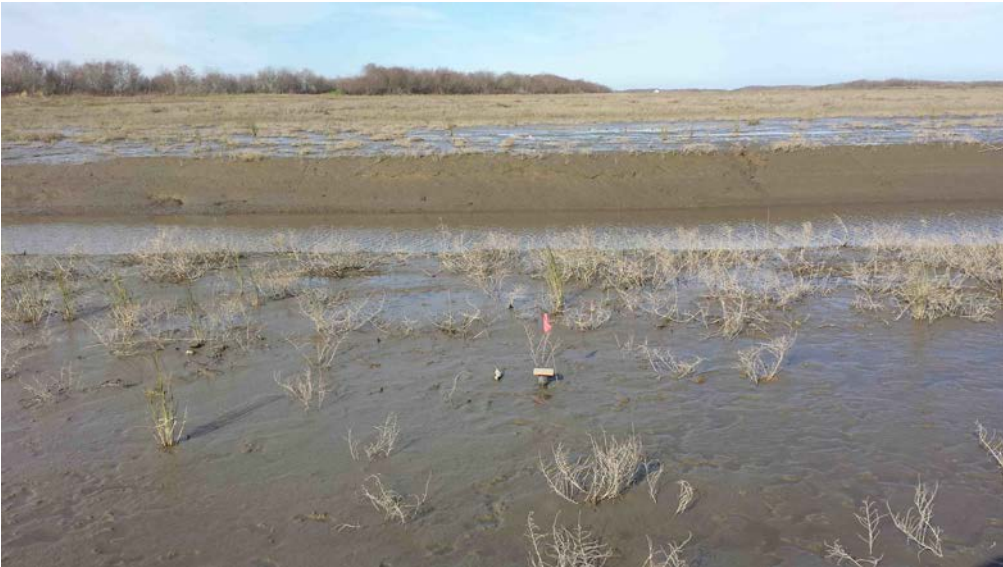
New South Channel Cross section 1 –SC1. View is looking west.

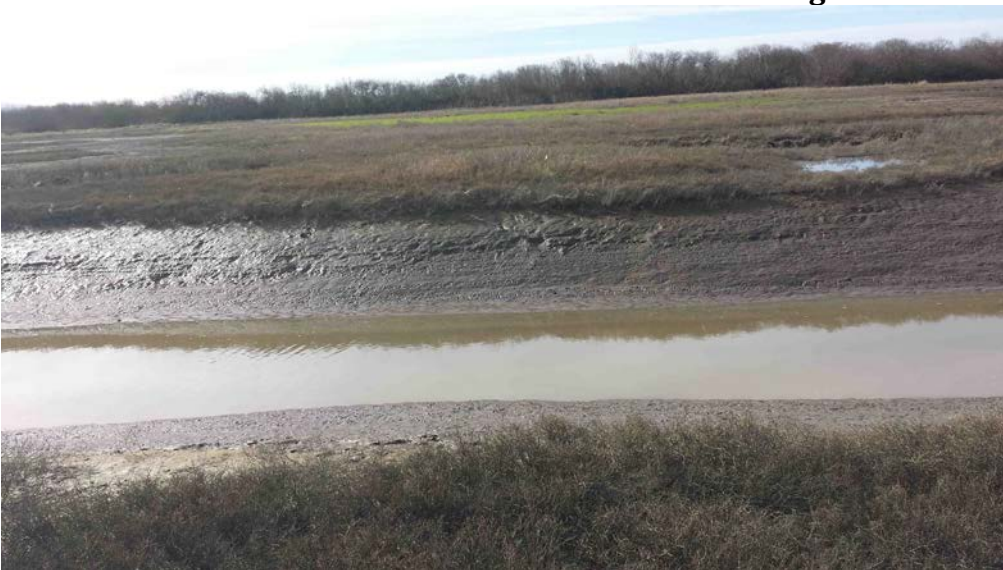
New South Channel Cross section 2 –SC2. View is looking south.

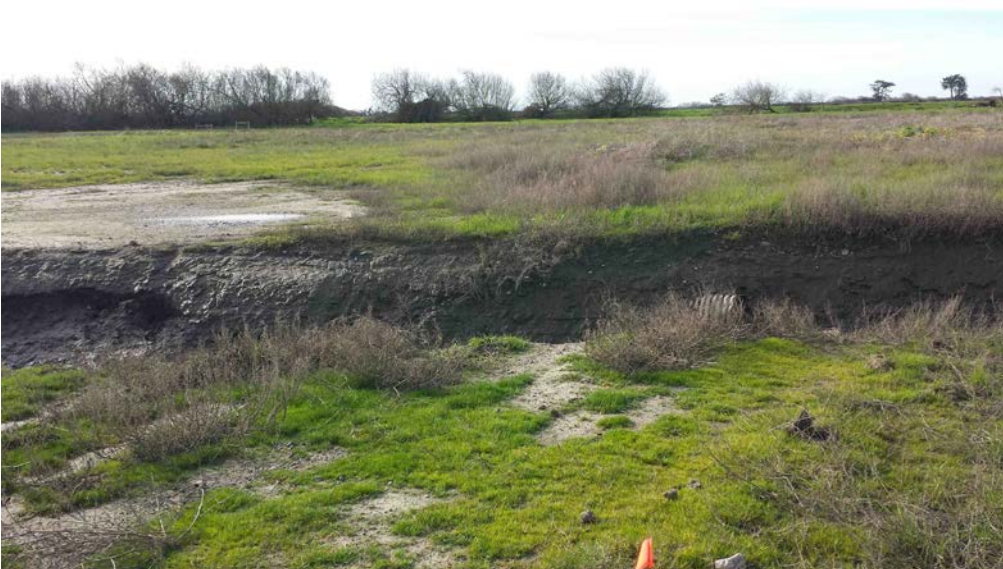
New South Channel Cross section 3 –SC3. View is looking south.
