Salt River Flash Grazing Assessment 2021

Salt River Watershed Council Property

Prepared by:
Humboldt County Resource
Conservation District
Eureka, California

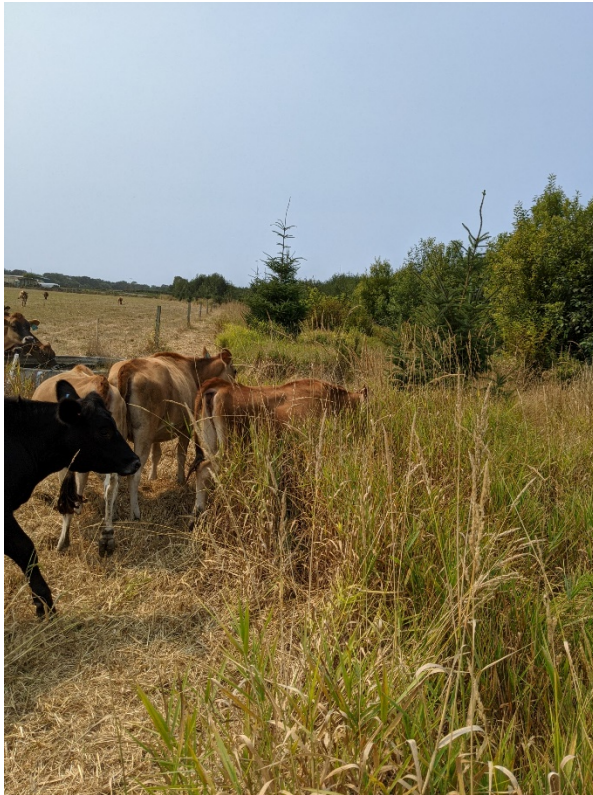
Figure 2. Lightweight livestock entering paddock on Day 1

The modification of the grazing management plan consisted of the following: The three acre channel corridor area proposed for flash-grazing was divided in half into two separate paddocks to concentrate grazing efforts. Each paddock would be grazed consecutively. Each paddock was roughly one acre in size. Approximately 50 head of light weight livestock (approximately 1- to 2-year-old heifers) were allowed access to the paddock(s) from a larger pasture so grazing efforts were not as intensive (Figure 2). However, livestock were allowed to roam in and out of

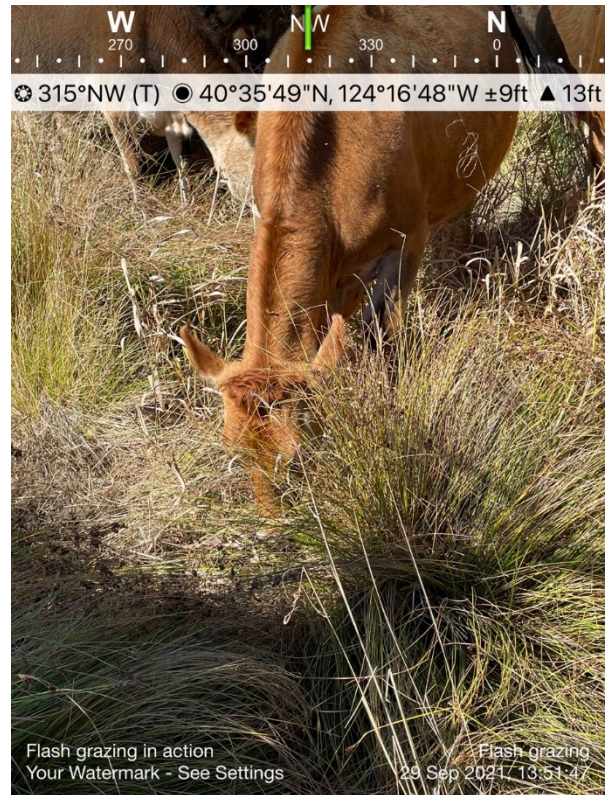
Figure 3. Livestock grazing around native bunch grass

the river corridor paddocks for up to eight days for each paddock (Figure 4). Grazing of the first acre began on September 1, 2021. The second acre was grazed beginning September 27th. The vegetation in the channel corridor consisted primarily of native bunch grasses (*Deschampsia cespitosa*) (Figure 3), invasive Reed Canary grass (*Phalaris arundinacea*), and native trees and shrubs such as Sitka spruce (*Picea sitchensis*), Twinberry (*Lonicera involucrata*), Pacific Willow (*Salix lucida*). Many of the larger trees and shrubs were unprotected from the livestock, though smaller plants were caged.

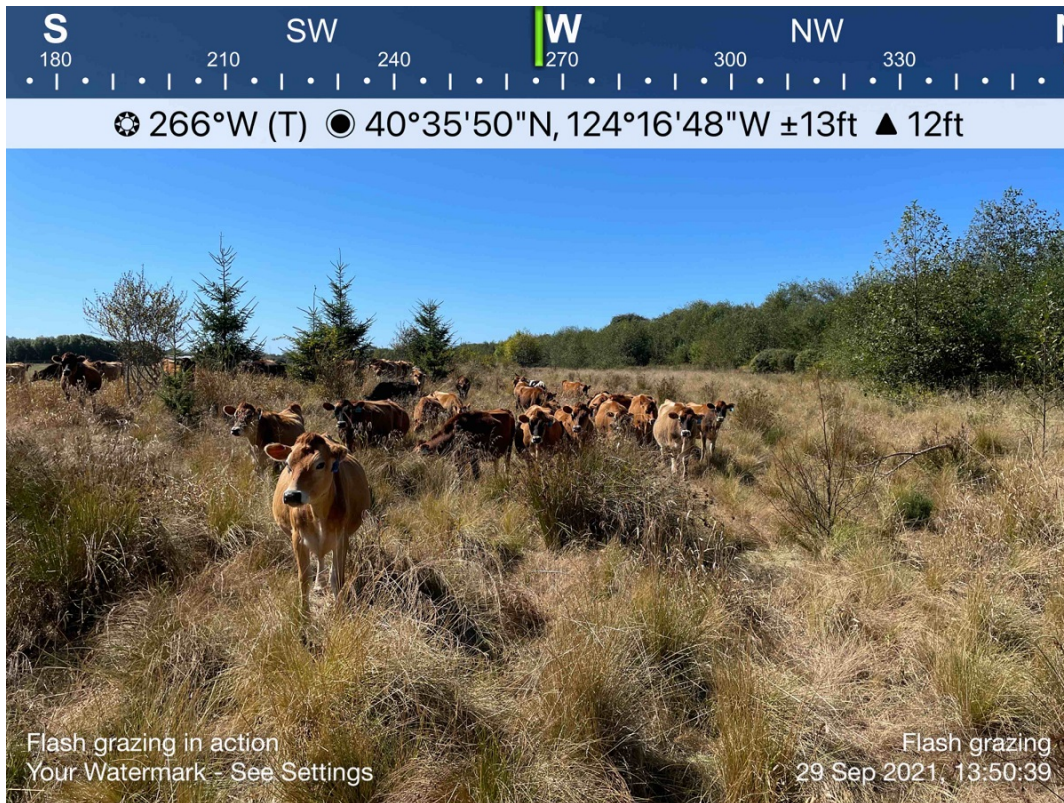
Figure 4. Livestock in second paddock on Day 2

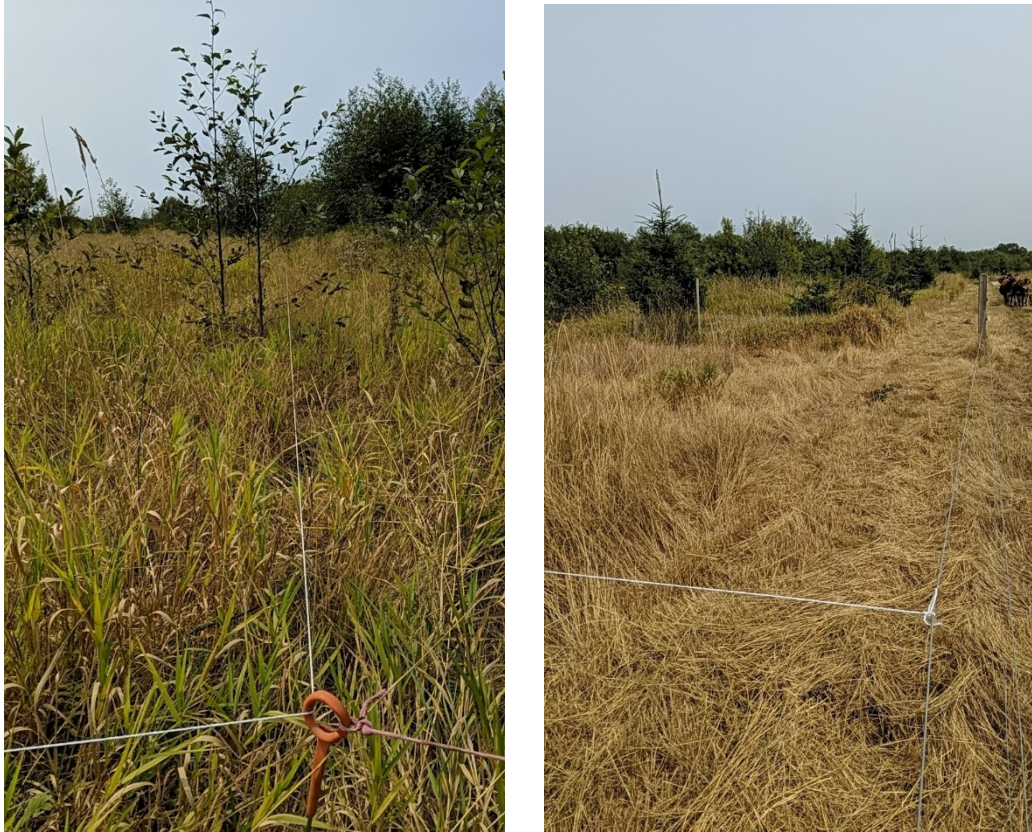
The vegetation on the river floodplain, prior to grazing, mainly consisted of up to 4.5' tall stalks of Reed Canary grass with individual native trees and shrubs emerging above (Figure 5 & 6).

Figures 5 & 6. Corners of the paddock prior to livestock grazing

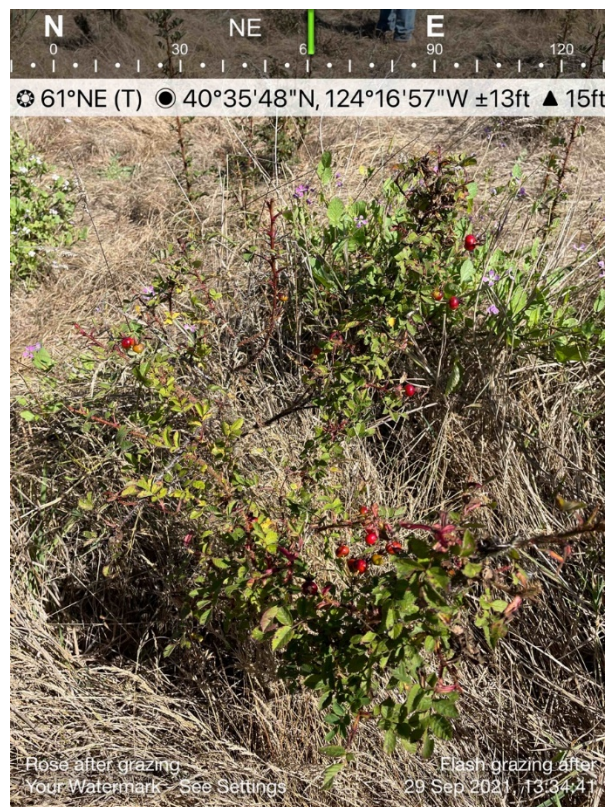
Figure 9. California rose revealed after grazing management.

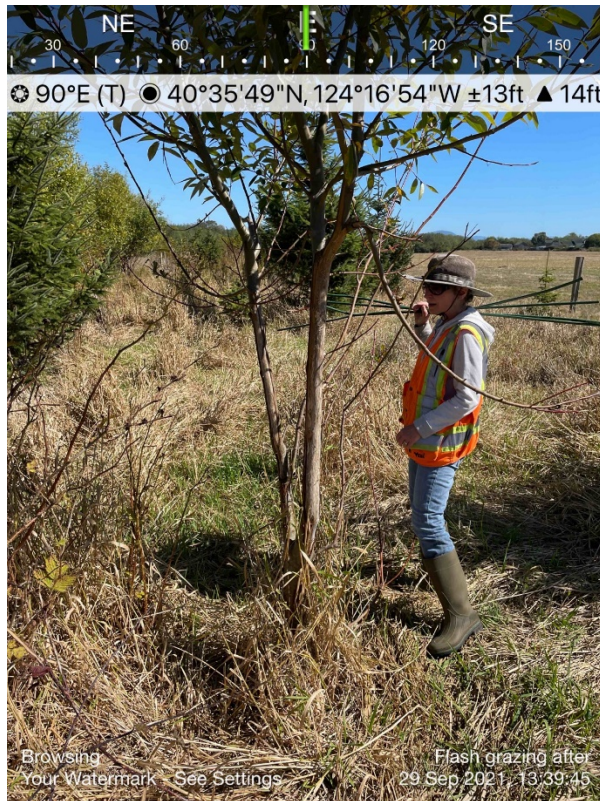
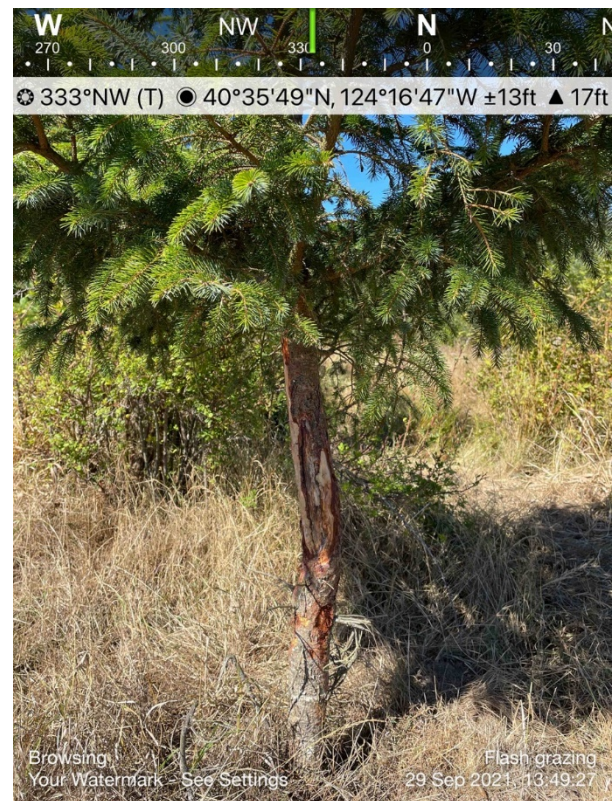
Figures 10 and 11. Pacific willow (left photo) and Sitka spruce (right photo) with bark stripped due to grazing activity.

Ultimately, the HCRCD grazing specialist and botanist felt that grazing in the paddocks met goals to reduce vegetation growth that inhibit planted native riparian as well as help control invasive species. However, if the same paddock and pasture access is retained for future grazing management, it is recommended that the days livestock have access to the paddocks be reduced to three to five days to limit curious browsing and impacts to planted native riparian. It is also recommended that the livestock producer ensure more frequent observation of livestock activities.
