**TIDAL EXCHANGE AND WATER QUALITY MONITORING  
SALT RIVER ECOSYSTEM RESTORATION PROJECT  
PHASE 1 & 2  
YEAR 3 – 2016**

Prepared for and by: Humboldt County  
Resource Conservation District  
5630 South Broadway, Eureka CA 95503  
Submitted: 1 February 2017

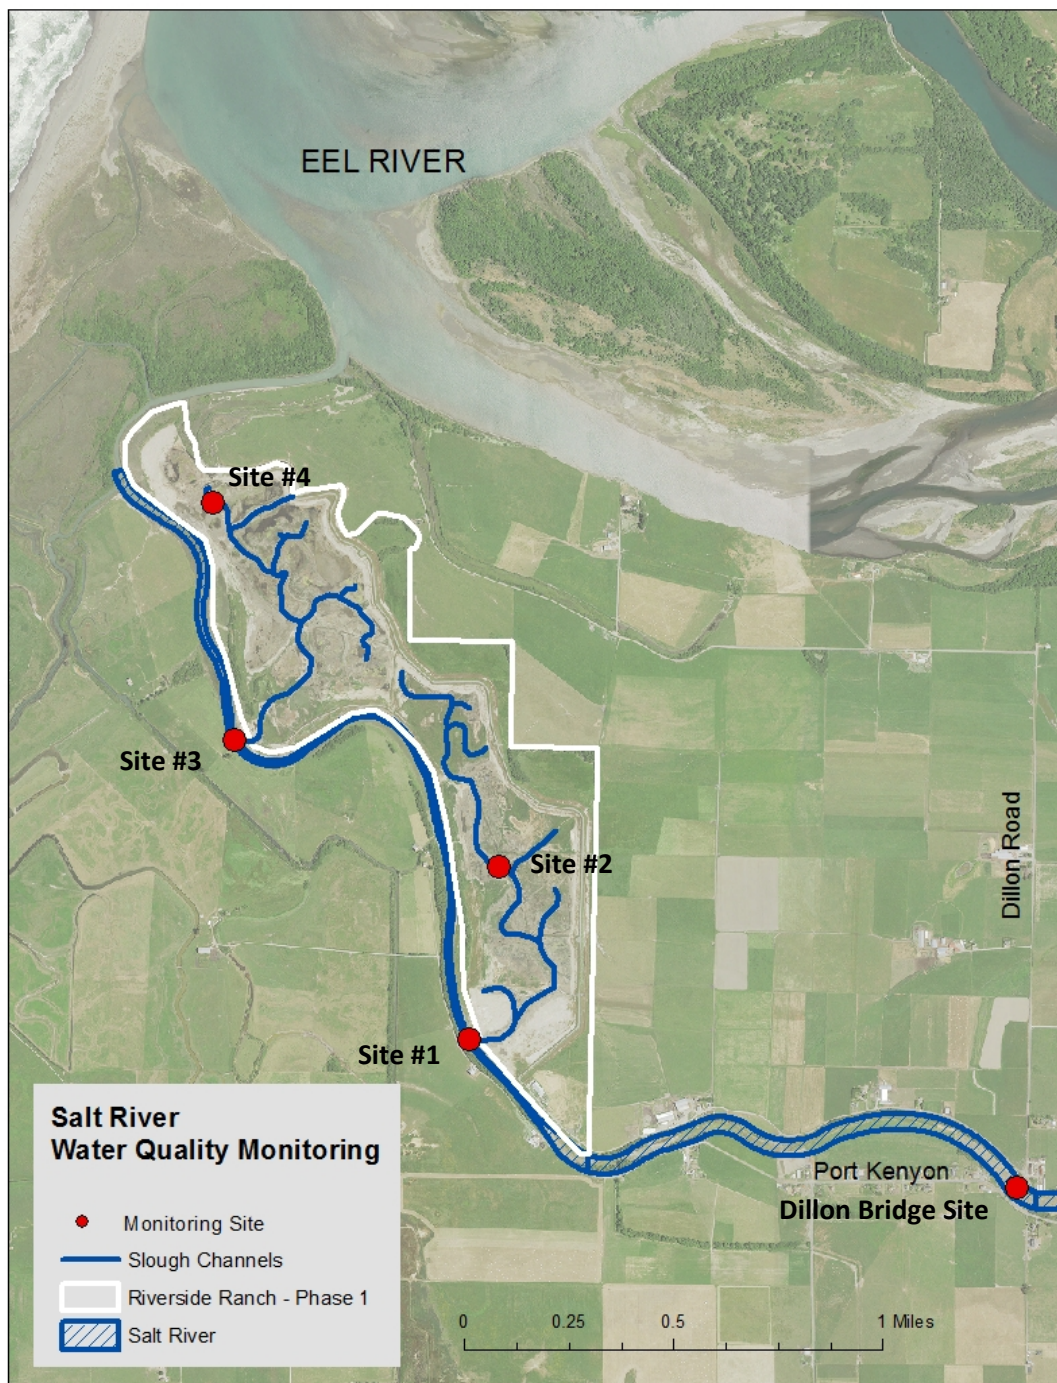
**Figure 1: 2016 Water Quality Sampling Sites across the Salt River Ecosystem Restoration Project.**

To measure tidal prism, multi-parameter recorders are deployed to determine tidal exchange, functional tidal prism, and a healthy salinity structure. These recorders measure water quality parameters such as water level, temperature, dissolved oxygen, and salinity levels. Recorders are deployed at four sites across Riverside Ranch (Figure 1). The 2016 sites include: 1) immediately downstream of the confluence of the southern slough channel on the Salt River; 2) at a large wood structure located midway upstream on the southern slough channel network, associated with a fish sampling site (modified from previous years due to degradation of original site); 3) immediately downstream of the confluence of the northern slough channel on the Salt River; 4) at a terminal end of the northern slough channel network, associated with a fish sampling site. Two additional sites were established outside of the Phase 1/Riverside Ranch footprint, which included a site near the confluence of the Salt River and Eel River and further upstream on the main stem Salt River channel near the upstream tidal extent (at Dillon Road Bridge). In 2016, the site near the confluence of the Salt River and Eel River was abandoned due to repeated loss of equipment in the highly dynamic system.

changing habitat conditions. Dissolved oxygen (DO) loggers are only required to be at two interior slough sites (Sites #2 and #4) on Riverside Ranch. These sites are associated with two fish sampling sites. DO loggers are deployed for only two weeks in July/August to determine DO levels in the slough channels during the warmest part of the year.
