# Salt River Ecosystem Restoration Project

## Adaptive Management Plan Monitoring Report 2022

Finalized March 2022

Prepared by the Humboldt County Resource Conservation District  
5630 South Broadway  
Eureka, CA 95503  
707.442-6058 ext. 5  
[hcrd@gmail.com](mailto:hcrd@gmail.com)

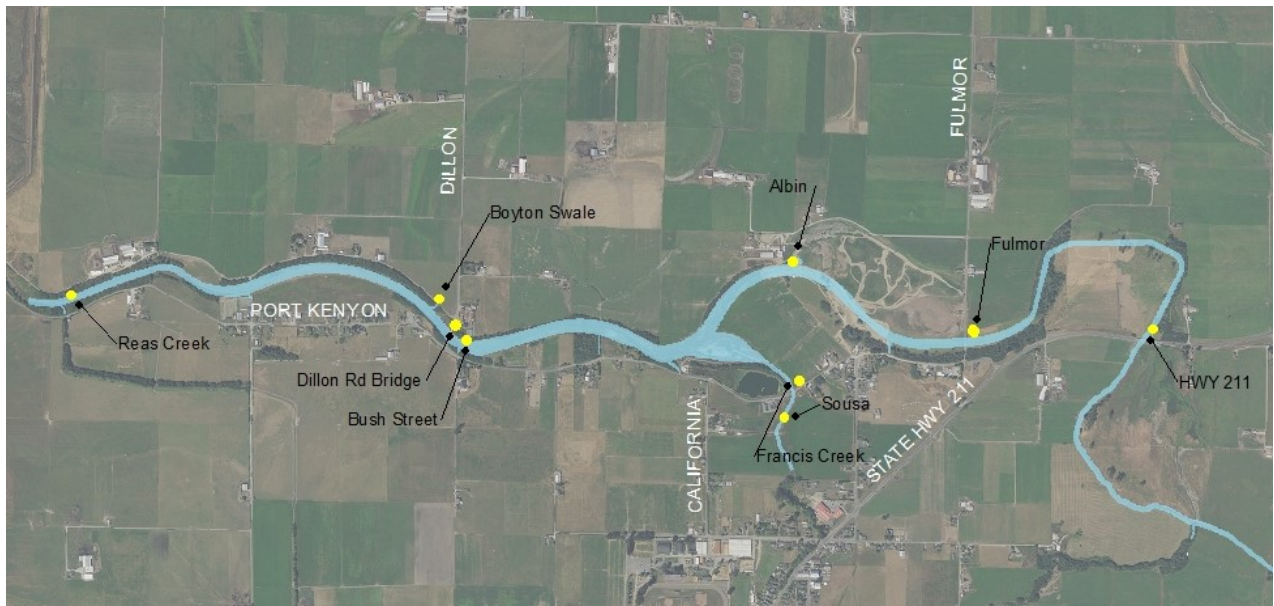
**Figure 3: Bridges and Culverts Locations on the Salt River restored corridor**

**Results and Discussion:** Four bridges (Dillion Road, Albin, Sousa, Francis, and Fulmor) span the restored Salt River channel. The Albin, Sousa, and Francis bridges were replaced or constructed as part of the Salt River restoration. Bridges were observed during variable flows throughout 2022 and no debris in the channel or flood plain are racking up on the bridge abutments or along banks. Erosion around the footings is not occurring. The Reas Creek, Boynton Swale, and Bush Street culverts have been functioning during high and low flows and appear to be functioning normally. Further follow up on the Bush Street culvert is merited due to dense vegetation obscuring visual observation and possibility that vegetation will eventually impede the opening of the flap gate on the outlet of the culvert.

**Recommendation:** Continue to monitor bridges and culverts at high and low flows.

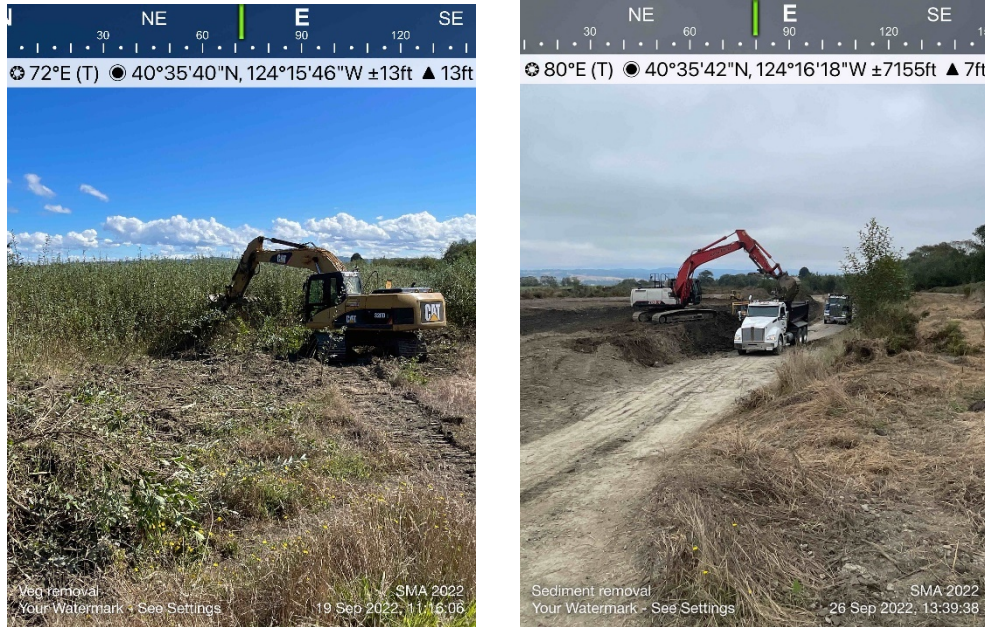
**Figure 5a (left) 2023 Removal of vegetation in the SMA. Figure 5b (right) 2023 Removal of sediment from the SMA.**

**Recommendation:** Perform vegetation control measures in summer 2023 if no clean out occurs. Perform visual evaluation in May 2023 to determine if sediment removal activities are required in fall of 2023.

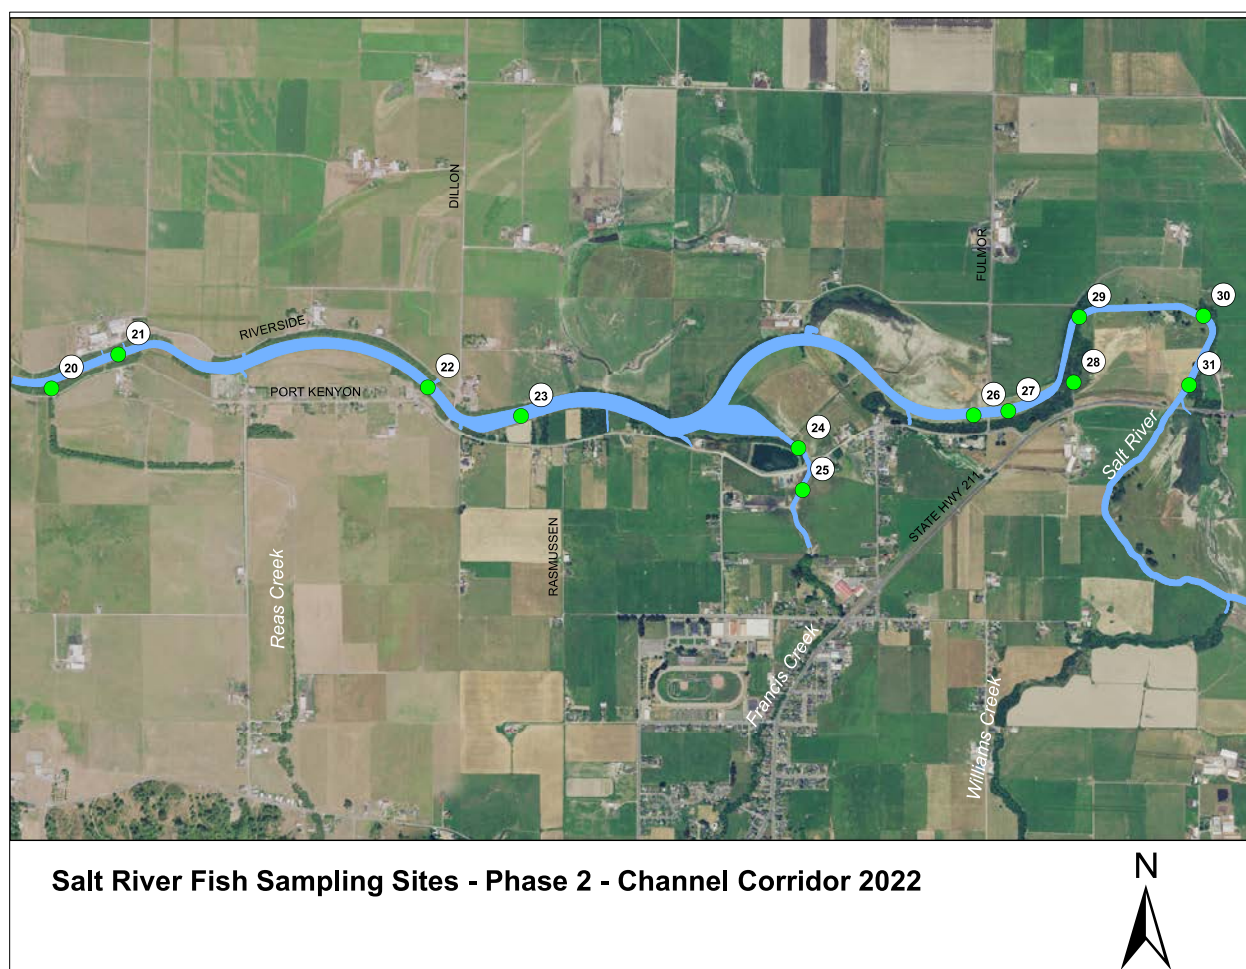
**Figure 8: Fish Monitoring Sites Across Phase 2 of the Salt River Ecosystem Restoration Project**

In 2022, once a month, from April to June, sites across the restored portions of Phase 2 (Figure 8) of the Salt River Ecosystem Restoration Project were surveyed for salmonids and tidewater gobies during low tide periods. Seven (7) sites on constructed portions of the Phase 2 restoration areas were selected and surveyed for fish presence and species distribution. The 2022 sites included sites #20, #24, #25, #26, #27, #29, and #31. These sites represent the diversity of channel size and habitats in the main Salt River channel and Francis Creek. Sites where the channel was wide enough were sampled using a 1/8th inch mesh pole seine net. Typically, a single pass with an 1/8-inch seine was made at each site. Non-seined sites were solely sampled by minnow traps which were deployed for at least an hour.

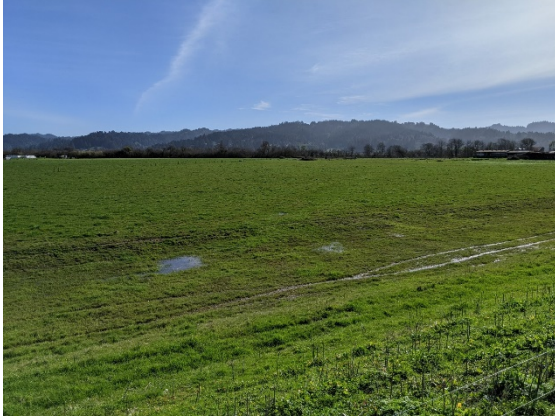
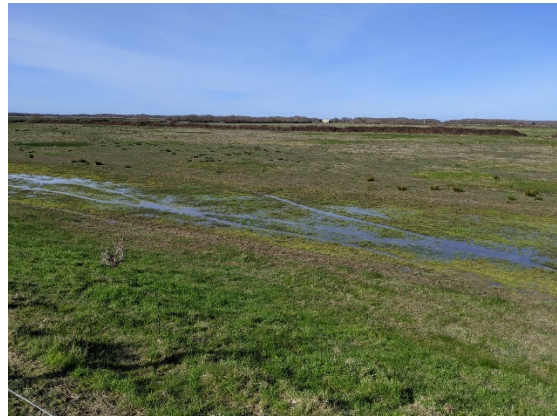
Riverside Ranch fields were sampled on February 4, 2022, prior to spring turnout. The fields were agriculturally managed by grazing with light weight cows (heifers). Cows were removed from the pastures in late winter. Grass sward heights were sampled across two fields where biologists determined geese would prefer to forage, as shrub and tree vegetation was minimal or absent. Sward heights were averaged and the values were 4.2 inches and 2.8 inches in the respective fields. CDFW recommends that sward height be in the range of 1.5 inches to 3 inches from December to March. The average sward height in field 1 (4.2 inches) exceeds the criteria range. However, field 1 appeared to have productive grass habitat and small water features that are more desirable to geese. Average sward height in field 2 (2.8 inches) falls within the range of the December-March criteria, however, the vegetation composition is not as desirable (sparse rye grass with wetland species) and frequent bare ground was observed (Figures 10a and 10b).

**Figure 10a: Field 1 shows lush pastures with water features. Figure 10b: Field 2 shows sparse pasture with juncus clumps, bare ground, and water features.**

**Recommendation:** Continue grazing management regime with lessee and annual monitoring efforts.
