# Salt River Ecosystem Restoration Project

## Habitat Mitigation and Monitoring Plan Monitoring Report 2022

Finalized March 2023

Prepared by the Humboldt County Resource Conservation District  
5630 South Broadway  
Eureka, CA 95503  
707.442-6058 ext. 5  
[hcrd@gmail.com](mailto:hcrd@gmail.com)

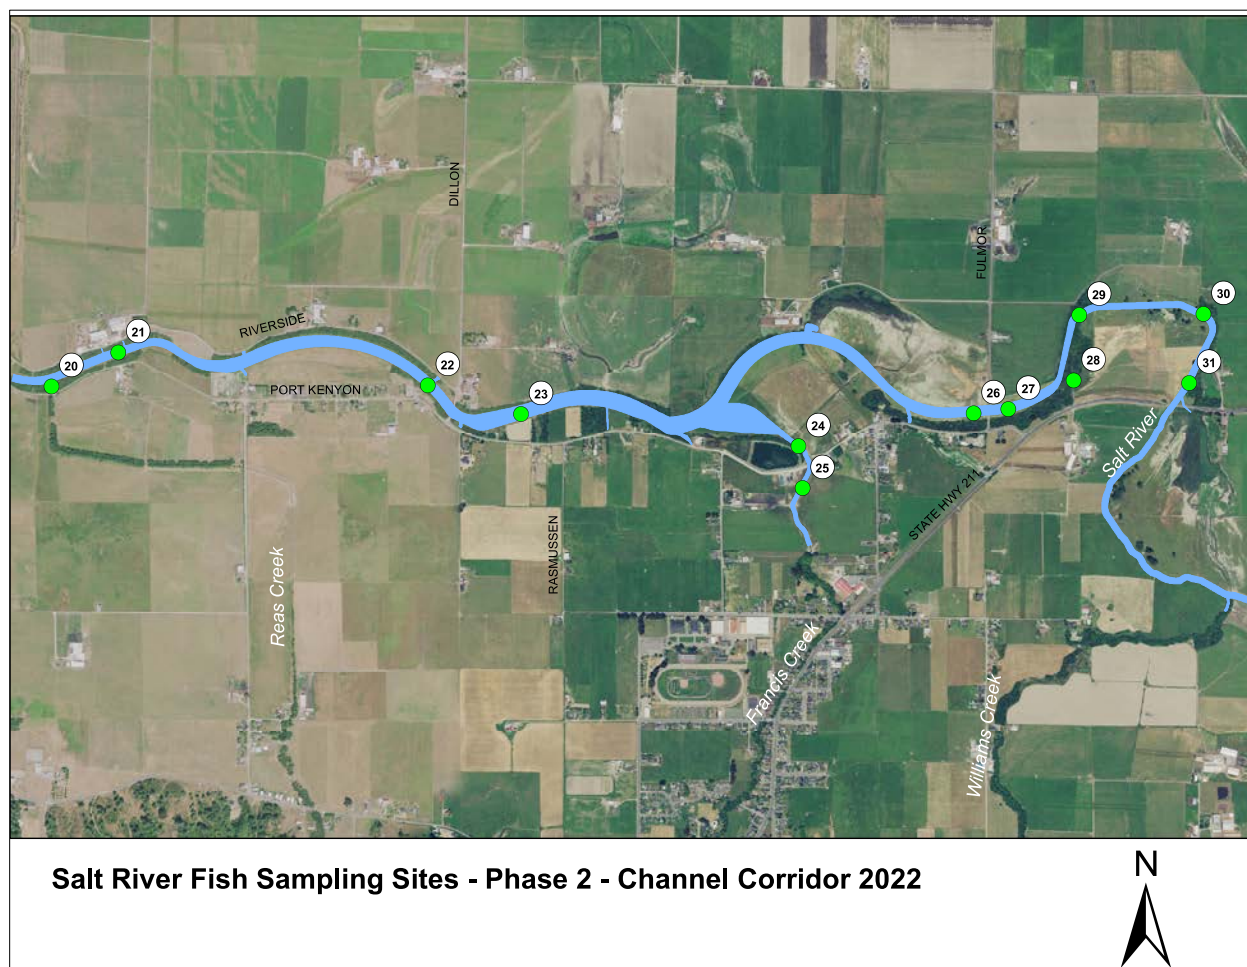
*Figure 2: Fish Monitoring Sites Across Phase 2 of the Salt River Ecosystem Restoration Project*

In 2022, once a month, from April to June, sites across the restored portions of Phase 2 (Figure 2) of the Salt River Ecosystem Restoration Project were surveyed for salmonids and tidewater gobies during low tide periods. Seven (7) sites on constructed portions of the Phase 2 restoration areas were selected and surveyed for fish presence and species distribution. The 2022 sites included sites #20, #24, #25, #26, #27, #29, and #31. These sites represent the diversity of channel size and habitats in the main Salt River channel and Francis Creek. Sites where the channel was wide enough were sampled using a 1/8th inch mesh pole seine net. Typically, a single pass with an 1/8-inch seine was made at each site. Non-seined sites were solely sampled by minnow traps which were deployed for at least an hour.

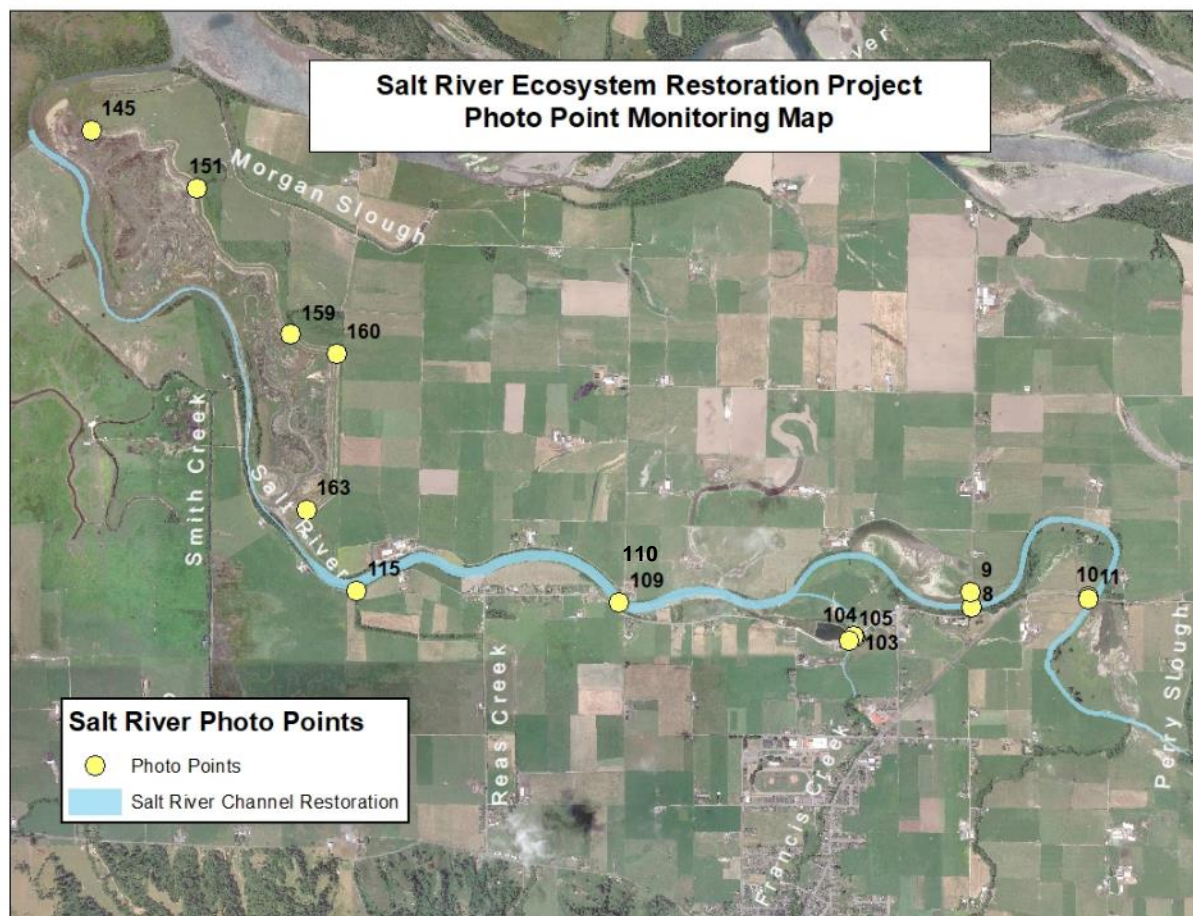
Figure 3: Photo Monitoring Points for the Constructed Footprint - 2022

Five photo monitoring sites were established across Phase 1 and ten sites across the completed Phase 2 channel corridor (Figure 3). Photos were taken prior to construction and annually post construction. The compass direction of the photo was recorded and

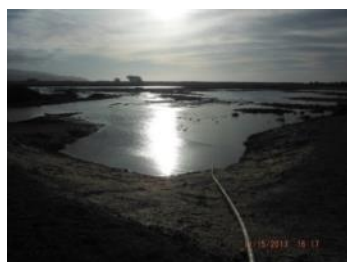
PP145 – SW – Nov 2013

Photo documentation indicates that vegetation continues to establish on Phase 1 and 2 where seed mixes are persisting and natural recruitment of natives, non-natives, and invasives are evolving. Some sites are experiencing increasing canopy cover.

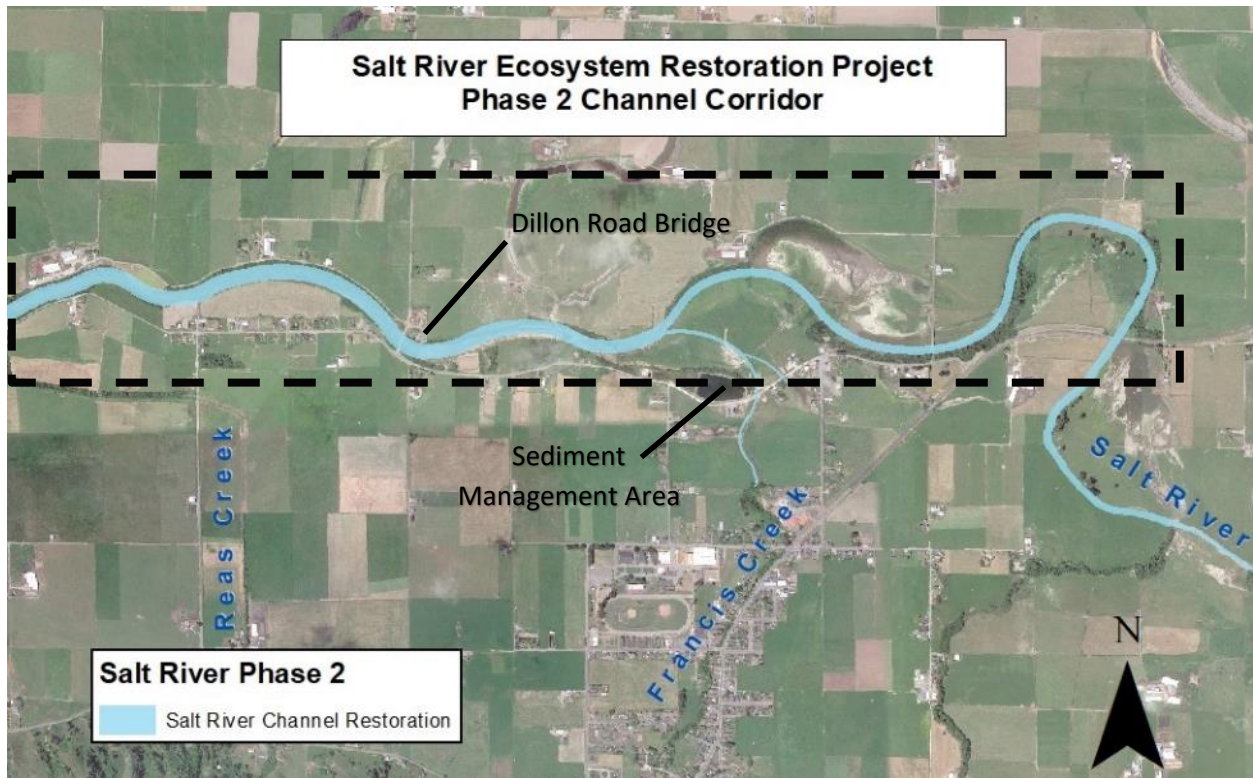
Figure 4: Salt River Phase 2 Channel Corridor. Dashed box delineates the Phase 2 channel that is constructed and surveyed.

three Humboldt County Resource Conservation District staff members noted observations of the channel's geomorphic condition when out in the corridor throughout the 2022 year (Figure 4).

**Results and Discussion:** The observational survey noted water presence throughout the Salt River Phase 2 active channel from Reas Creek to Francis Creek, where tidal influence was seen up to the Dillon Road Bridge area. Limited river flow occurred during wet winter months in the Salt River channel above the Francis Creek confluence, but was primarily dry in the summer and fall months, as no consistent flow input exists in this upstream area.

Established reaches of the Salt River channel (below the confluence of Francis Creek) were seen to have a channel bottom with a naturally formed thalweg, some undercut banks, and vegetated banks. The Salt River channel above the Francis Creek confluence is retaining its constructed channel trapezoidal geometry. Further observations gathered during the entire channel walk did not indicate substantial changes in the channel geometry from previous surveys. No new bank slumping, erosion, scour, or deposition were observed in or along the channel.

Some beds of cattail (*Typha sp.*) continue to be noted in the channel between the Sediment Management Area and Dillon Road Bridge. This area could slow down water flow, causing deposition within the river channel. It was noted that sections of the channel that had a closed riparian canopy and/or tidal influence did not contain in-channel vegetation. In 2022, maintenance of the channel included the excavation of aggraded sediments in the Salt River immediately upstream and downstream of the sediment management area (SMA) confluence, as well as wood debris removal within the Salt River channel approximately 1,000 feet upstream of the SMA.
