Salt River Ecosystem Restoration Project

Adaptive Management Plan Monitoring Report 2023

Finalized January 2024

Prepared by the Humboldt County Resource Conservation District
5630 South Broadway
Eureka, CA 95503
707.442-6058 ext. 5
info@hcrd.org

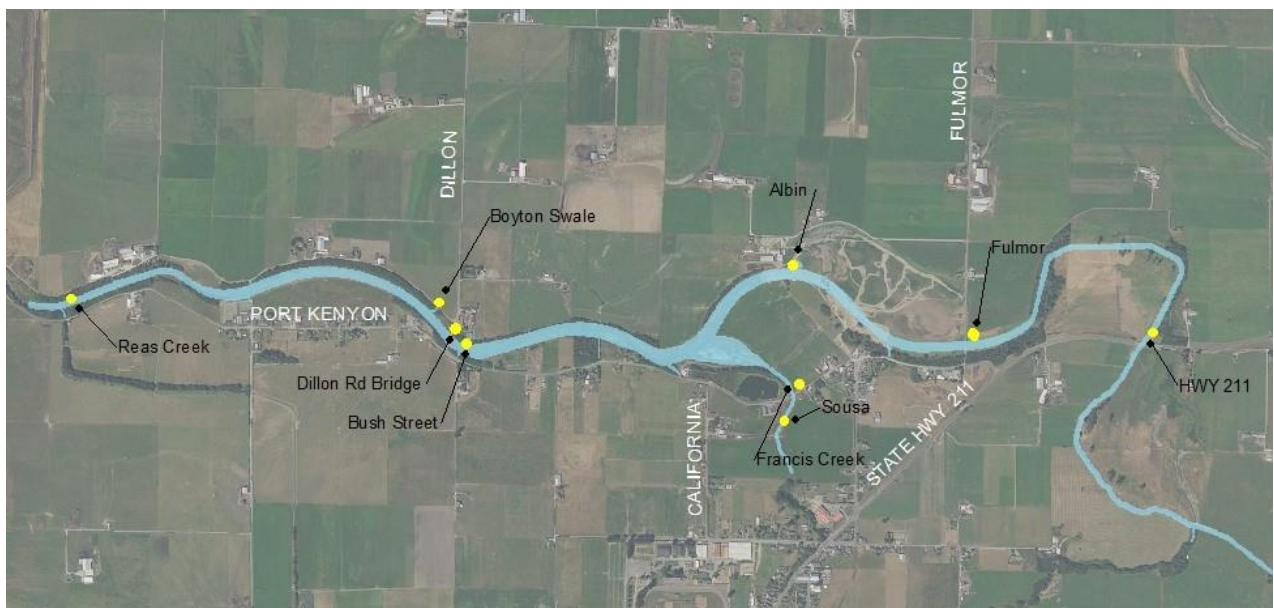
Figure 3: Bridges and Culverts Locations on the Salt River restored corridor

Results and Discussion: Four bridges (Dillion Road, Albin, Sousa, Francis, and Fulmor) span the restored Salt River channel. The Albin, Sousa, and Francis bridges were replaced or constructed as part of the Salt River restoration. Bridges were observed during variable flows throughout 2023 and no debris in the channel or flood plain is racking up on the bridge abutments or along banks. Erosion around the footings is not occurring. The Reas Creek and Bush Street culverts have been functioning during high and low flows and appear to be functioning normally. Further follow-up on the Bush Street culvert is merited due to the dense

vegetation blocking the tide gate from functioning fully. The drainage does not seem to be affected but the tide gate appears to have potential blockages preventing its ability to close completely. The Boynton Swale has been cleared and maintained by the landowners ensuring its continued function.

Recommendation: Continue to monitor bridges and culverts at high and low flows.

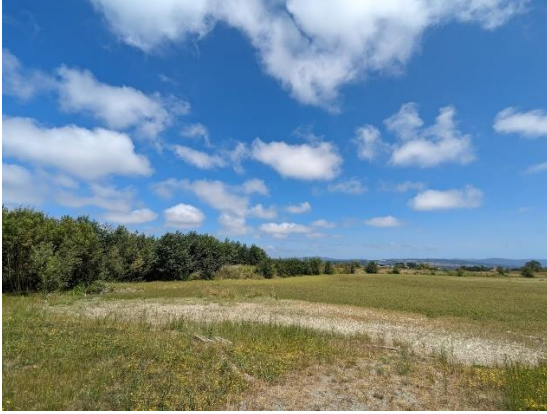
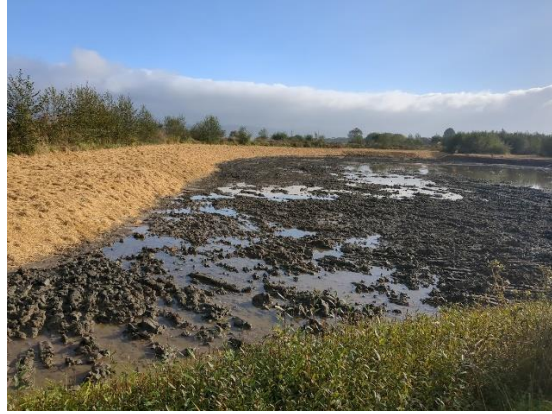
Figure 5a (left) 2023 before the removal of sediment from the SMA. Figure 5b (right) 2023 after the removal of sediment from the SMA.

Results & Discussion: The active sediment management area was evaluated in the summer of 2023 when surface water was confined to an established channel through the SMA. A topographic survey determined that the SMA warranted the removal of captured sediment. In June 2023, topographical surveys calculated that SMA captured approximately 16,150cy of sediment (the SMA can accommodate up to 15,000cy) (Figure 4). To prepare for the clean out of the SMA, a portion of the Francis Creek channel, from the SMA diversion structure to the confluence of the Salt River, was de-fished by CDFW in mid-June, and flow was diverted from the SMA into the SMA diversion channel to allow for the SMA collection basin to dry. Funding was secured for the excavation of sediments and delivery of sediments to

Recommendation: Perform vegetation control measures in summer 2024 if no clean out occurs to avoid the need to remove large vegetation during future cleanout activities. Perform a visual evaluation in May 2024 to determine if sediment removal activities are required in the fall of 2024.

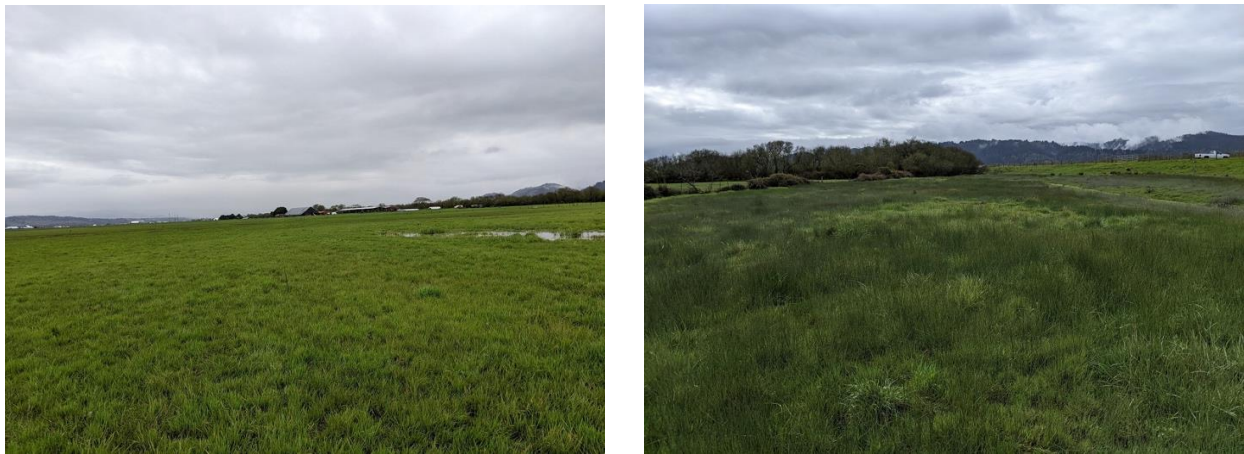
Riverside Ranch Pasture fields were evaluated for short grass habitat in March 2023. The fields were agriculturally managed by using lightweight cows (heifers) to graze the pastures. Cows were removed from the pastures in late winter. Grass sward heights were sampled across two fields where biologists determined geese would prefer in terms of access. Sward heights were averaged and the values equaled 5.47 inches and 5.52 inches in the respective fields. CDFW requires that sward height be in the range of 1.5 inches to 3 inches from December to March. The average sward height in field 1 (5.47 inches) is exceeding the criteria range. However, field 1 appeared to have productive grass habitat and small water features that are more desirable to geese (Figure 10a). The average sward height in field 2 is above the range of the December-March criteria, however, the vegetation composition is not as desirable (sparse ryegrass

with wetland species), and frequent bare ground was observed (Figure 10b).

Figure 10a: Field 1 (left) shows lush pastures with water features on the right of the photo. **Figure 10b:** Field 2 (right) shows a sparse pasture with *Juncus* clumps, bare ground, and a water feature that runs through the left side of the field in the image. Overall, the agricultural fields provide a habitat for migrating geese and other species.

Recommendation: Continue the grazing management regime with the lessee and annual monitoring efforts.
