Salt River Ecosystem Restoration Project

Habitat Mitigation and Monitoring Plan Monitoring Report 2023

Finalized January 2024

Prepared by the Humboldt County Resource Conservation District

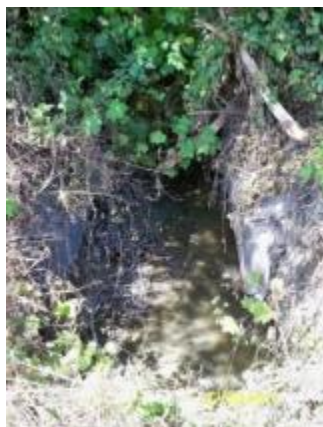
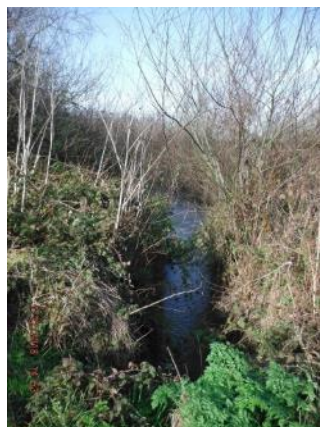
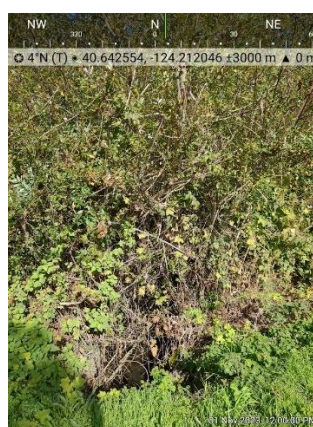
PP115 – Reas Ck – Jul 2011

Photo documentation indicates that vegetation continues to establish in Phase 1 and 2 where seed mixes are persisting and natural recruitment of natives, non-natives, and invasives are evolving. Some sites are experiencing increasing canopy cover.
