Salt River Ecosystem Restoration Project

Adaptive Management Plan Monitoring Report 2020

Finalized February 2021

Prepared by the Humboldt County Resource Conservation District
5630 South Broadway
Eureka, CA 95503
707.442-6058 ext. 5
hcrd@gmail.com

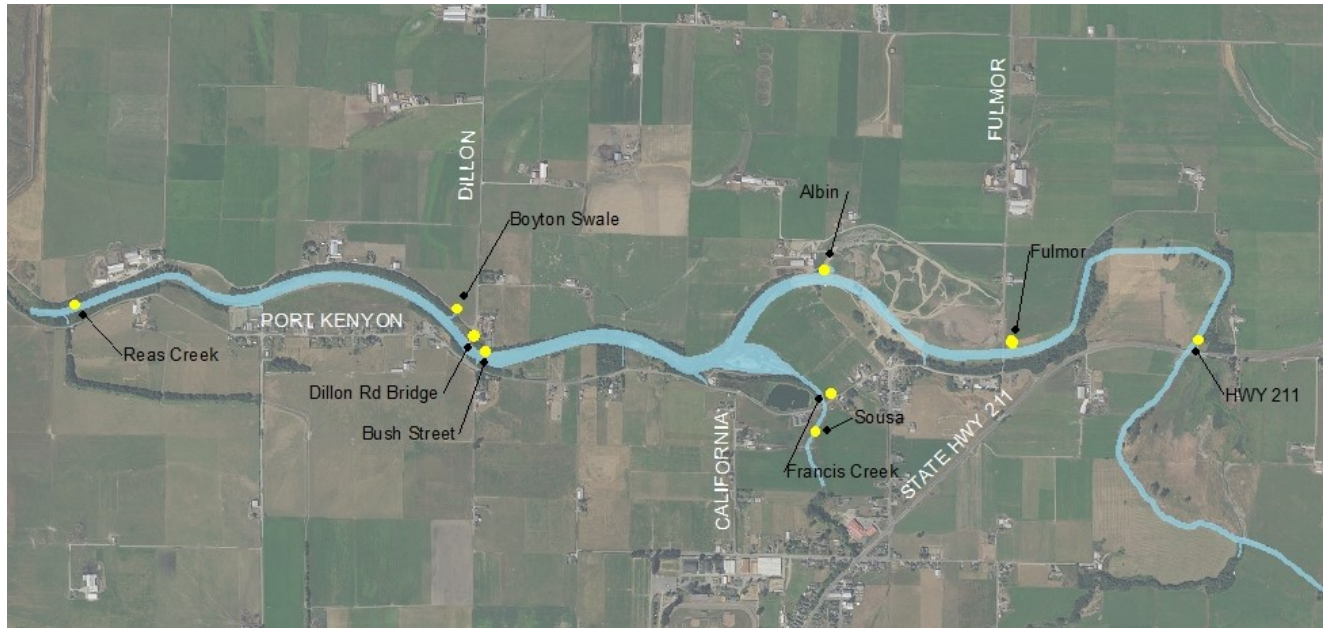
Figure 8: Bridges and Culverts Locations on the Salt River restored corridor

Results and Discussion: Four bridges (Dillion Road, Albin, Sousa, Francis, and Fulmor) span the restored Salt River channel as of the 2019 monitoring period. The Albin, Sousa, and Francis were bridges replaced or constructed as part of the Salt River restoration. All bridges were observed during low and high flows and no debris in the channel or flood plain are racking up on the bridge abutments or installed rock slope protection. Erosion around the footings is not occurring. The Reas Creek, Boynton Swale, and Bush Street culverts have been functioning during high and low flows and appear to be functioning normally. Further follow up on the Bush Street culvert is merited due to dense vegetation obscuring visual observation and possibility that vegetation will eventually impede the opening of the flap gate on the outlet of the culvert.

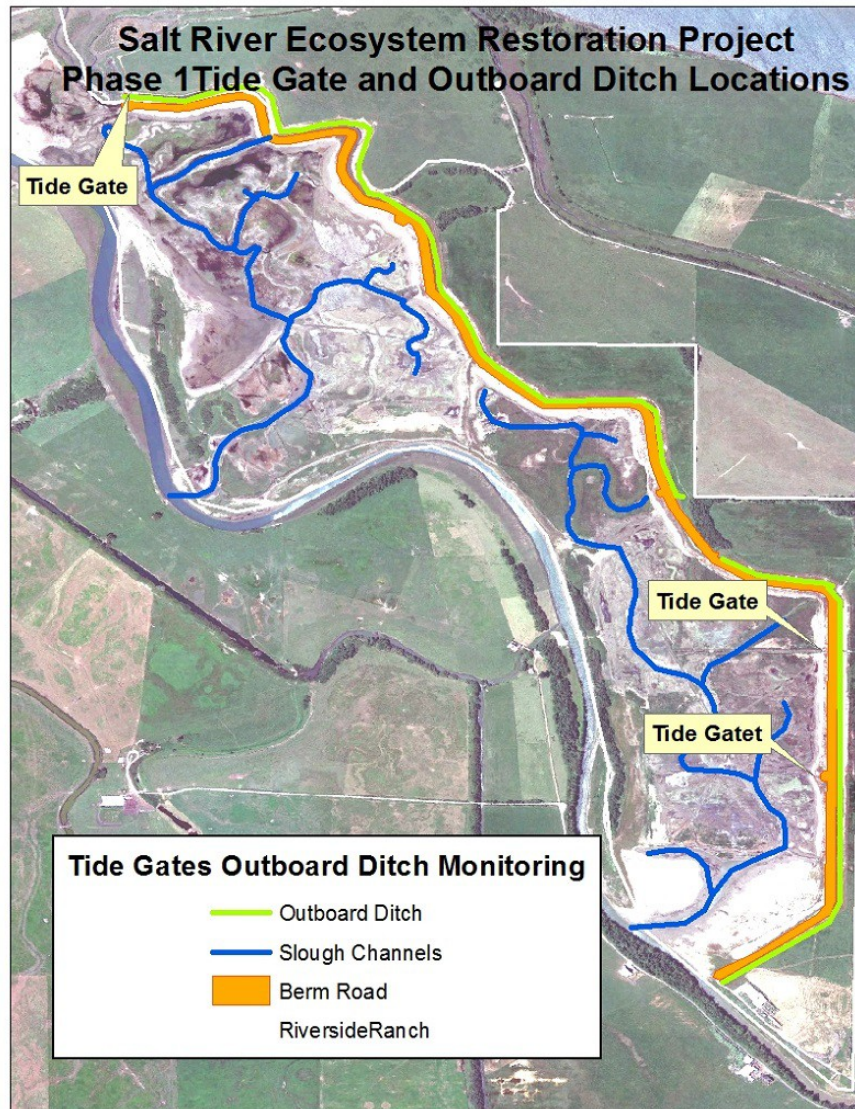
Figure 23: Tide Gates and Outboard Ditch Locations

Results and Discussion: The Phase 1 (Riverside Ranch) project area is monitored for various items, which include the three tide gates and the outboard ditch. The 2020 monitoring was conducted on a periodic basis. No culverts remain on Riverside Ranch; all culverts were removed during construction. The installed tide gates are functioning as expected. No debris has been observed to obstruct the closing or opening of the tide gates. Vegetation in the outboard ditch is managed through grazing activities by the agricultural lessee.
